Uneven illumination surface defects inspection based on convolutional neural network

Abstract—The Surface defect inspection based on machine vision is affected by uneven illumination. In order to improve the inspection rate of surface defects inspection under uneven illumination condition, this paper proposes a method for detecting surface image defects based on convolutional neural network, which is based on the adjustment of convolutional neural networks, training parameters, changing the structure of the network, to achieve the purpose of accurately identifying various defects. Experimental on defect inspection of copper strip and steel images shows that the convolutional neural network can automatically learn features without preprocessing the image, and correct identification of various types of image defects affected by uneven illumination, thus overcoming the drawbacks of traditional machine vision inspection methods under uneven illumination.

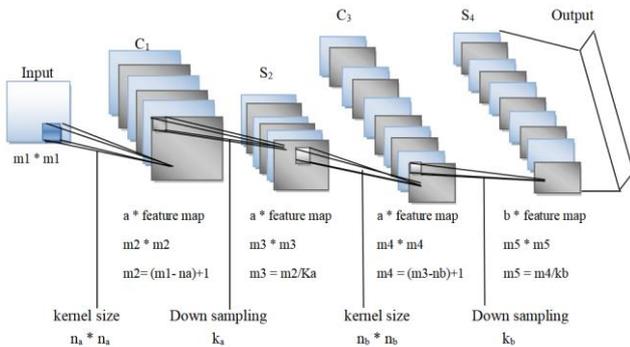
LeNet-5 is one of the convolutional neural networks [18], and its structure is shown in Figure 1: LeNet-5 structure were seven layer structure. First as the input layer of input, then C1 is the convolution layer, which contains a Four feature map, the convolution kernel size is $n_a \times n_a$, and the feature map size after the convolution operation is $m_2 \times m_2$. S2 Sampling is the next layer, comprising feature image with number of a , each feature in C1 neurons corresponding features of $n_b \times n_b$ local neighborhood as input. C3 is also a convolution layer, a feature maps has the size of $m_4 \times m_4$. S4 is the downsampling layer, including b feature maps, each of the neurons in each feature map of S4 corresponds to C3 feature map. Subsequent to S4 is a fully connected layer containing neurons. The final output layer consists of radial basis functions used to identify defects.

Fig. 1. Convolutional neural network structure .

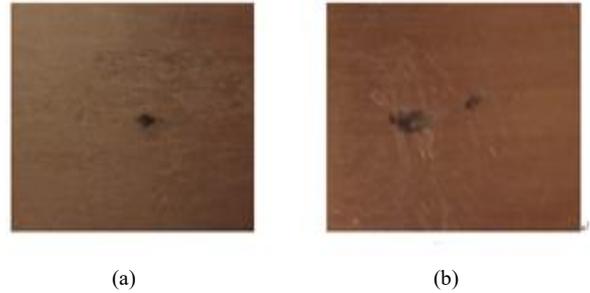
Firstly, collect a set of surface images such as copper strip image image samples, including 30 training images, where the normal number is 15, the defective number is 15. And 30 test images, 15 of which are normal and others defective. For simple defects such as inclusions, pits, and flaking, the defect images are shown in Figure 2 : where these defects are obvious, the right part area is darker than the left area , that is, they are affected by uneven illumination .

Fig. 2. Defect copper image samples. (a): inclusions; (b): pits.

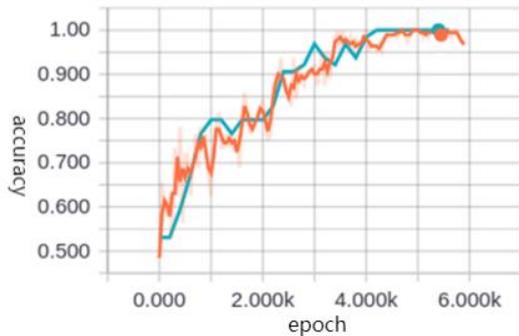
Based on the computer configuration, and there is no GPU built, the training is cost for 2 hours, and the correct rate and loss during the training. The function changes are shown in Figure 3 and Figure 4 below. The orange and blue curves represent changes in the training set and the validation set, respectively.

It can be clearly seen from Fig. 3 and Fig. 4 that at the beginning of training, the loss function is about 0.6 and the correct rate is about 0.5. As the number of training steps increases, the loss function gradually decreases, and the correct rate gradually increases. When it reaches 2000, the loss function is about 0.5, and the correct rate is about 0.8. When the number of training steps reaches 5000, the loss function has been reduced to about 0, and the correct rate is close to 1. Therefore, according to the displayed results, the model for classifying the copper strip image defect inspection and identification is satisfactory. Therefore, the trained model is saved, and then the selected model is tested on the trained model.

Fig. 3. Correct rate change curve: training set (orange) and verification set (blue)

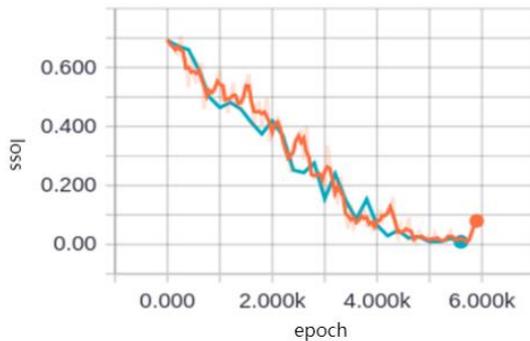
Fig. 4. Loss function curve: training set (orange) and verification set (blue)

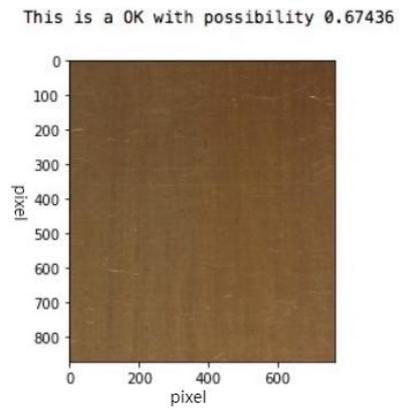
Fig. 5. Qualified sample test results

It can be seen from Figure 5 that there is no defect in the image of the copper strip image tested, it is a complete good copper strip image, and the result of the experimental model output " this is OK with possibility 0.67436 ", it is also a correct determined for the copper strip image. The probability of judgment is approximately 0.674. The judgment is correct.

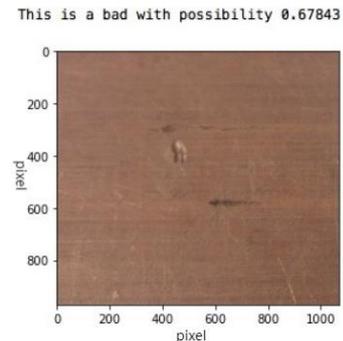
Furthermore, there are obvious defects in Figure 6. The test results show that the possibility of the copper strip image being defective is 0.678. Thus, the judgment result is correct. After several consecutive tests, the experimental results were the same as above, and no judgment errors occurred.

Fig. 6. Defective sample test result
