3^{RD} European Conference on Plasma Diagnostics 6^{TH} - 9^{TH} of May 2019 Lisbon, Portugal

Observation of thermal events on the plasma facing components of Wendelstein 7-X

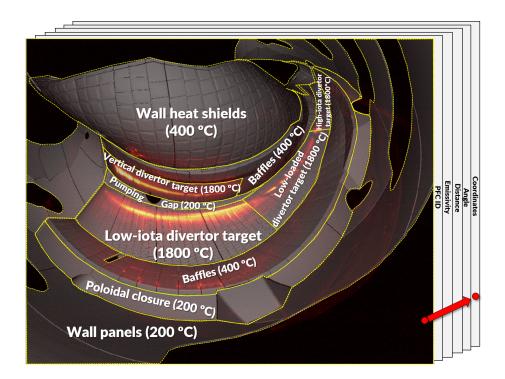
Figure 1. The PFCs as seen from the endoscope camera. The immersion tube cameras have the same view but with less distortion. The scene model and the OP1.2 operational limits are overlaid on top of the image.

The first divertor operational phase OP1.2 of Wendelstein 7-X (W7-X) concluded in October 2018 [1]. W7-X is composed of 5 symmetric modules equipped with 10 divertors, i.e., 5 upper and 5 lower units. During this operational phase inertially-cooled test divertor units (TDUs), made of fine-grain graphite and with the same geometry as the water-cooled divertor, were used. In addition, a thermography diagnostic was commissioned to provide real-time protection of plasma facing components (PFCs) [2] in order to avert the danger of damaging the high-heat flux (HHF) divertor, able to withstand 10 MW/m². Apart from observing the divertors, the thermography diagnostic observes other PFCs such as the baffles, the inner wall heat shields as well as the outer wall and pumping gap panels. The baffles and heat shields are also made of fine grain graphite and are limited to a heat flux of 0.5 MW/m² and a surface temperature of 400 °C. The wall and pumping gap panels are made of stainless steel and are limited to 0.2 MW/m² and 200 °C (see Figure 1).

spots due to the heating systems, fast particle losses and surface layers. The detection algorithm uses a scene model that provides pixel-wise information of the PFCs (see Figure 1), which requires a precise geometric calibration of the cameras to fit the CAD model to the strongly distorted images [3]. The surface temperature of the thermal event is computed taking into account for each pixel the target emissivity, its distance and the angle of the line of sight respect the normal to the surface. The world coordinates are then used to measure the physical size and the position of the event in order to evaluate its risk.

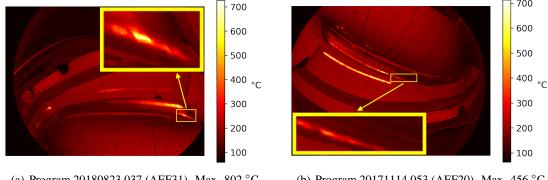
(a) Program 20180823.037 (AEF31). Max. 802 °C

(b) Program 20171114.053 (AEF20). Max. 456 °C

Figure 2. (a) Hot spots were detected in the baffle above the vertical target in the high-mirror and standard configuration in all modules, but specially in module 3 in the high-mirror configuration. These hot spots were caused by an island at the edge, which is intersecting the baffle next to the divertor target. It is still unclear if this is due to a misalignment of the baffles or to the magnetic field structure caused by error fields. Some experiments were conducted to try to remove these heat loads by adjusting the control coil currents. By making the island bigger the heat loads were diverted to other targets in the same island chain. The heat load on the baffle was greatly reduced but the hot spot remained. (b) The strike-line in the vertical target extends towards the baffle in the high-mirror configuration due to a high current (>2.5 kA) in the control coils that enlarge the magnetic islands at the edge. This limited the maximum current that could be applied to the control coils in this configuration.

Several thermal events were detected during the OP1.2 that limited operation and these will have to be addressed before the steady-state operation starts (see Figure 2). Other thermal events did

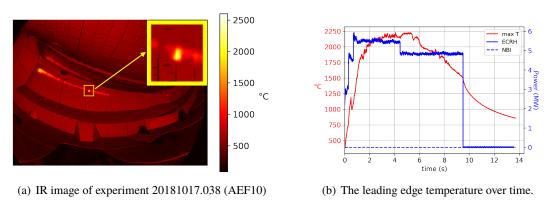
Figure 4. A 10 mm long leading edge was overloaded reaching a maximum temperature of 2229 °C.

In general, the divertor plates intersect the magnetic field lines at a shallow angle to effectively spread the power loads over larger areas, but misalignments of the divertor modules or fingers may result in prominent edges and, hence, higher heat loads that can exceed the operational limits of the tiles [4]. One of the goals of OP1.2 was to assess the effects of leading edges on the plasma performance, in preparation for the HHF divertor operation phase. Overloading of leading edges can lead to excessive release of carbon into the plasma and, as a result, cause a premature termination of the discharge, which can significantly hinder the steady state operation. Dedicated experiments, with increasing injected energy, were carried out in order to overload a well-known leading edge and evaluate its effect (see Figure 4). Despite a significant carbon release, the plasma survived until the end of the discharge in all of the experiments, suggesting that the plasma edge effectively shields the plasma core. However, these impurities will accumulate in steady-state operation and overloading of leading edges must be avoided. Moving the strike-line position away from an overloaded leading edge can be achieved by means of the control coils, a special set of coils placed under the divertor modules which can change the topology of the magnetic islands at the edge. An advanced algorithm is currently under development to change in real-time the control coil currents and the strike-line position to avoid these overloads.

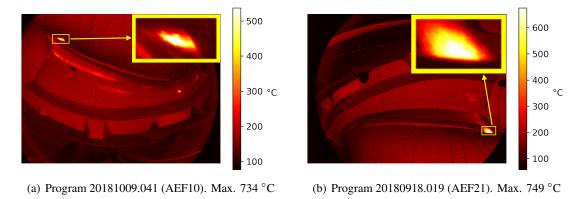
Figure 5. (a) The ECRH causes an overload of the inner wall heat shields. (b) The NBI beam 7 hits the wall and a shine-through hot spot is detected the inner wall heat shields (failed experiment without plasma).

Shine-through hot spots caused by the ECRH, which operated at a maximum power of 7.5 MW, and NBI heating systems, which operated at 1.8 MW for 5s, were also detected on the wall heat shields in OP1.2. The ECRH shine-through hot spots were observable with the infrared cameras placed at the opposite side of the inner wall. In OP1.2b the NBI heating system was used for the first time with one neutral injector and two different beams in operation (called source 7 and 8). Only the beam dump of source 7 was directly observable by an IR camera. Examples of these wall overloads can be seen in Figure 5.

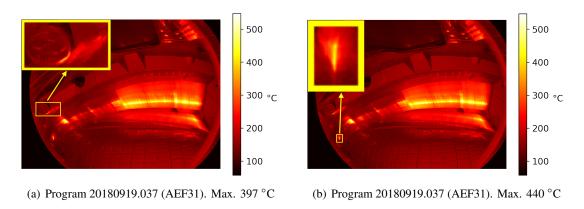
Figure 6. (a) A hot spot due to fast ion losses from the NBI is detected on the protection collar of one of the immersion tubes. (b) A hot spot is detected on the baffle next to the high-iota divertor targets due to the NBI.

According to simulations [5] hot spots caused by fast ion losses were expected at the walls, baffles and some diagnostic ports due to the NBI operation. The monitoring of these hot spots is of vital importance to guarantee a safe operation of the NBI (see Figure 6).

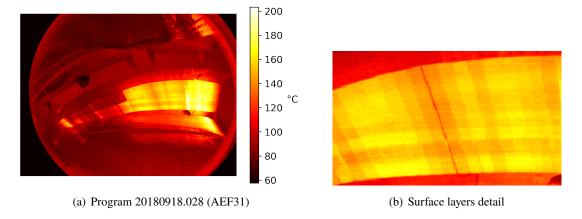
Figure 7. The complex pattern of erosion and deposition layers on the divertor in thermal equilibrium.

Carbon erosion caused by the strike-line produces thin surface layers on the PFCs due to redeposition. They show as hot spots due to their low thermal capacity and their poor thermal connectivity to the underlying material. In W7-X, the magnetic configuration and the bootstrap current can change the strike-line position and, hence, the erosion-deposition patterns (see Figure 7). This means that the imaging system has to detect the surface layers in real-time in order to avoid false alarms [6].
