A Review on Environmental Barrier Coatings: History, Current State of the Art and Future Developments

Daniel Tejero-Martin, Chris Bennett, Tanvir Hussain*

Faculty of Engineering, University of Nottingham, Nottingham, NG7 2RD, UK

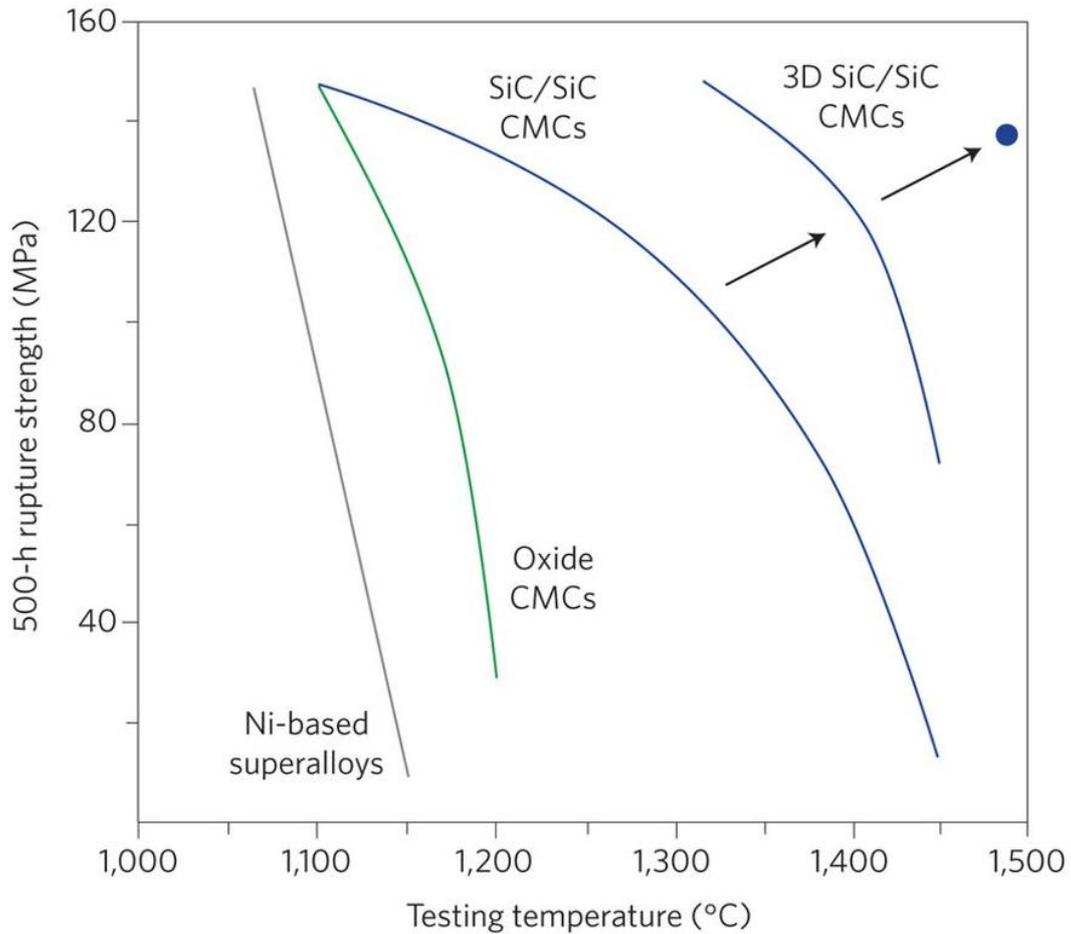
Figure 1: Rupture strength after 500 h of continuous exposure versus testing temperature of Ni-based superalloys, oxide CMCs and various SiC/SiC CMCs. The blue point is the 300 h rupture strength [2]

Gas turbine engines for aerospace and energy generation represent the cornerstone of a rapidly growing sector, with an estimation of 2 trillion USD for the cumulative sales of gas turbine engines in the 2017-2031 period [1]. Due to this considerable economic presence, there is a great interest for the development of better performing components. Ni-based super-alloys have been for the past decades the norm for components in the hot section of gas turbine engines. Improvements on thermal barrier coatings and cooling mechanisms have allowed the industry to increase the gas inlet temperatures up to 1500 °C [2,3], driving upwards the thermal efficiency, the thrust-to-weight ratio and reducing the emission of noxious by-products. Nevertheless, this strategy is approaching the intrinsic limit imposed by the melting point of Ni-based super-alloys, and novel strategies will be needed to further increase the gas inlet temperature. A new approach is required for the next breakthrough in jet engines, and SiC/SiC ceramic matrix composites are the most promising material to fulfil the role. When compared to Ni-based super-alloys, CMCs provide an increased melting point and superior strength at high temperature, as it can be seen on Figure 1.

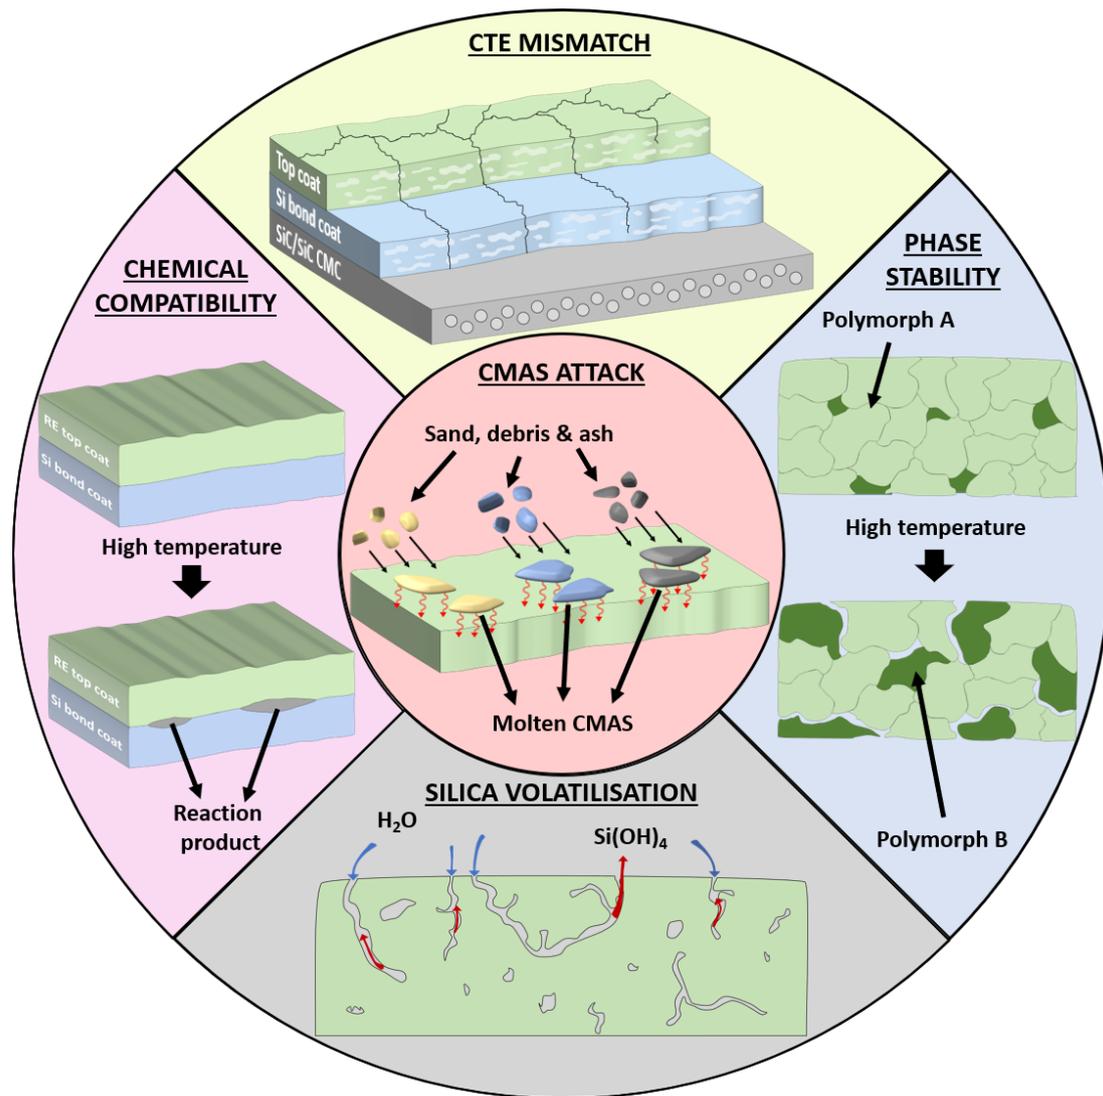
Figure 2: Schematic of the main five requirements that any successful EBC is expected to fulfil.

As it can be seen in Figure 2 high temperature induces a series of phenomena that determine whether the EBC will remain protective and fulfil its role, or fail. At the top, a representation of the effects of a mismatch in the CTE is shown. Due to the presence of heating and cooling cycles during service, thermal expansion and contraction will take place for each of the components of the EBC. If the magnitude of their CTE is too different from each other, the thermal stresses induced will lead to the formation of cracks. On the right sector it can be seen how the presence of polymorphs can affect. The as-deposited coating might show a majority of polymorph A, but at high temperatures there might be a phase transformation into polymorph B, which can be accompanied by a noticeable volume contraction (or expansion), causing cracking and defects such as porosity. At the bottom, the process of silica volatilisation is presented. The presence of steam at high temperature induces the formation of silica containing gases, such as Si(OH)_4 , producing the recession of the material. On the left, the chemical compatibility between the layers present is shown. Materials that at room temperature might show good compatibility and stability might become reactive and produce unwanted by-products when exposed to high temperatures for extended periods of time. Finally, in the middle, the presence of various debris

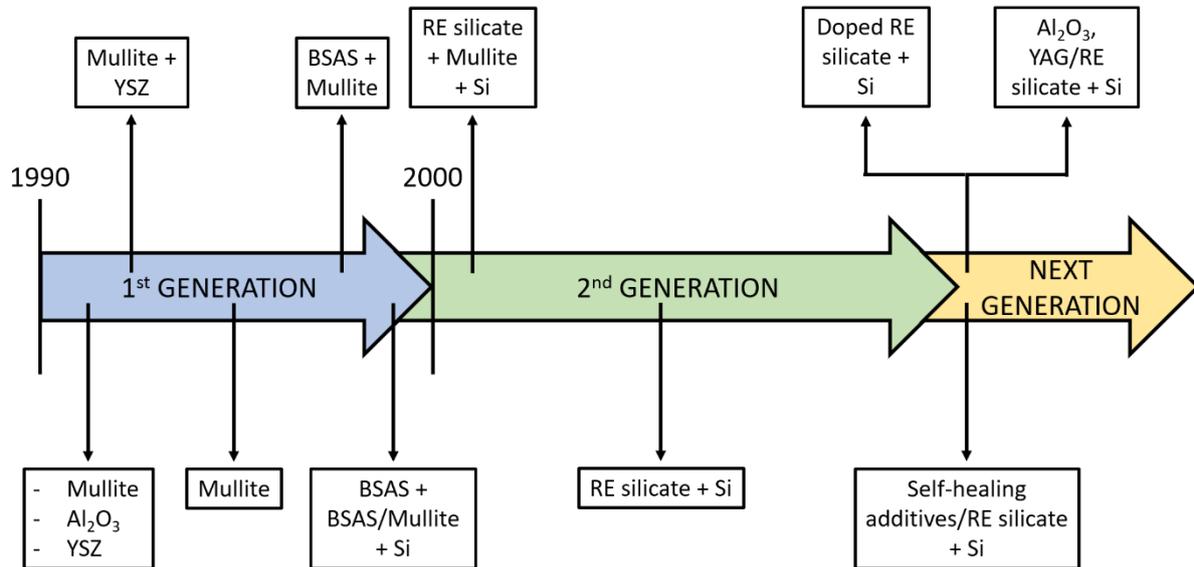
Figure 3: Timeline of the evolution in the design of EBCs, including some of the major compositions used

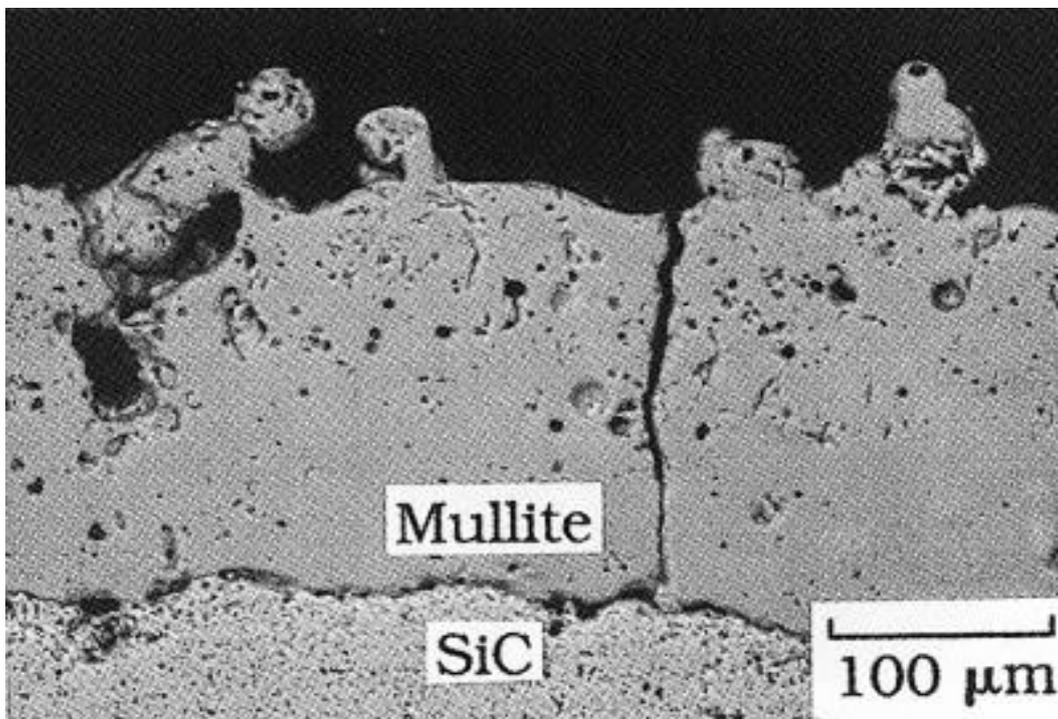
Figure 4: Mullite coated SiC after ten 20 h cycles between room temperature and $1400\text{ }^\circ\text{C}$ showing cracks due to the crystallisation process [18]

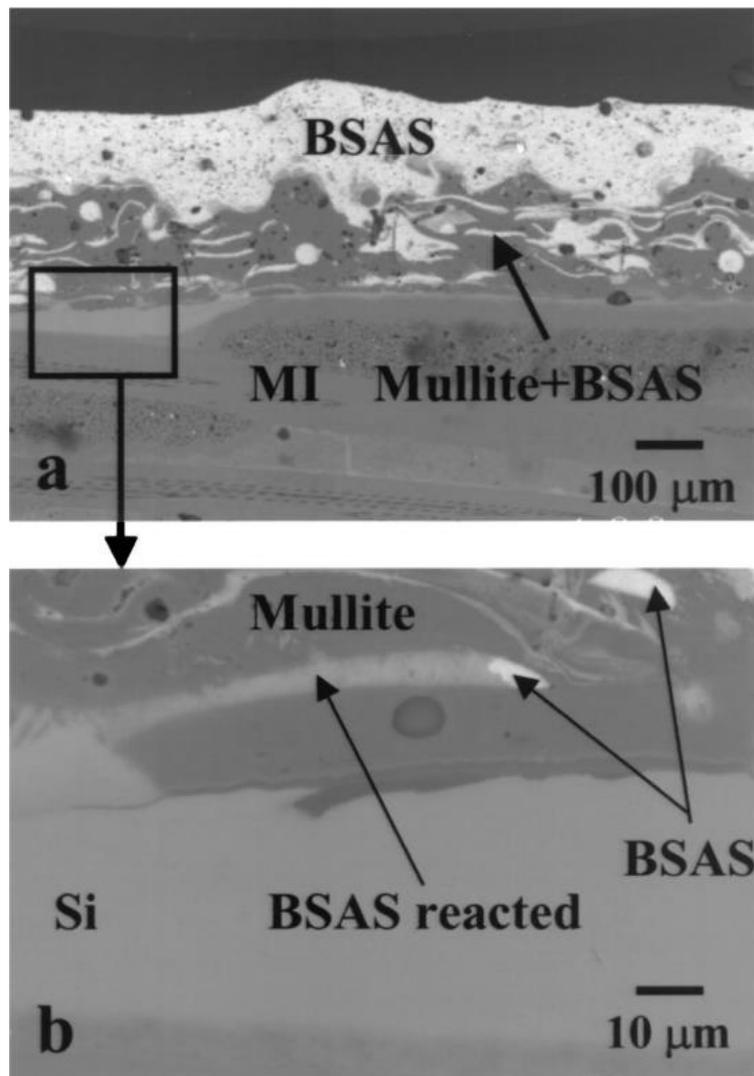
Figure 5: Cross section of the Si/(mullite-BSAS)/BSAS EBC deposited on melt infiltrated SiC/SiC continuous-fibre-reinforced composite (MI CFC) after 100 h in 90% H₂O - 10% O₂ at 1300 °C [29]

Despite the clear advancements made possible by this first generation of EBCs, some issues still limited the performance of the coatings and the maximum temperature capable of withstanding. When BSAS was first identified as a promising EBC, due to the fulfilment of the two main requirements described so far, namely CTE match with SiC and phase stability, tests were conducted to evaluate the performance of BSAS directly deposited on CMC. Thermal cycling at $1300 \text{ }^\circ\text{C}$ under an atmosphere of $90\% \text{ H}_2\text{O} - 10\% \text{ O}_2$ for 100 h showed extensive reaction between BSAS and the thermally grown silica layer, causing large pores at the interface [29]. The reaction caused the appearance of a low-melting ($\sim 1300 \text{ }^\circ\text{C}$) glass product and interfacial porosity. Such pores were formed due to the bubbling of gaseous species, product of the BSAS – silica reaction, ultimately leading to the spallation of the coating. In order to overcome the nefarious interaction between BSAS and silica, a chemical barrier was applied. The already mentioned modified mullite-BSAS bond coat provided an improvement on the durability of the EBC, showing reduced oxidation when tested under the same conditions described above. The addition of a bond coat did not, however, completely prevented the reaction between BSAS and silica. After 1000 h at $1300 \text{ }^\circ\text{C}$ under an atmosphere of $90\% \text{ H}_2\text{O} - 10\% \text{ O}_2$, evidence of this glassy by-product was observed, as shown in Figure 5.

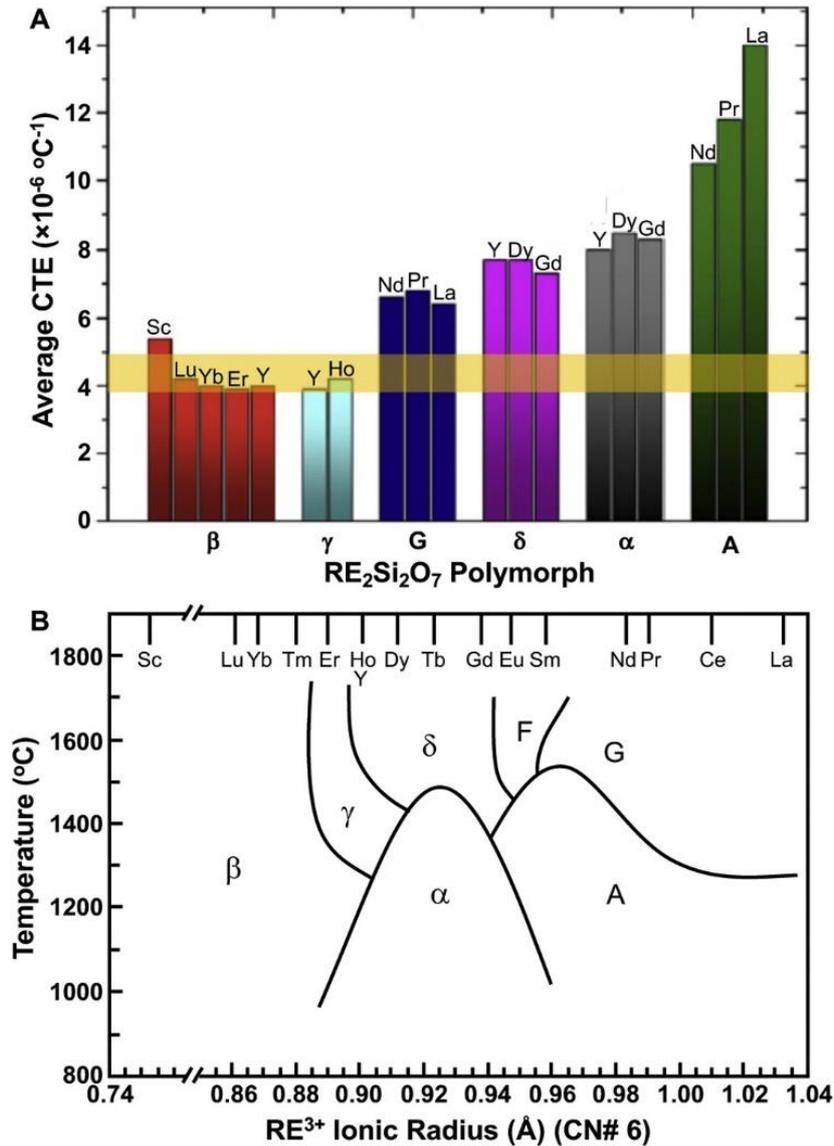
Figure 6: (A) Average CTE of rare earth disilicates polymorphs. The horizontal band indicates the range of CTE values for SiC CMCs. (B) Diagram of the different polymorphs present within rare earth disilicates according to temperature [36]

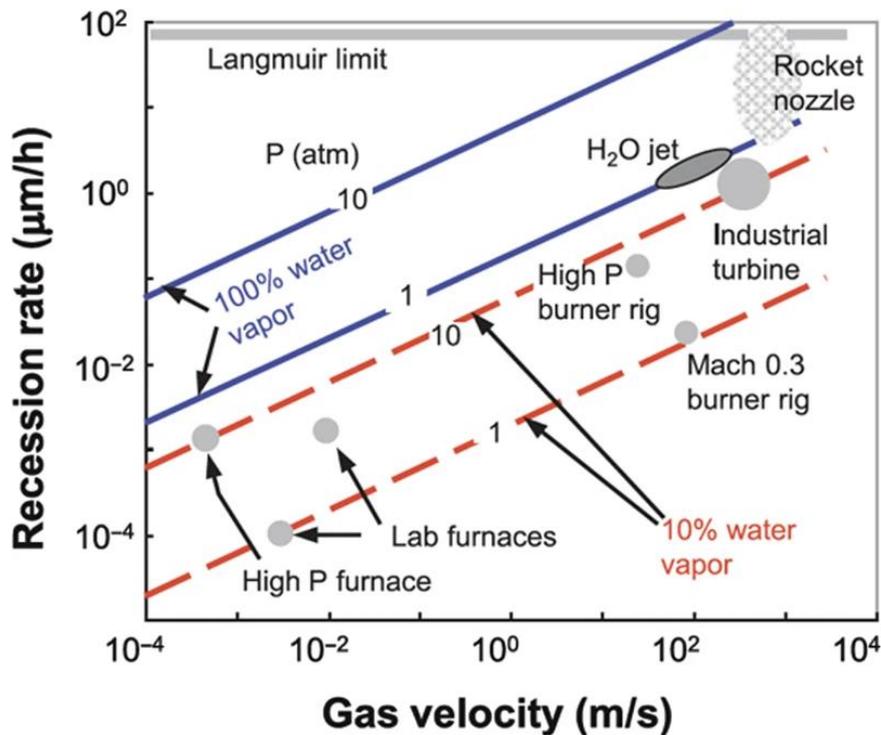
Figure 7: Recession rate for SiC under different conditions, in all cases being the temperature 1316 °C and assuming linear flow [1]

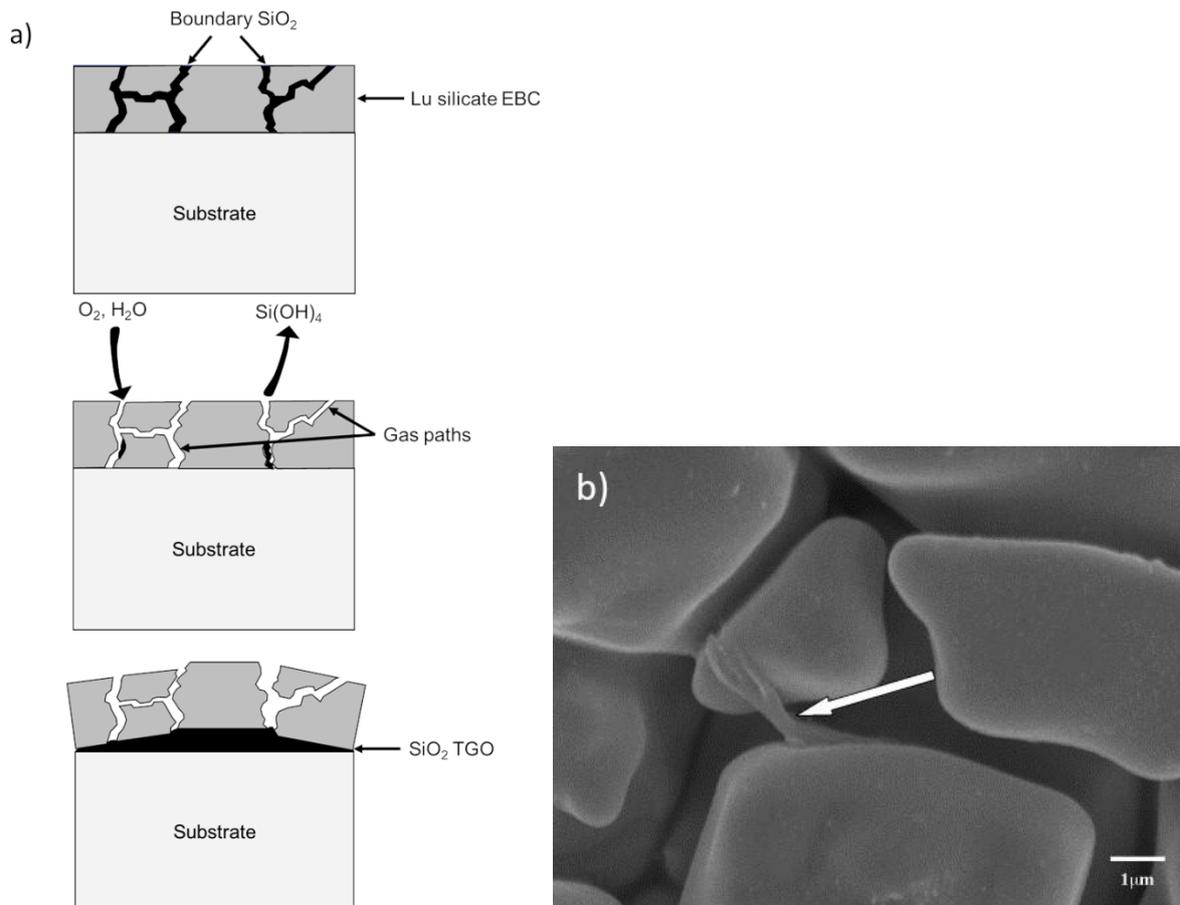
Figure 8: a) Schematic of the corrosion attack caused by hot steam on a Lu silicate EBC layer on a silicon nitride substrate, showing the volatilisation of the SiO_2 grain boundary and the access of oxidisers to the substrate underneath. b) SEM image of the corrosion experienced at the grain boundaries after steam testing at 1300 °C with 30% H_2O /70% air for 100 h and a gas flow rate of 175 ml/min. Redrawn from [44,46]

The presence of silica at the grain boundary was the cause of the failure of the coatings, since its removal upon interaction with the steam caused the formation of gas paths within the coating, as can be seen in Figure 8. These gas paths provided an entry for oxidisers into the substrate underneath, causing excessive oxidation and mass gain of the tested samples.

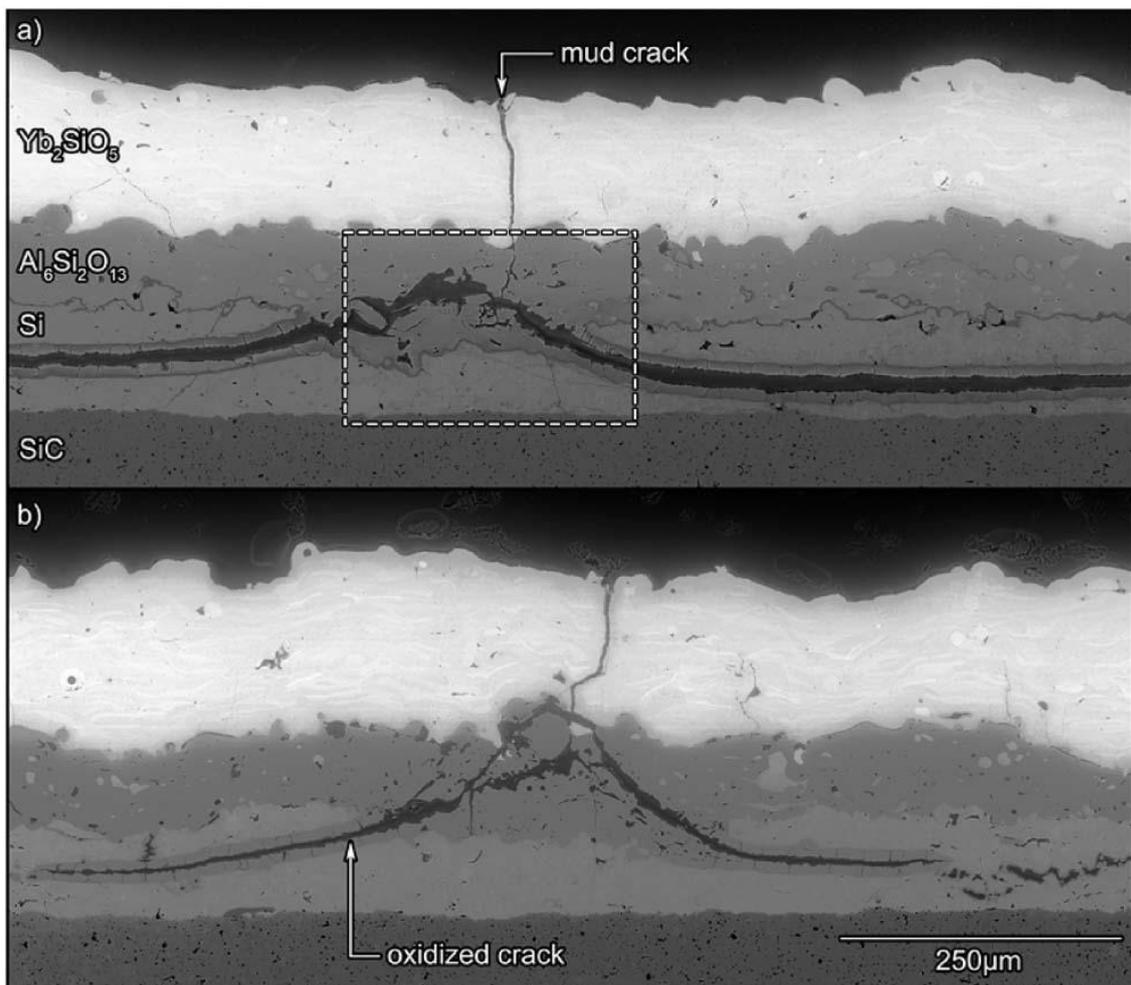
Figure 9: SEM images of the cross section of the failed coating after 250 1-h steam cycles [56]

present in the coating, combined with the CTE mismatch between the layers, produced the failure of the system through the appearance of vertical cracks (mud cracks), as shown in Figure 9, after annealing in air at 1300 °C for 20 h. Those same mud cracks were partially responsible for the poor performance of the coating under steam cycling conditions (1 atm pressure, flow velocity of 4.4 cm/s, 90% H₂O/10% O₂ environment, 60 min at 1316 °C and 10 min at 110 °C), presenting spallation after less than 200 cycles. It was concluded that despite the considerable efforts concerning the optimisation of the deposition method, the characteristics of the deposited coating and the adherence between the layers, the CTE mismatch was too great to produce a successful EBC. Vertical cracks would appear during the heat treatments, as it can be seen in Figure 9, providing a preferential path for the ingress of oxidisers, which then reacted with the Si bond coat, producing the failure of the EBC.

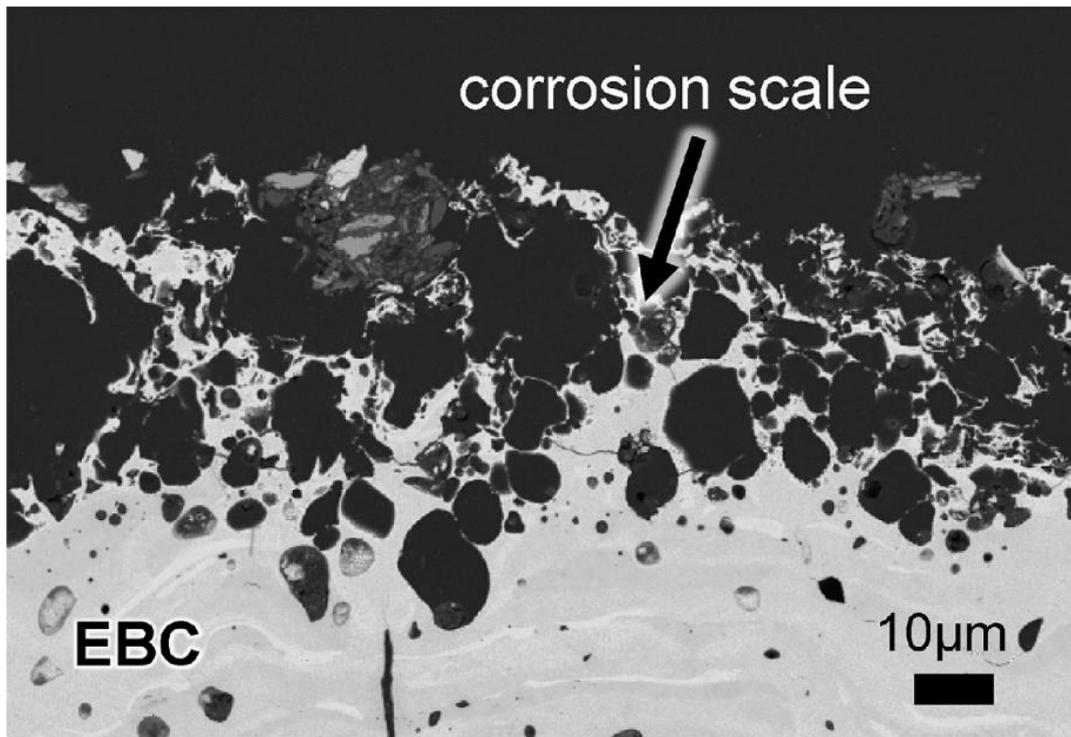
Figure 10: BSE SEM image of the cross section of a ytterbium disilicate coating deposited using APS and exposed to steam corrosion (temperature: 1200 °C, gas flow velocity: 100 m/s, $P_{H_2O} = 0.15 \text{ atm}$, $P_{total} = 1 \text{ atm}$, time = 200 h) [57]

When considering the effect that flowing steam at high temperature has on EBC systems it is necessary to remember that an EBC is expected to behave as a gas-tight layer, reducing the penetration of oxidisers to the substrate underneath. Nevertheless, as it has been shown before, several factors can affect the physical integrity of the EBC, in which case the coating loses its gas-tight characteristic, causing the system to experience a shortened effective life. Two main mechanisms can be identified as the cause for the structural failure of the coatings. First, as described before, flowing steam at elevated temperatures will induce the volatilisation of silica from the rare earth silicate top coat. Even in the ideal scenario of a homogenous material removal from the coating, this mass loss will eventually lead to the failure of the coating, leaving exposed the unprotected component beneath. On top of this, material removal due to silica volatilisation is rarely a homogenous process in coatings. Differences in the phase content, porosity level and surface roughness cause hot spots for volatilisation and erosion due to the flowing steam, producing accelerated material removal, as reported by Bakan *et al.* [57] and shown in Figure 10.

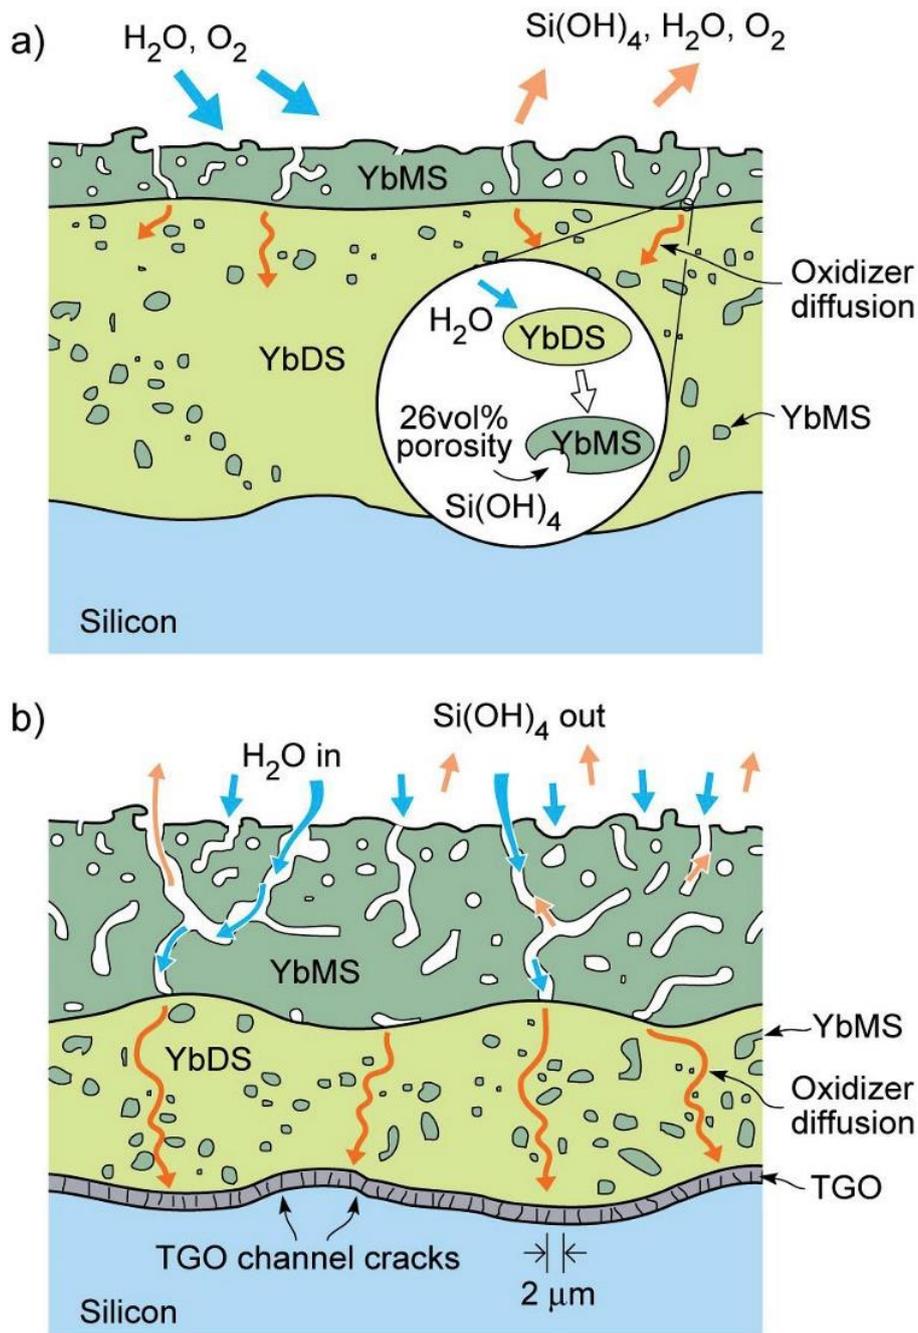
Figure 11: Schematic representation of the volatilisation of silica from the initial YbDS and formation of YbMS. (a) shows the initial stage of the process, while (b) shows the late stages [69]

This volatilisation not only removes material from the top coat, reducing the time required for oxidisers to diffuse to the silicon bond coat, but also can cause the appearance of connected porosity, which represents a preferential pathway for the ingress of oxidisers. This phenomenon, reported by Richards *et al.* [69] on a APS deposited YbDS top coat with a Si bond layer, tested under steam cycling conditions (total pressure of 1 atm, oxygen partial pressure of 0.1 atm, flow velocity of 4.4 cm/s, 90% H₂O/10% O₂ environment, 60 min at 1316 °C and 10 min at 110 °C for up to 2000 h), is shown below in Figure 11.

Assuming that the only volatile product produced is $Si(OH)_4$, the transformation from YbDS into YbMS, described in Equation 7, implies a volume reduction of 26%. This coupled with the increased content of YbMS (which has a higher CTE when compared to SiC) produced a CTE mismatch that induced thermal stresses upon cycling testing, producing vertical cracks and facilitating the access of oxidisers to the silicon bond coat. This preferential access of oxidisers to the silicon bond coat produced a quick growth of the TGO.

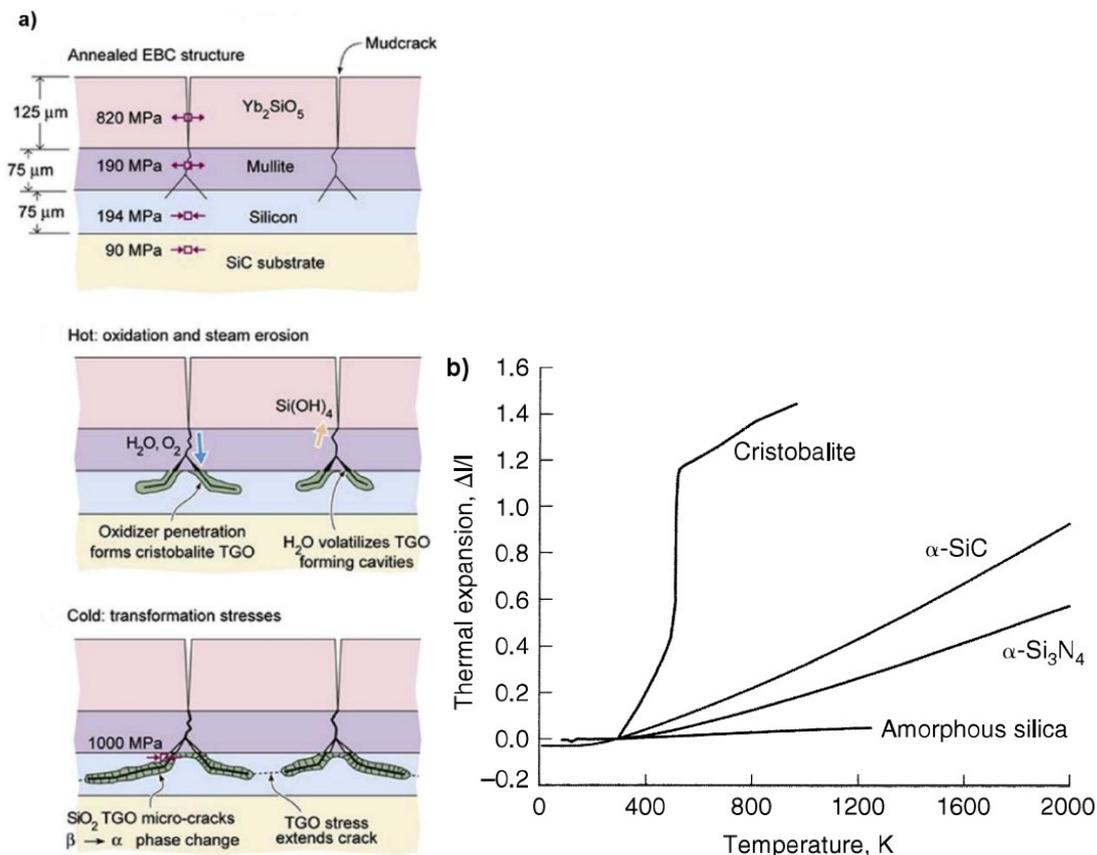
Figure 12: a) Schematic of the spallation process induced on multilayer EBC systems due to the formation of β -cristobalite TGO and the transformation to α -phase upon cooling, causing cracking. b) Change of the coefficient of thermal expansion with temperature on cristobalite, SiC, Si_3N_4 and amorphous silica [56] [9]

In addition to the volatilisation of the rare earth silicate, failure of EBCs exposed to steam containing environments can take place due to the appearance of vertical cracks and spallation. Regarding vertical cracks, they can be formed due to CTE mismatch between the initial compositions of the different layers, as mentioned before, or due to the formation of a new phase with a different CTE value. This situation may arise in the case of top layers made of rare earth silicates with several polymorphs. The newly formed cracks allow the access of oxidisers to the silicon bond coat, inducing the rapid growth of a β -cristobalite TGO. Upon cooling below $\sim 220^\circ\text{C}$, this β -cristobalite SiO_2 , transforms to the α -phase, process accompanied by a volume reduction of approximately 4.5% [55,56]. This process promotes the formation of cracks parallel to the interface, which eventually lead to the coating spallation, as shown in Figure 12a. Figure 12b shows the mentioned change of the CTE of cristobalite with temperature, seeing a sharp change around $\sim 220^\circ\text{C}$ ($\sim 500\text{K}$).

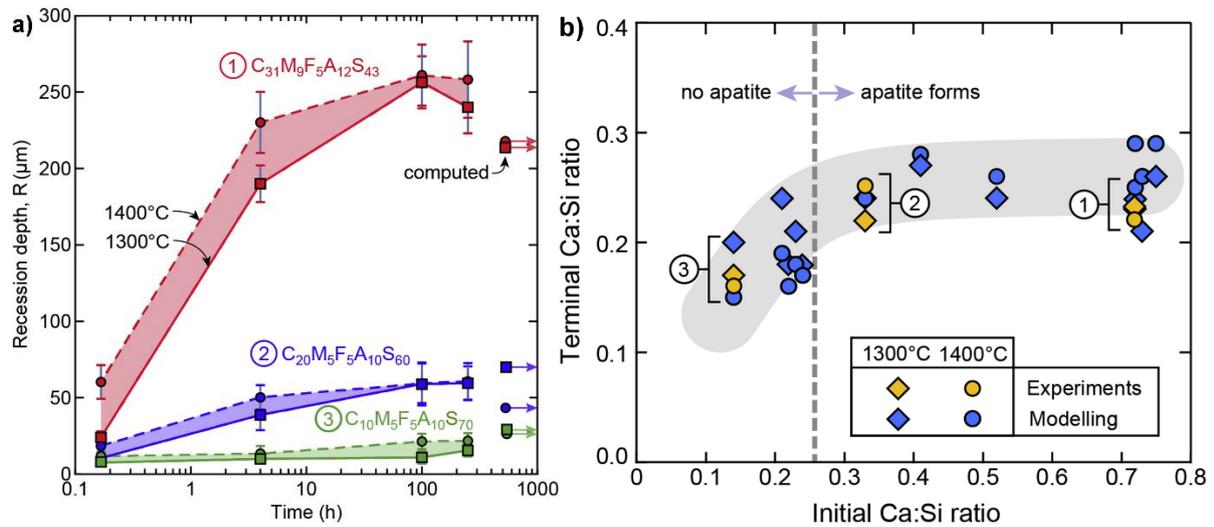
Figure 13: a) Experimental data on recession depth of the YDS surface after CMAS attack with different compositions. Theoretically derived values are represented to the right as "computed" (1) indicates a CaO rich composition, (2) an intermediate CaO composition and (3) a CaO lean composition. b) Terminal Ca:Si ratio versus initial Ca:Si after heat treatment of YDS for two temperatures and three CMAS compositions, both from theoretical calculations and experimental results. The dashed grey line represents the minimum initial Ca:Si ratio discovered for the formation of apatite precipitates [77]

mentioned previously, and different compositions have been demonstrated to present different reactions [75,76], as shown in Figure 13.

Despite the wide range of effects described in Table 3, accounting for the variability in rare earth silicates tested, the different CMAS compositions and testing conditions, some general features can be observed. First of all, if reaction between the rare earth silicate and the CMAS does occur, precipitation of RE-Ca-Si apatite is the most common product, with the appearance in occasions of β -SiO₂ cristobalite. This reaction will produce the recession of the coating and appearance of defects such as cracks or porosity. However, reaction with CMAS is not always guaranteed, and penetration of CMAS can also take place without almost interaction, particularly for lower Ca-containing CMAS compositions. This infusion of CMAS into the EBC is undoubtedly undesirable, as it can lead to blister damage as shown in Figure 15b. Secondly, as mentioned before, the CaO content present in the chosen CMAS composition plays a key effect in the corrosion mechanism observed and its severity. Higher CaO contents will have a more nefarious interaction with the top coat in terms of recession rates and precipitation of apatite. On the other hand, lean CaO compositions are still highly undesired due to the potential switch from silicate-CMAS reaction to CMAS penetration, as shown in Figure 13b.

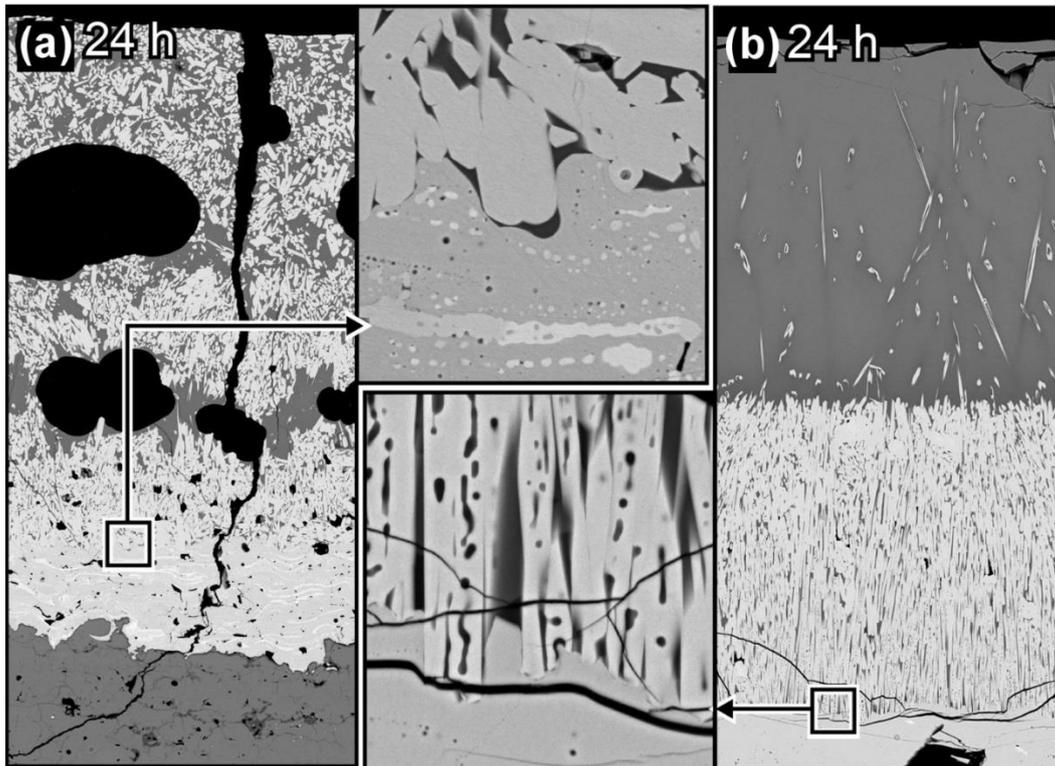
Figure 14: YDS and CMAS interaction after 24 h at 1300 °C in air where an APS-deposited coating (a) is shown versus a sintered body (b). The same CMAS composition and testing conditions were used in both cases.

Another factor that should be considered is that the majority of the studies regarding rare earth silicates and CMAS have been reported on sintered pellets or bulk material. Sintered bodies or bulk materials, as discussed with the steam interaction, can provide useful information, but should be treated carefully if conclusions are to be extracted regarding coatings produced through thermal spraying, as required per many sectors of the industry. Additionally, these studies tend to be performed in phase-pure fully crystalline materials, which does not accurately represent the reality of deposited coatings. The differences between tests performed on sprayed coatings and sintered bodies are clearly represented in Figure 14.

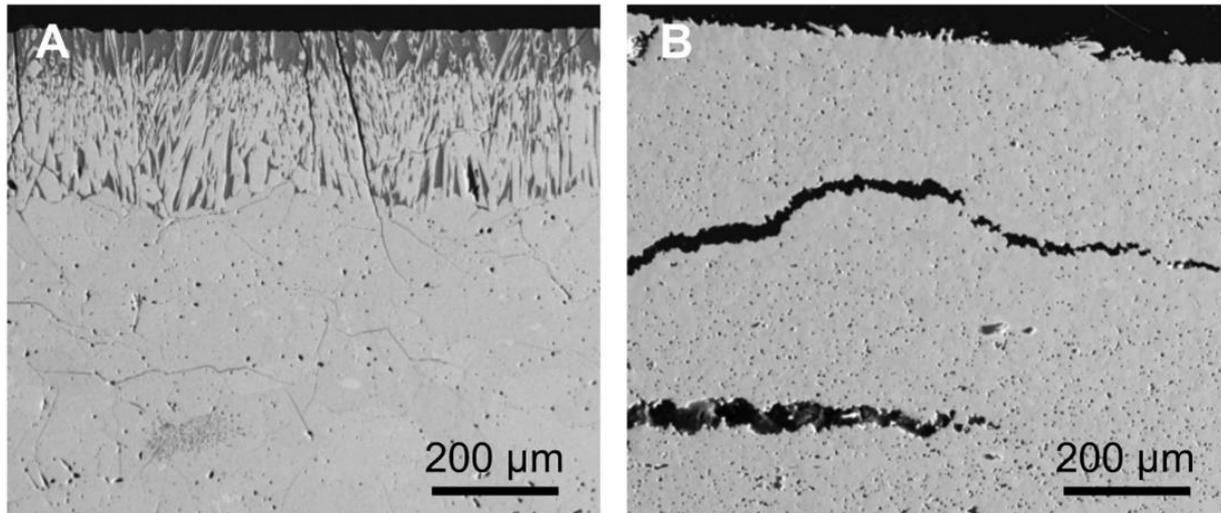
Figure 15: Cross-section SEM images of rare earth silicates pellets exposed to CMAS at 1500 °C for 24 h. Image A corresponds to $Y_2Si_2O_7$ and image B to $Yb_2Si_2O_7$. Adapted from [36]

Although the degradation suffered by EBCs due to CMAS is highly variable depending on the testing temperature, the composition of the CMAS used, the deposition method chosen and the composition of the EBC top coat (pure phase or mixed phases), as mentioned above, several common aspects have been discovered when studying the interaction of rare earth silicates and CMAS at high temperatures. Two main degradation mechanisms have been identified, with examples being shown in Figure 15. The first interaction observed involves the reaction between the molten CMAS and the EBC top coat. Such mechanism has been reported for Y_2SiO_5 and $Y_2Si_2O_7$ [15,75,77,79–83], in which the reaction with the CMAS produces the dissolution of the EBC followed by the recrystallisation of yttrium monosilicate and Y-Ca-Si apatite in solid solution, forming characteristic needle-like structures, as it can be seen in Figure 15a. The second possibility is based not on the reaction between CMAS and the top coat, but on the penetration of the CMAS material along grain boundaries, reaching deeper layers of the EBC and causing “blister” damage, as seen in Figure 15b for $Yb_2Si_2O_7$, due to the dilatation gradient caused by the slow penetration of CMAS.

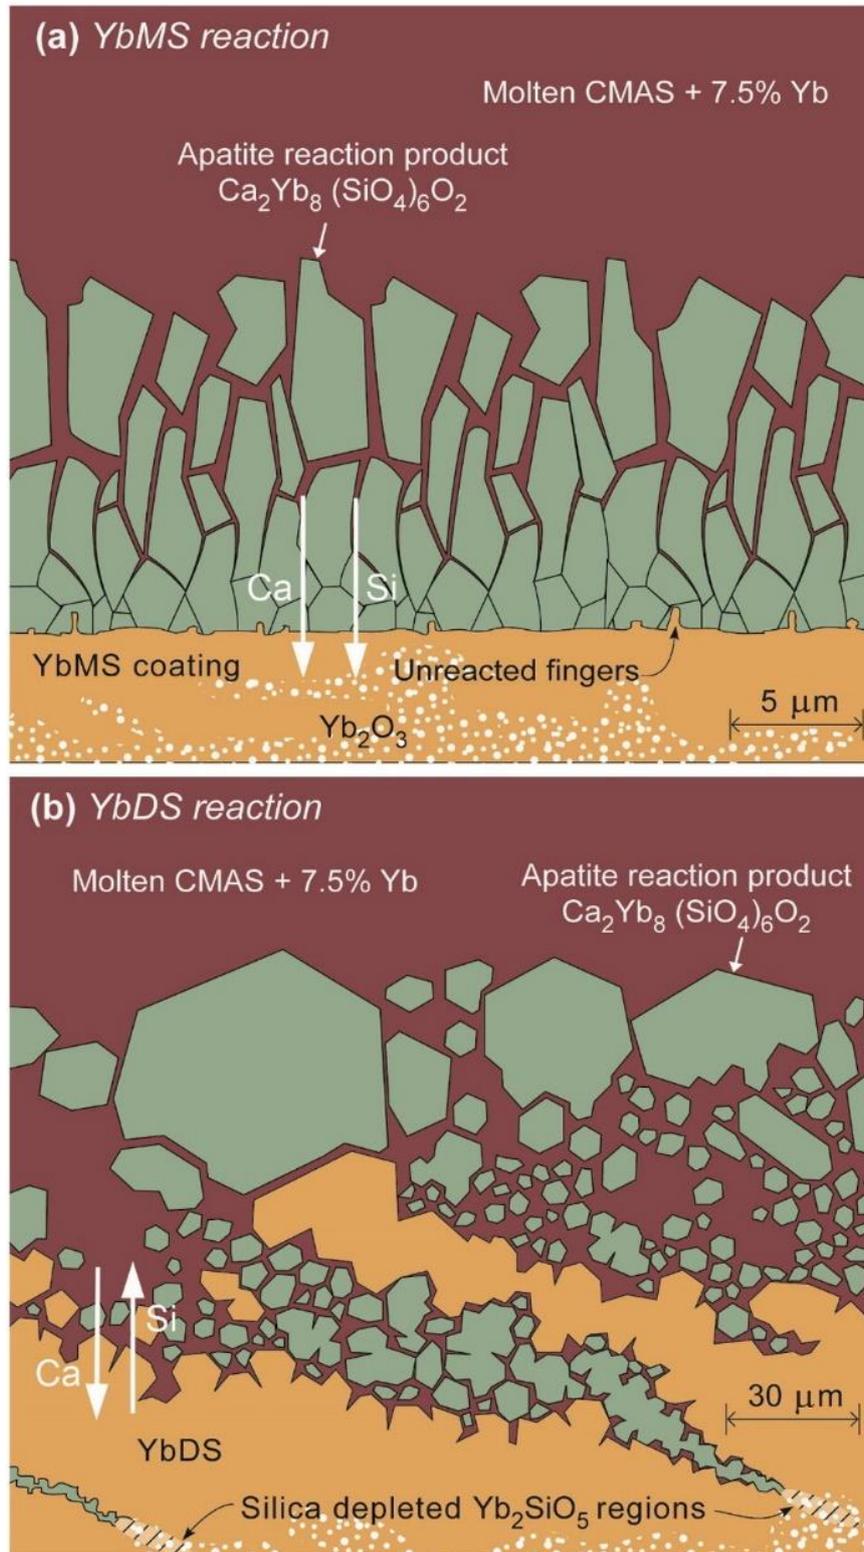
Figure 16: Schematic of the proposed interaction mechanism between YbMS (top) and YbDS (bottom) when exposed to CMAS at 1300 °C [86]

The mechanism shown in Figure 16a) for YbMS is based in the discussed dissolution of the monosilicate and posterior precipitation as needle-like apatite grains with areas of intercalated residual CMAS, forming the already seen reaction layer. In the case of YbDS, shown in Figure 16b), the initial

apatite grains are coarser and larger in size, with an irregular reaction layer where no clear reaction front can be determined. As the corrosion continues, molten CMAS preferentially attacks the YbMS-rich areas of the coatings. Due to the lamellar structure of the plasma deposited coatings, the YbMS-rich splats are elongated and parallel to the surface, which produces a rapid advance of the reaction in this direction. The precipitation of the apatite grains creates a “cleft” effect, as it can be seen in the schematic.

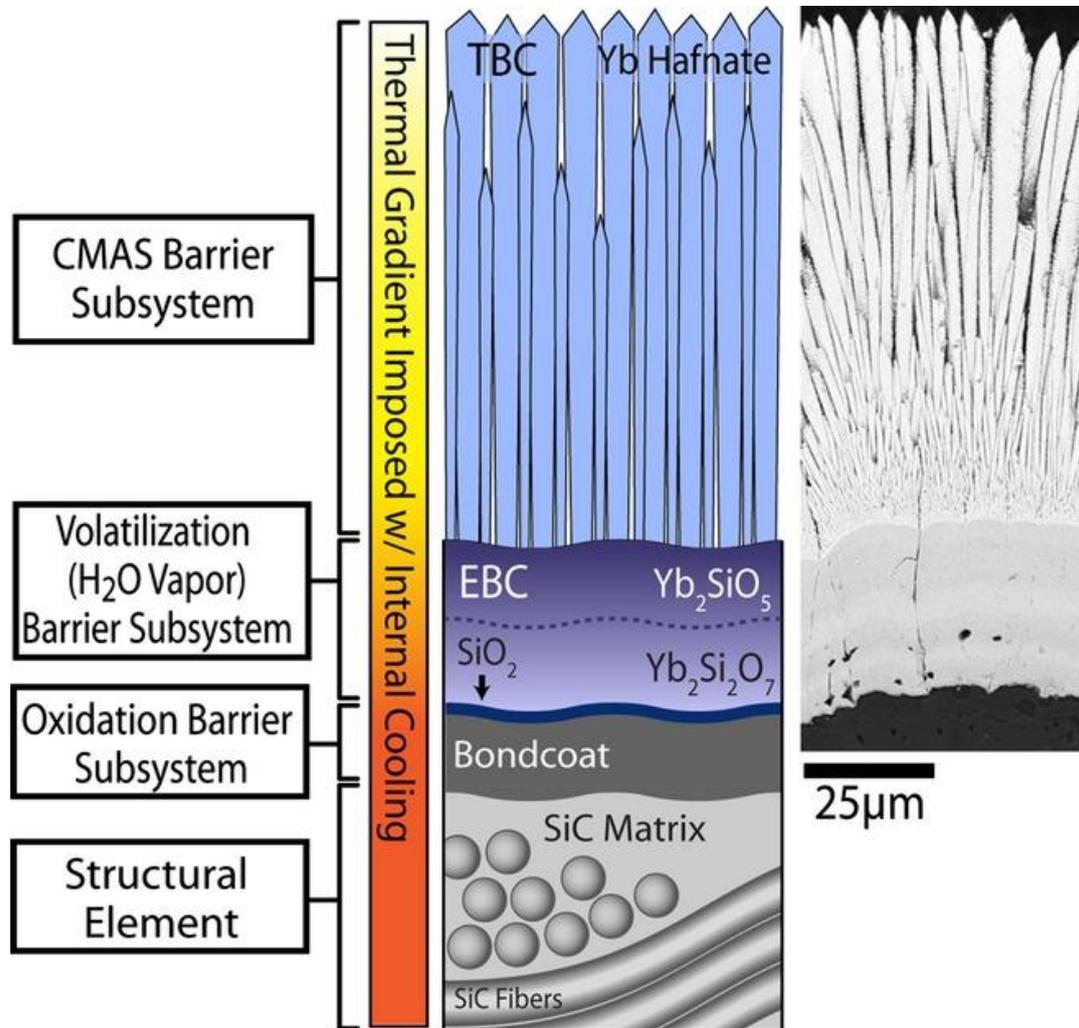
Figure 17: Schematic structure of an EBC sharing features of a thermal barrier coatings (TBC), being mixed TBC/EBC systems aiming to provide protection against steam and CMAS attack [85]

Perhaps, as it was mentioned in the case of the steam corrosion of rare earth silicates, it is too ambitious to expect the same top coat composition to provide effective protection against steam at high flow speeds while showing appropriate CMAS corrosion against a wide range of compositions. To this end, different alternatives are being considered [85,95], and some of them are borrowed from the previous knowledge gathered in the field of TBC, as it is shown in Figure 17.

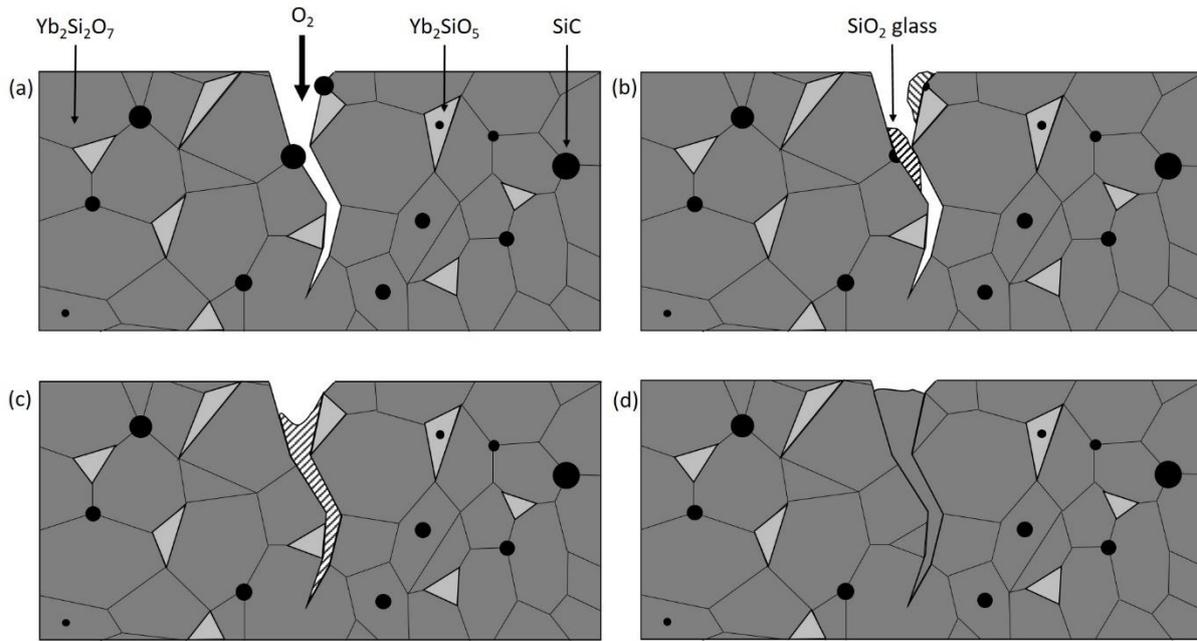
Figure 18: Schematic of the self-healing mechanism for YbDS/YbMS+SiC systems. Image (a) shows the cracked material, image (b) shows the formation of SiO_2 glass (dashed areas) during annealing due to the reaction between the SiC nanoparticles (black circles) and the ingressed oxygen, image (c) shows the filling of the crack with the viscous SiO_2 glass and image (d) shows the healing of the crack through the reaction between the SiO_2 glass and the YbMS grains (light grey), forming newly created YbDS (dark grey). Redrawn from [99]

As it has been previously said in this work, one of the basic functions of a successful EBC is to provide protection against the environment at which it will operate during service. Regarding the presence of steam and the proven detrimental effect that it has on SiC CMC components, this implies a gas-tight coating capable of preventing the ingress of steam to the substrate underneath. Therefore, it is quite clear that cracks within the coating are highly undesirable, as they represent a preferential pathway for steam to reach the substrate. Nevertheless, cracks are likely to appear during service due to the presence of several temperature cycles, which will cause the accumulation of thermal stresses and, eventually, relaxation vertical cracks. Aiming to increase the service life of EBC systems, research has been carried out with the goal to incorporate self-healing capabilities. The interest for a self-healing EBC can be demonstrated by the presence of patents on the topic [96,97] and the published papers exploring different compositions and mechanisms, as described below. An early example of a self-healing EBC is reported by Nguyen *et al.* [98,99]. A schematic of the proposed mechanism behind the self-healing capabilities can be seen in Figure 18.

The proposed mechanism is based on the addition of 10 vol.% β -SiC nanocomposites (nanoparticles, nanofibers or nanowhiskers) to the YbDS/YbMS system. Once a crack appears, as seen in Figure 18a, it provides access for the atmospheric oxygen into the material. During annealing at 1250 °C, the SiC nanofillers react with the atmospheric oxygen, creating viscous SiO_2 glass. This viscous amorphous SiO_2 is capable of filling the cracks, and then reacts with the YbMS present within the system to form YbDS, effectively sealing the crack due to the associated volume expansion. A similar approach was recently reported by Vu *et al.* [100], where crack self-healing was demonstrated on sintered bodies of composition yttrium monosilicate, yttrium disilicate and a combination of both with a 5 vol.% of SiC nanoparticles, after exposure to temperatures ranging between 1000 °C and 1300 °C for 1 – 24 h in air. Their results provide a better understanding of the self-healing process, accounting for the study of this effect at different temperatures and exposure times. The authors also remark the importance of ion diffusion as an explanation for the crack-healing, mechanism not previously considered and discussed. Despite the promising results reported, some considerations should be taken into account. First, as mentioned by the authors, the consumption of both the SiC nanofillers and the YbMS phase limits the self-healing capabilities to a single annealing process. After that, the presence of both SiC and YbMS would not be high enough to trigger the self-healing mechanism when a crack appears. Secondly, the experiments were carried out using sintered bodies, which has already been pointed out in this work that is a less than ideal representation of EBC deposited with techniques currently favoured by the industry. The reduced porosity of the sintered body, for instance, causes that the majority of the reaction between the SiC nanofillers and the oxygen takes place at the cracks.
