# Effect of high temperature service on the complex through-wall microstructure of centrifugally cast HP40 reformer tube

Thibaut Dessolier<sup>1,\*</sup>, Thomas McAuliffe<sup>1</sup>, Wouter J. Hamer<sup>2</sup>, Chrétien G.M. Hermse<sup>3</sup> & T. Ben Britton<sup>1</sup>

## Abstract

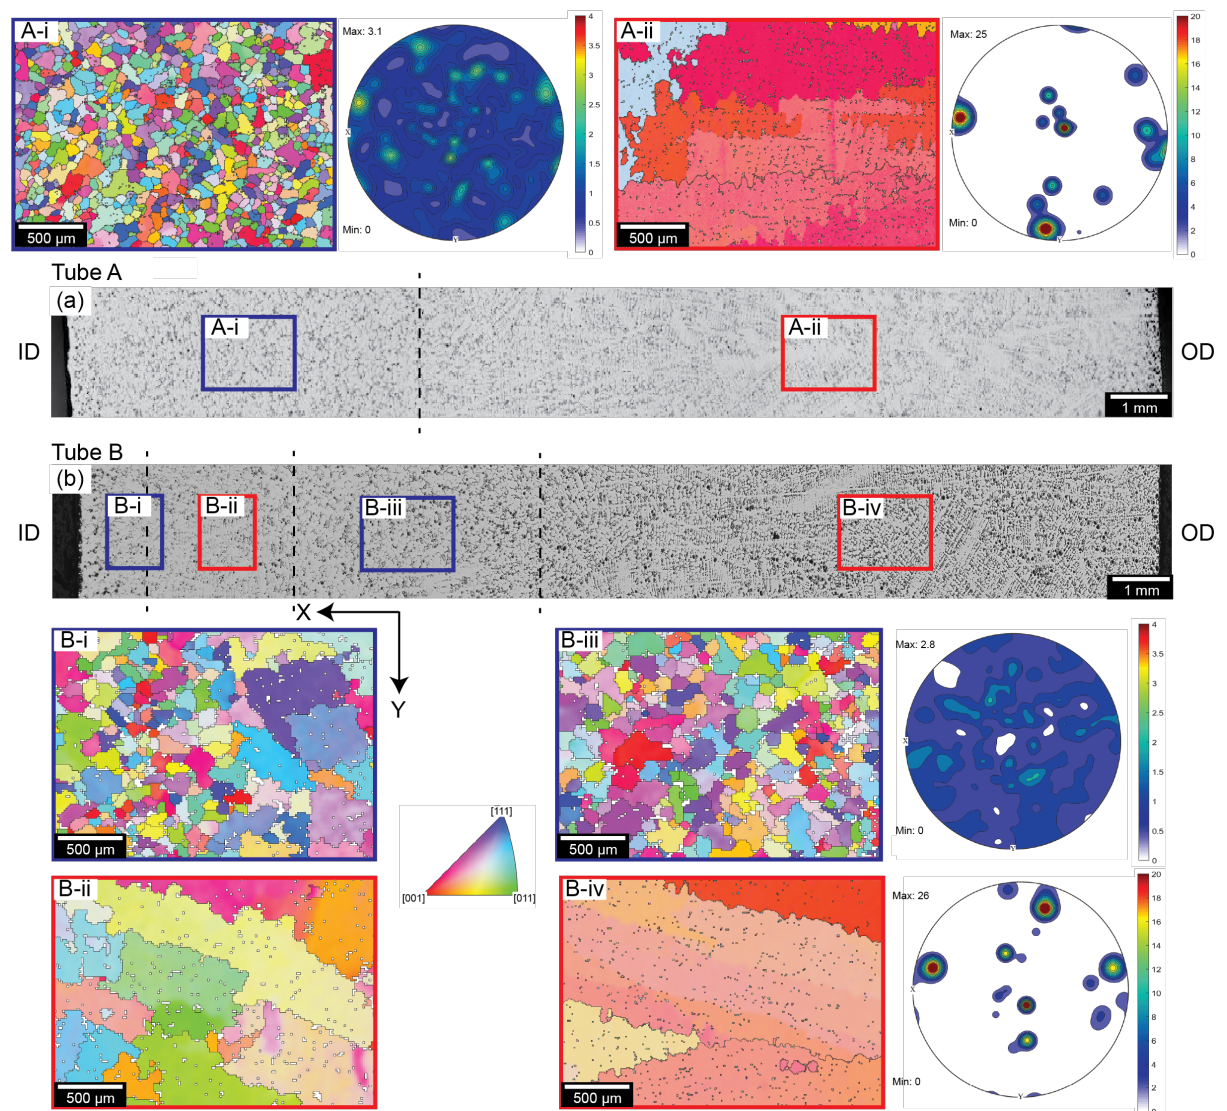
**Figure 1: Comparison of the microstructure of both tubes with optical images of (a) tube A and (b) tube B. EBSD analyses were performed in several regions for both tube with Inverse Pole Figure map along the X direction. Regions A-i and A-ii correspond to the tube A while regions B-i, B-ii, B-iii and B-iv correspond to the tube B.**

For each tube, the centrifugal casting process leads to an axially symmetric microstructure, with variations in structure along the radial axis. A section from both tubes is presented in Figure 1, with optical microscopy and EBSD orientation maps.

Tube A shows a typical microstructure, where the matrix phase (Ni-rich and FCC) includes very large columnar grains near the outer diameter, OD (region A-ii) that extends 15 mm from the OD to the inner diameter, ID. Tube A has a fraction of 70% of columnar and of 30% equiaxed grains along the tube section.

In Tube B, there is a similar columnar grain region (B-iv) near the outer diameter, followed by an equiaxed microstructure. However, in this tube there is a second columnar and equiaxed band towards the centre of the tube. The columnar grains in region B-ii are smaller than those found in region B-iv. This second band could be a result of a slight change in manufacturing.

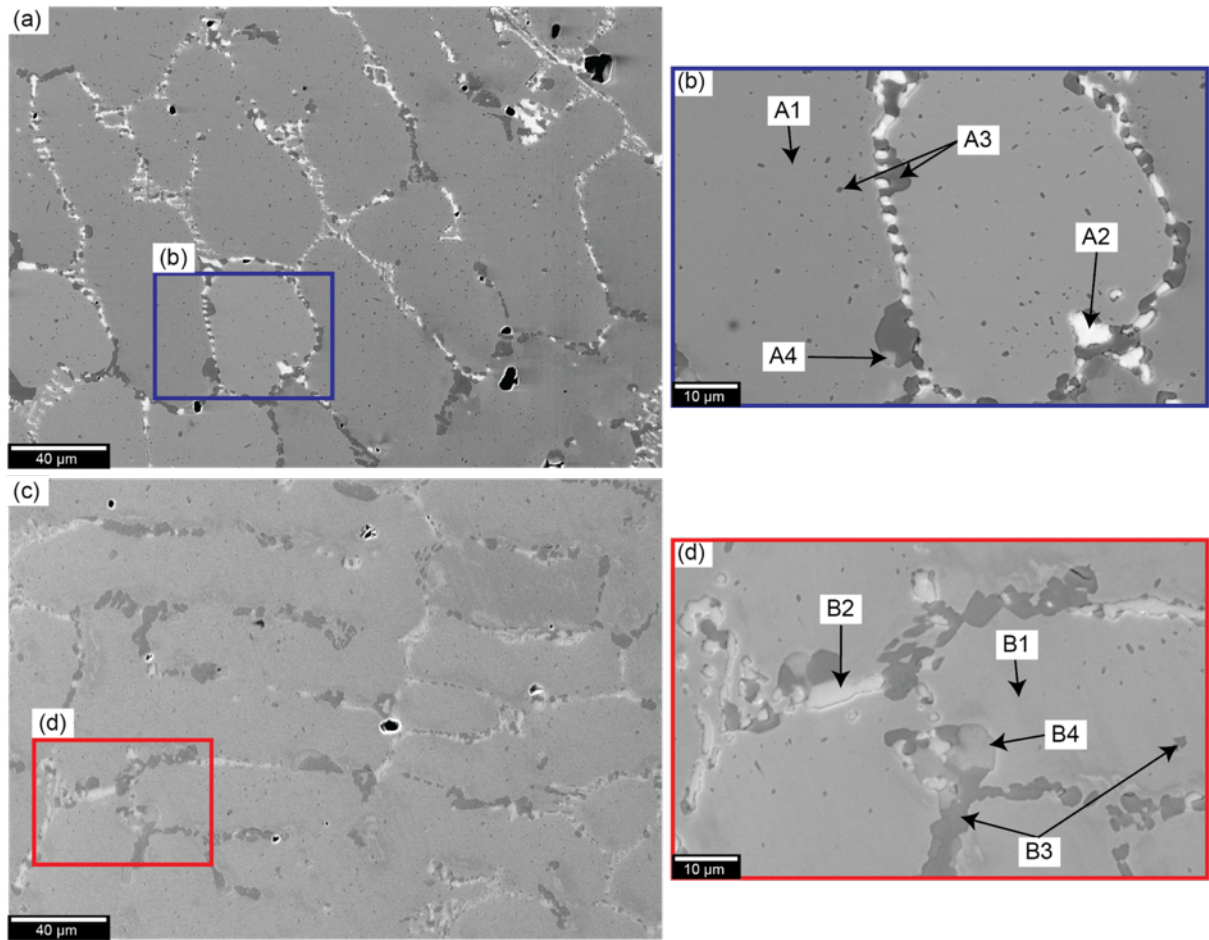
Figure 2: Backscatter electron images from, tube A columnar region A-ii with (a) low magnification and (b) a high magnification region, and tube B columnar region B-iv with (c) low magnification and (d) a high magnification region.

High magnification backscatter electron imaging was performed together with chemical analysis with EDS, and results are shown in Figure 2 and Figure 3. Carbides are found at grain boundaries and the intersection of the dendrite arms. The initial categorisation will be performed on images taken within the large dendrite/large-grain region.

Three types of carbide (labelled 2-4 in Figure 2) were found in tubes A and B:

3 – carbides interlaced with other carbides (2 and 3) on the dendrite boundaries, as large carbides extending from this interlaced carbide structure and also within the grain interior. Within the grain interior, these carbides have an irregular shape. They are darker than the matrix (i.e. a lower backscatter coefficient). EDS analysis indicates the presence of significant Cr, and limited Nb, Si, Ni and Fe. The EDS spectrum looks consistent with  $M_{23}C_6$  spectra found by [29, 30, 34].

4 – Light grey carbides often found on the dendrite boundaries. They have an intensity very close to the intensity of the matrix (i.e. a similar backscatter coefficient). EDS analysis indicates the presence of Si, V, Nb, Cr and Ni. This is likely that the spectra correspond to the  $M_6C$  carbide [30 and 35].

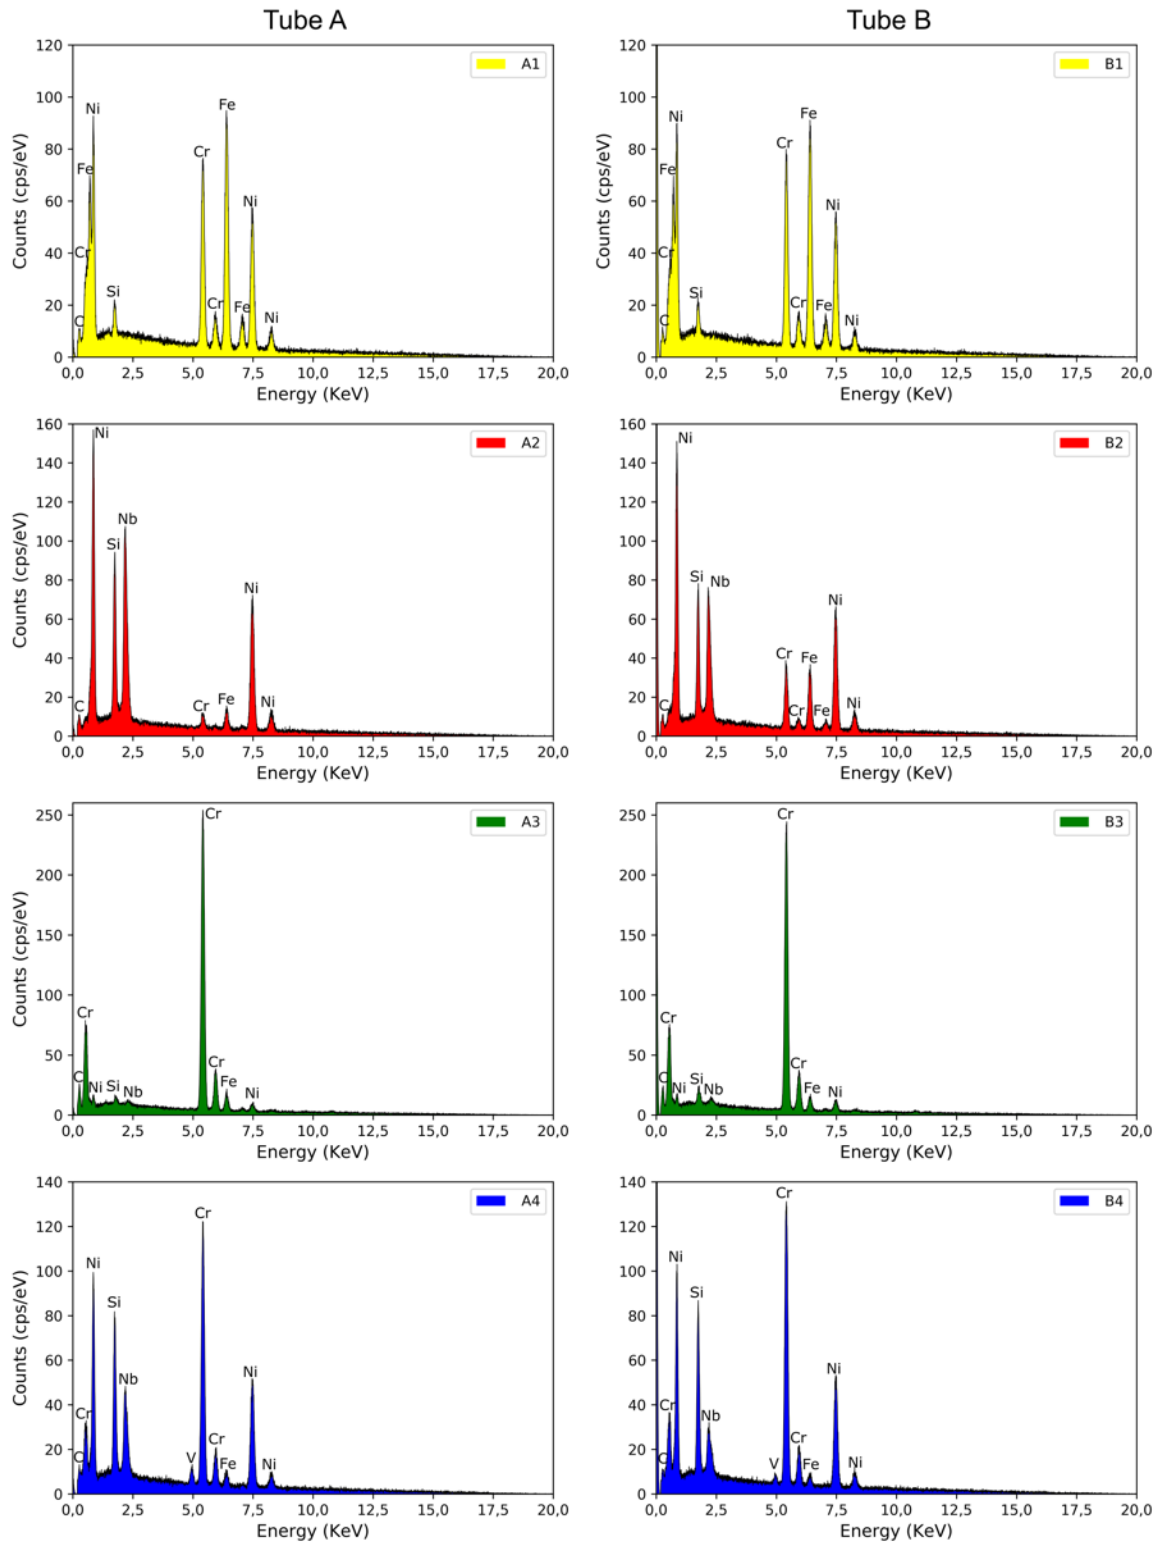
Figure 3: EDS analysis were performed on tube A on the phases noted A1, A2, A3 and A4 inside Figure 2 (b), and on tube B on the phases noted B1, B2, B3 and B4 inside Figure 2 (d).

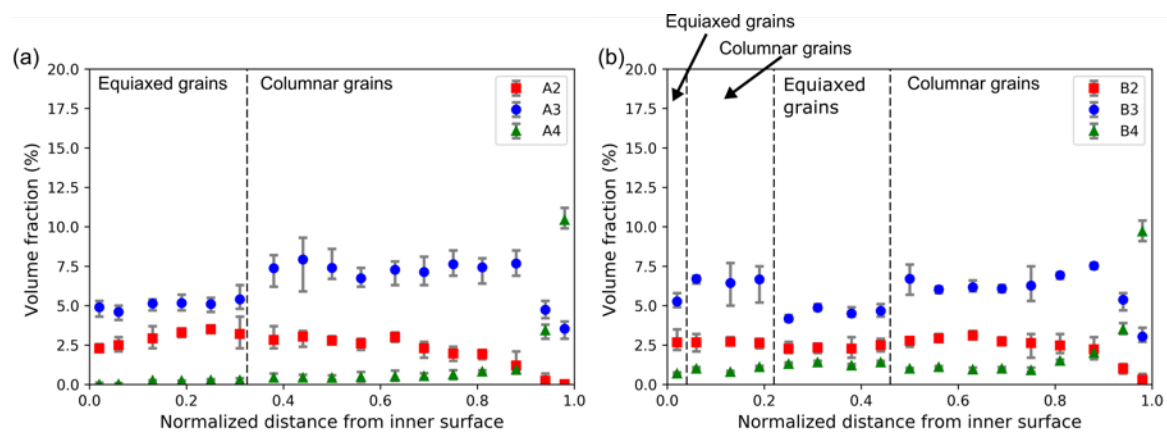
Figure 4: Volume fraction of each carbide phases function to the distance from ID to OD for (a) tube A and (b) tube B.

- Phase 2 is evenly distributed along each tube section except the region close to the OD where volume fraction tends towards zero;
- Phase 3 seems to be less present inside the equiaxed grains region than in the columnar grains area;
- Phase 4 is mainly present at the OD. Also, it seems that the phase is more present along the tube section for the tube B than tube A where the phase volume fraction is clearly not significant.

When the phase 4 volume fraction increases, the volume fraction of the phase 2 decreases. One hypothesis is that during tubes service condition the temperature was not consistent along tube section and this is supported by Buchanan and Brear [30 and 5] who noted that there is a temperature gradient along tube section, where the OD was exposed to higher temperatures than ID. This mean that initial NbC phase present in as-cast condition was transformed to the G phase (phase noted 2). However, as the temperature was higher at the OD, subsequent G phase formation was not possible, so instead NbC transformed into  $M_6C$  carbide (noted phase 4).

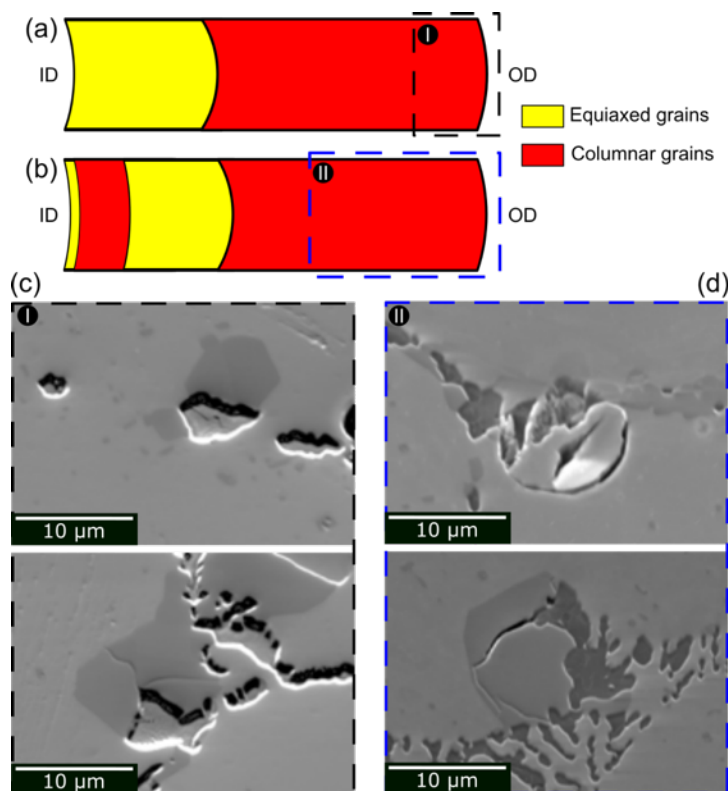
Figure 5: Drawing of the microstructure with equiaxed and columnar grains region area of (a) tube A and (b) tube B. (c) Two SEM backscatter electron images of micro cracks inside some carbides which are present inside the I area while (d) present two SEM secondary electron images of micro cracks inside some carbides which are inside the II area.

During the capture of the images required to create Figure 4, microcracks were observed near the carbides in both tubes. These are shown in Figure 5, where the microcracks were observed within the regions indicated with the black dashed line in Figure 5 (a) and blue dashed line in Figure 5 (b). Micro cracks are mainly located close to the outer diameter for tube A while micro cracks are present from the middle of tube section until the OD for tube B.

Example of micro cracks are presented in Figure 5 (c) and (d) which correspond respectively to tube A and B. These two figures highlight the fact that these micro cracks are only present inside the carbide and not the matrix. The micro cracks are observed within different carbides, as Figure 5 (d) shows, with a micro crack inside a white phase in backscatter imaging, lighter than all other phases (i.e. the highest backscatter coefficient) which could correspond to the G phase, while the other micro crack is present inside a dark phase in backscatter imaging (i.e. a lower backscatter coefficient) could possibly correspond to Cr rich carbide.

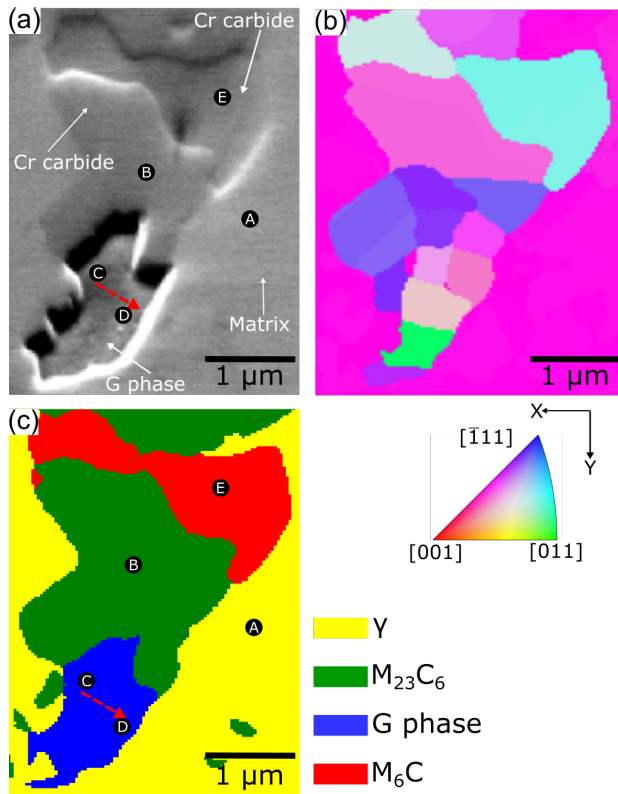
Figure 6: (a) SEM image of the microstructure of the tube A inside columnar grains region, (b) Inverse Pole Figure map along the X direction and (c) results from the PCA with the phase map.

Table 5: Composition of each measurement point (% at.) from Figure 6.

Figure 9 also indicates that the current results are consistent with the observation noted with the Figure 6 (c).

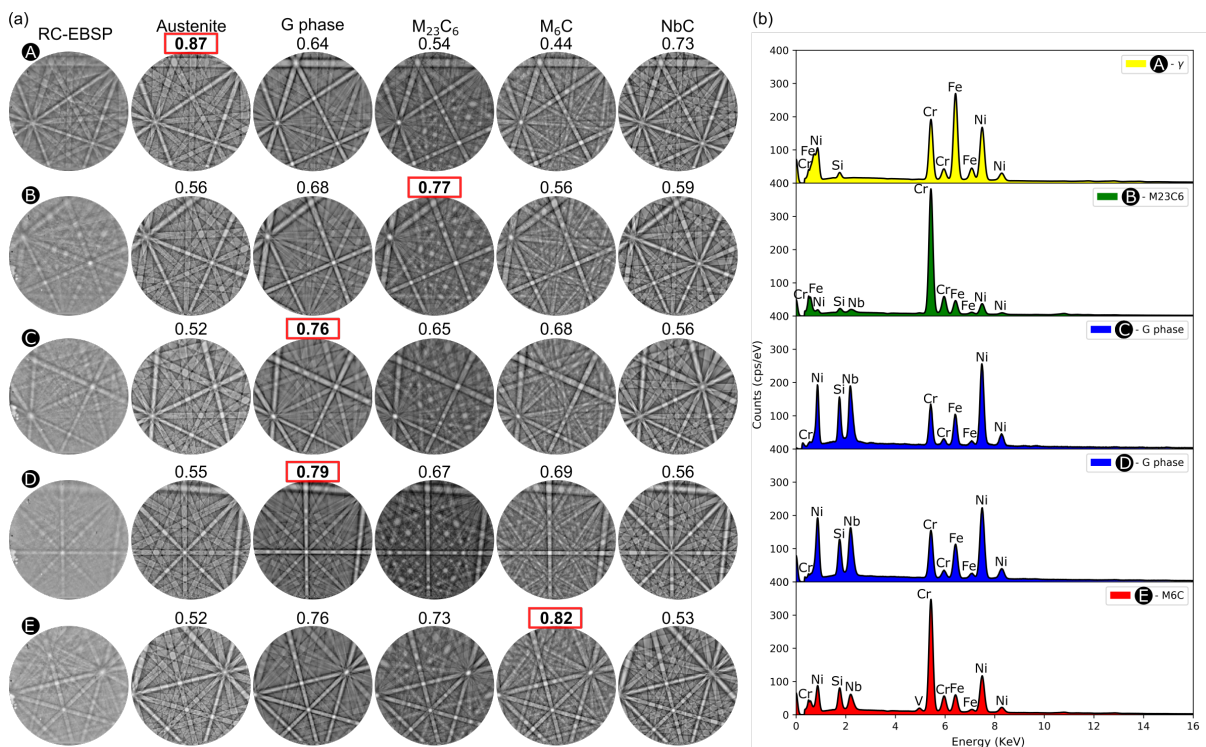
Figure 7: (a) Comparison between the experimental Rotated Characteristic EBSP (RC-EBSP) and the simulated phases for the points A, B, C, D and E of Figure 6. (b) EDS spectra of the points A, B, C, D and E. The numbers above each pattern are the correlation coefficients matching the simulated pattern to the RE-EBSP, and a higher number indicates a better match.

For none of the points in the maps, did the latent experimental patterns match the dynamical simulation of the NbC phase. This can be confirmed by the presence of a bright zone axis within the RC-EBSP which is not present within the NbC simulated pattern. This means that NbC carbide seems to not be present in our microstructure and that all the NbC was decomposed either into the G phase or into the  $M_6C$  carbides.

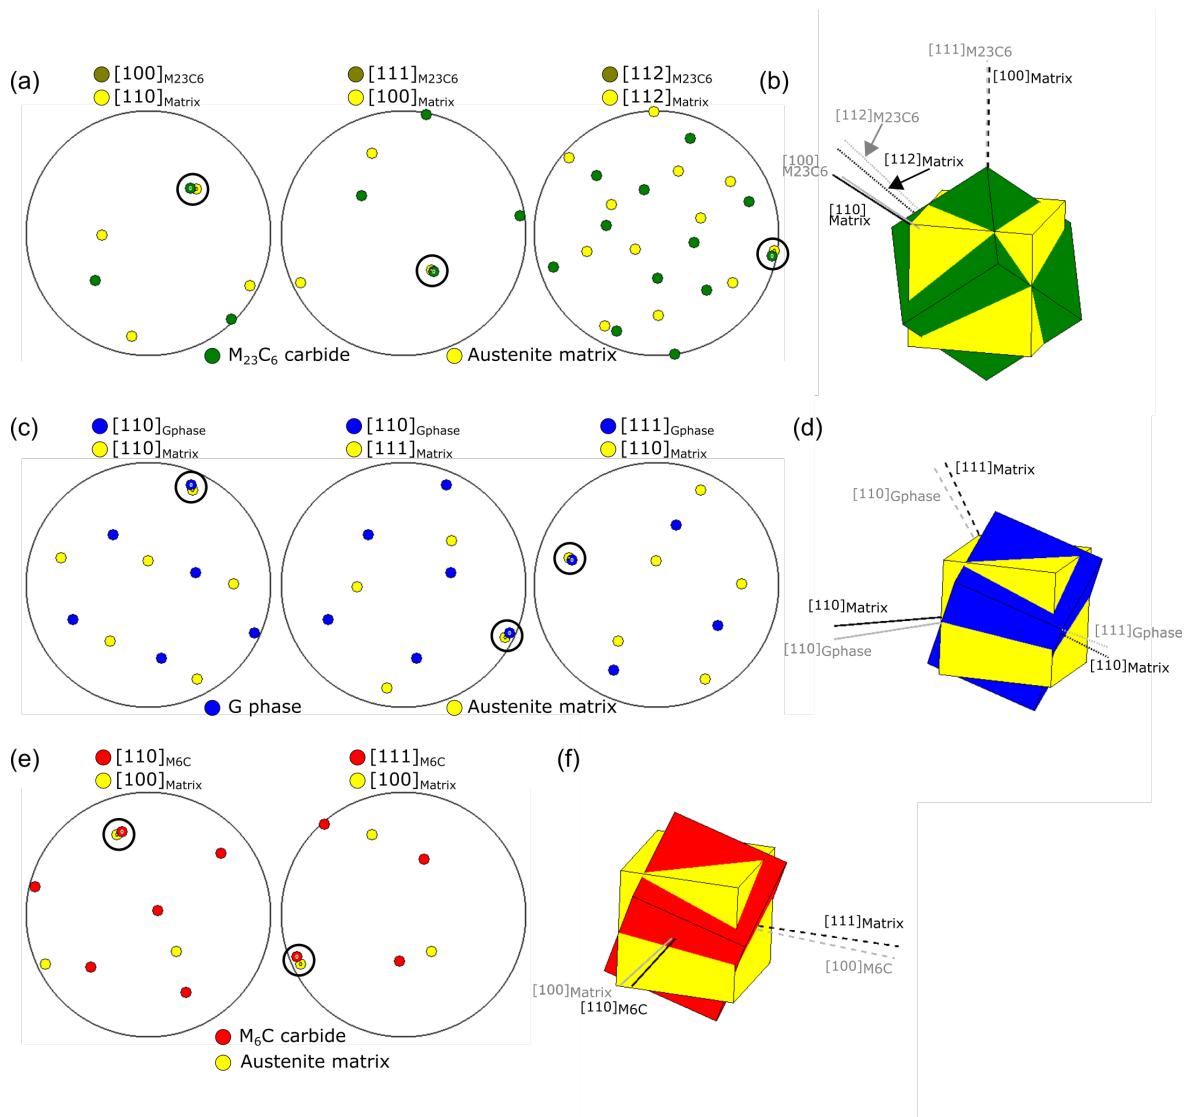
**Figure 8:** Superimposition of the pole figure map between (a) one  $M_{23}C_6$  grain and the austenite matrix, (c) one G phase grain and the austenite matrix and (e) one  $M_6C$  and the austenite matrix. Black circles show in each of them the location where carbide and matrix have pole deviation inferior to  $5^\circ$ . Cubic cells connection between carbides and matrix with the different direction are show for (b) the  $M_{23}C_6$  grain and the austenite matrix, (d) the G phase and the austenite matrix and (f) the  $M_6C$  and the austenite matrix.

Table 6 presents all the OR (which are cubic-cubic pairs) found between one grain of each carbides ( $M_{23}C_6$ , G phase and  $M_6C$ ) and the austenite matrix.

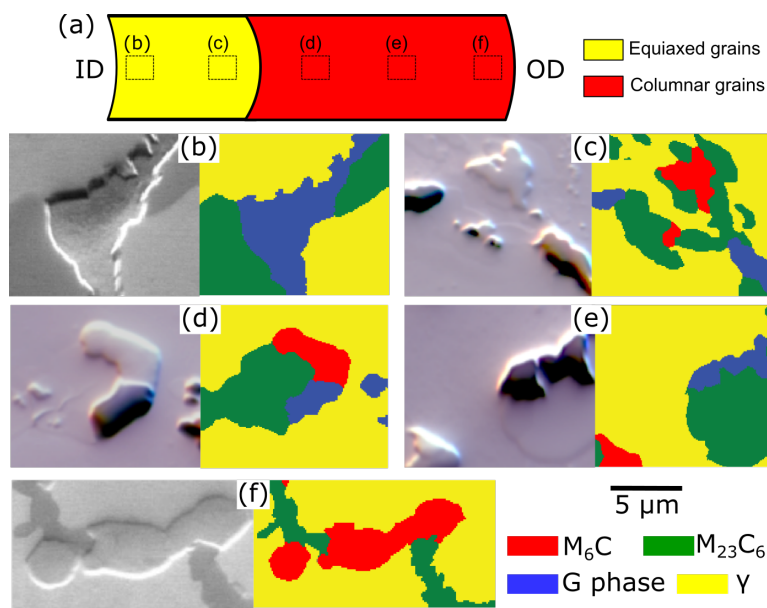
Figure 9: (a) Drawing of grain regions of tube A. (b), (c), (d), (e) and (f) correspond to several areas where PCA was performed. For each area, a secondary electron SEM image present the region of the analysis while there is also the result map with phase index.

- NbC phase is not present at all in our tubes (at least for these length scales) and confirms the conclusion reached in section 3.2.1. It is most likely that any NbC carbide which may have been initially present in as-cast condition were fully transformed into either the G phase or the  $M_6C$  carbide during service.
- The G phase is present everywhere along the tube section, except the region close to the OD. This is consistent with Figure 4.

- In contrast, the  $M_6C$  carbide is found distributed within the microstructure in the representative regions extending from the ID to the OD except in the region extremely close to the ID. The area fraction of  $M_6C$  is higher closer to the OD, but these  $M_6C$  carbide are also present in very small quantities for the rest of the tube section. This is consistent with Figure 4.
