Effect of laser surface hardening on a low carbon steel substrate wear and hardness

Matheus Rodrigues Furlani¹, Sheila Medeiros de Carvalho¹, Milton Sergio Fernandes de Lima^{2*}

Laser surface hardening (LSH) is an effective process to produce hard and wear resistant steel surfaces. This work produced hardened surfaces using a fiber laser in a bare (B. uncoated) and carbon-coated (C) conditions. The obtained hardness and microstructure were compatible to martensite (B) and cementite (C) major constituents. A low coefficient of friction was obtained using C-condition. The treated surface also presented little damage during a reciprocating wear against a hard metal sphere.

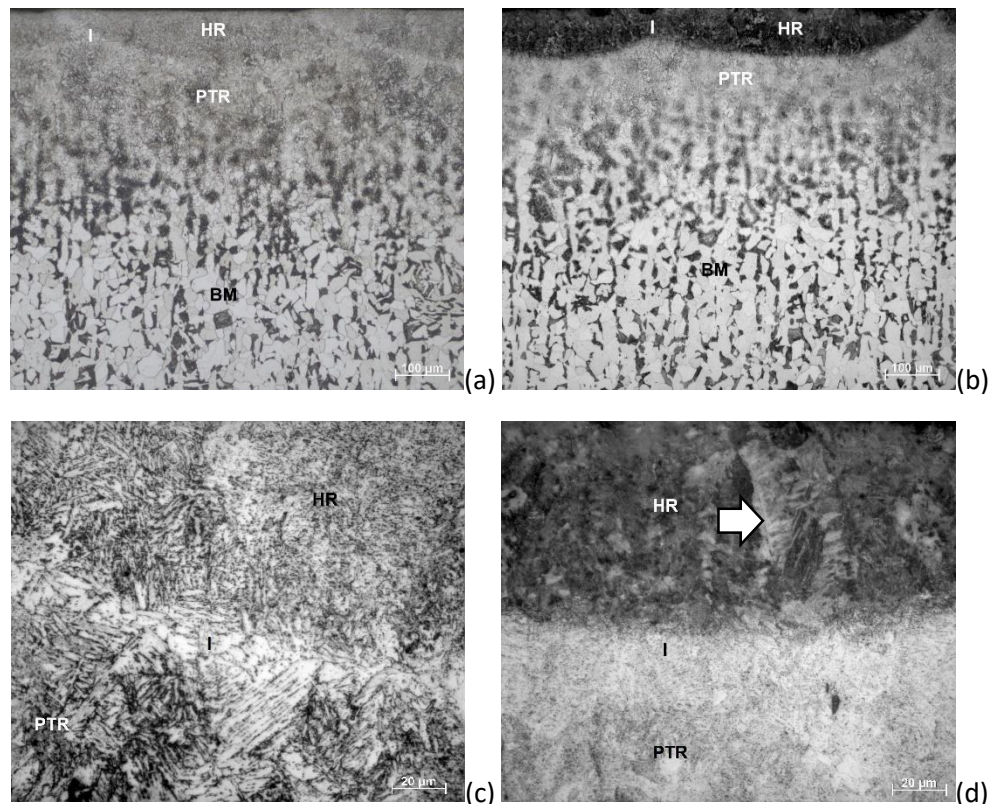
Figure 1. Light optical images of the cross sections of the samples near to the treated surface. (a) low-magnification image of the B-condition; (b) low-magnification image of the C-condition; (c) high-magnification image of the B-condition; (d) high-magnification image of the C-condition. Nital Etching.

Figure 1c-d presents the same regions of Figure 1c-d, but with more magnification. As can be seen in Figure 1c, the microstructure of the bare condition HR and PTR is marked by martensite transformation and the interface (I) presented tempered martensite due to the partial overlap between the tracks. Figure 1d presents a zoom of the region near to the treated surface for condition C. Both PTR and I are composed of martensite, however the HR clearly differ from B-condition. A faceted micro-constituent linked to the cementite phase occurred (marked by an arrow in Figure 1d) corroborating the assumption of carbide phase growth in HR when graphite was applied to the surface. Looking at the interface between the tracks (I, Figure 1) the overlap did not temper the martensite in C condition (Figure 1b) because carbide is the main constituent (Figure 1d).

Figure 3 also presents the HV profile for C condition where the highest value was obtained 82 μm below the surface (330 HV). The carburization of the exposed surface improved the hardenability of the sample up to approximately the interface (I, Figure 1d). As proposed before, the enthalpy necessary to obtain cementite reduce the total energy for a depth hardenability. Consequently, the HV profile from PTR to BM in Condition C is below the trend line of Condition B.

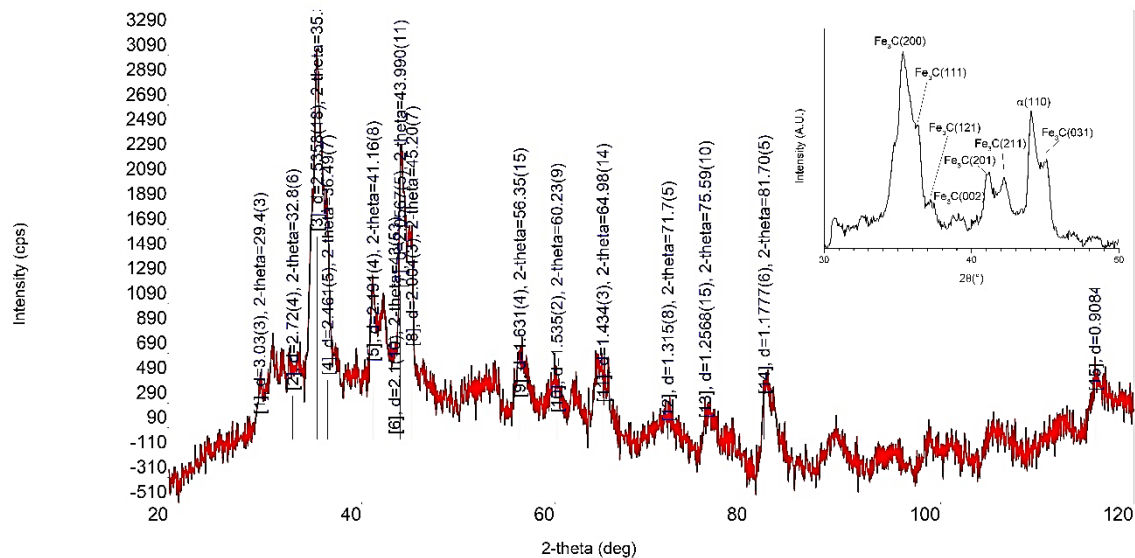
Figure 2 presents the X-ray diffractogram of the surface treated using condition C. The spectrum of condition B was suppressed in Figure 2 because it presents only α (ferrite) phase. Each peak was identified according to the interplanar spacing (d) and the position (2θ), however the effect of multiple reflections and the fluorescence effect of the copper radiation in iron render difficult the indexation. A more refined view of the interest interval is presented at up-right corner of Figure 2, showing the peaks associated to the Miller index of ferrite (α) and cementite (Fe_3C) phases. The X-ray diffraction analyses corroborated the assumption of cementite after LSH in condition C, although the volumetric fractions could not be estimated because of the crystallographic texture.

Figure 2. X-ray diffractogram of the surface C. The detail at up right corner is a zoom around the main peaks identifying both cementite and ferrite peaks.

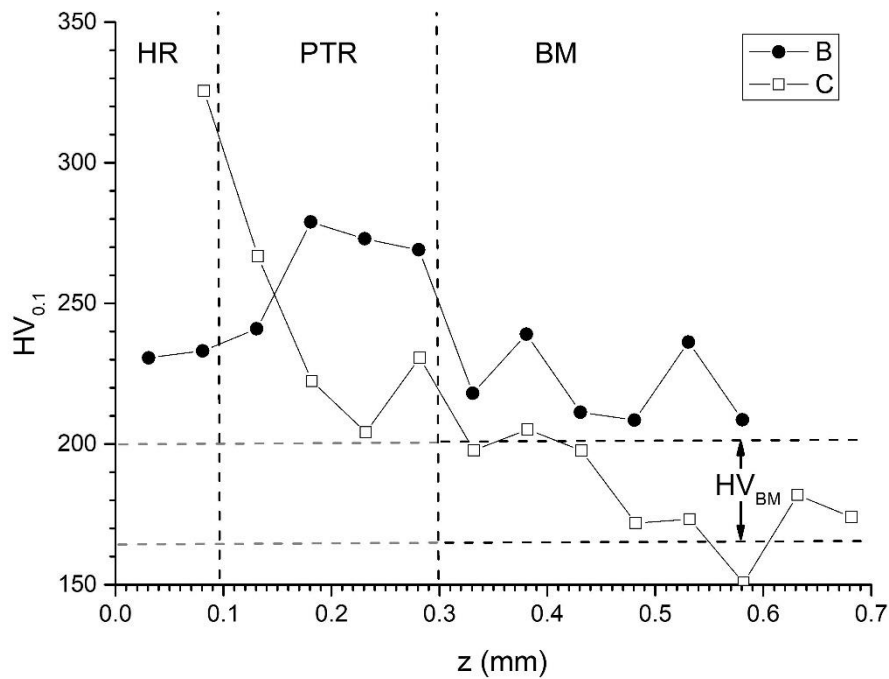
Figure 3 presents the Vickers hardness profile as a function of the depth (z) for B and C conditions. In the figure, the approximate *loci* of each region, HR, PTR and BM, are indicated together with the range of the base material hardness range (HV_{BM}).

Two of indentations in the HR of condition B and one near to the interface (I) resulted in hardness values well below than the value obtained at $z = 0.2$ mm, in the middle of PTR (Figure

3). The absence of a protective gas shielding created a carbon depletion in the HR during remelting, as already seen after laser processing of steels [6, 11]. The maximum hardness of 280 HV is then 0.2 mm from the surface. The values observed in Condition B in BM are slightly above the HV_{BM} as a consequence of some collateral heating of the substrate [3]. Collateral heating also appears to be responsible for the small difference between the hardnesses at 0.58 mm below the surface of parts B and C (Figure 3). Piece B may have heated a little more than part C due to the transformation of cementite, which explains hardness B being slightly above BM and vice versa for C.

Figure 3. Vickers Hardness profile as a function of depth (z) for conditions B and C. The acronyms are cited in the text.

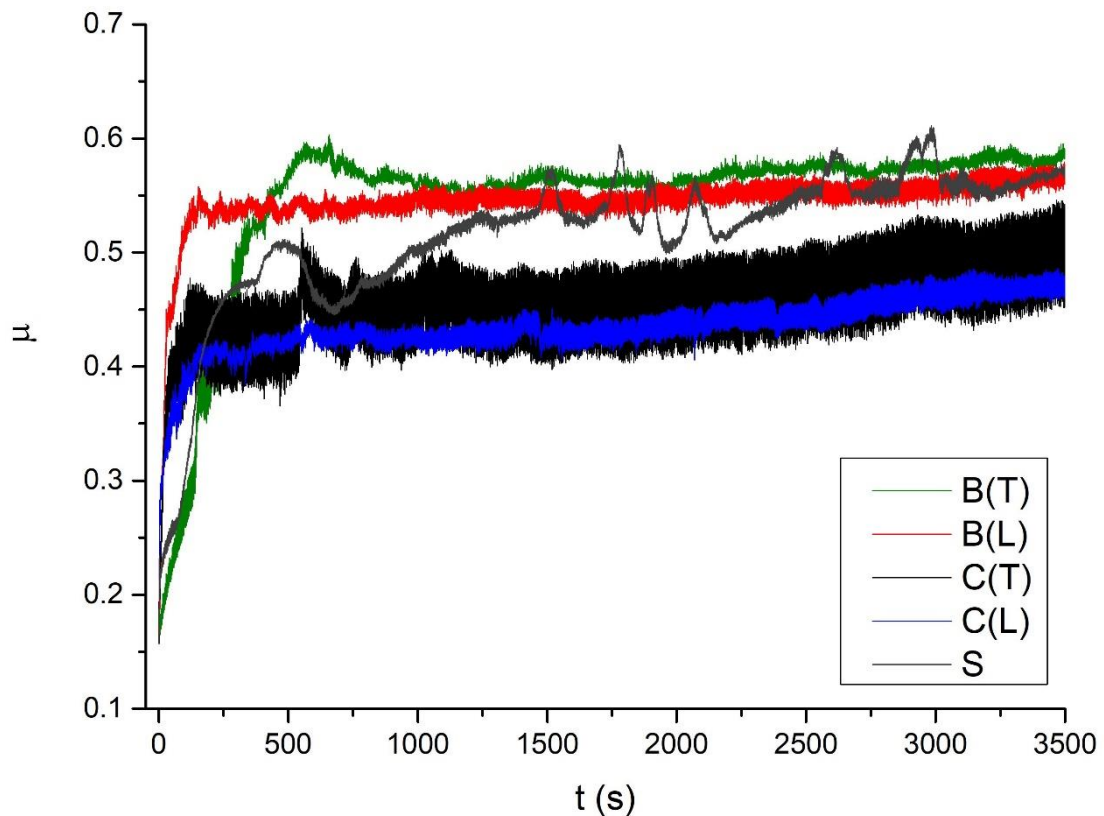
Reciprocating abrasive wear allowed measuring the resistance to motion called coefficient of friction (COF) as given in Figure 4. The curves were representative of three tests for each experimental condition. Five curves are superposed for comparison: S (substrate, untreated), B (bare, LSH without C) and C (carbon layer LSH), these later with a reciprocating movement transversal (T) or longitudinal (L) to the laser tracks. After an initial period of about 500 s, the curves S, B(T) and B(L) presents some similarities. The S-curve, however, presented a wide variation of COF during the tests. According to Milan et al. [12] this aperiodic variation of COF during abrasive wear is resulting from a complex interaction of the hard metal ball and the AISI 1020 substrate (S) where temperature changes create oxides and heat treats the base

In the bare (B) conditions, the COF attained a maximum of 0.55 after 160 s (L) and 0.59 after 660 s (T) (Figure 4). Together with S condition, both B(T) and B(L) presented the highest level of final COF, i.e. $COF_{final}=0.58\pm0.02$. However, differently from S-tests, the equipment did not present vibration. For a while, up to 420 s, the tests transversal to the laser tracks B(T) shown a COF less than B(L), however, after this, the B(T) surpassed any value of B(L). A possible explanation comes from the topography of the treated surfaces. When the tests starts the hard metal ball (counterpart) bumped on the top of laser-fabricated mountains. Then, after a given time, these tips were broken and entered as a third body in the tribological system. On the other hand, B(L) laser tracks were aligned to the ball motion. After a given time, the tracks were less rough and the debris are free to run though the laser tracks (valeys). The hardness of the HR zone (Figure 3) in both B(L) and B(T) are not too above the substrate values and the COF procedure are similar to the untreated surface (S).

Figure 4. Coefficient of friction as a function of time for the conditions S (substrate, untreated), B and C. The letters L and T mean longitudinal and transversal to the laser tracks.

Figure 4 also presents the evolution of COF as function of time when the surface is pre-coated with carbon before LSH: C(T) and C(L). The C-curves in the figure are quite similar which indicates COF is about the same disregarding if the reciprocating motion is transversal (T) or longitudinal (L) to the laser tracks. The wide dispersion of COF in C(T) condition compared to C(L) indicates that the bumping at the mountain tops created some noise. Although this noise is unperceived during the tests, no shaking the equipment. At the end of the tests, the final

COF for C-conditions is approximately $COF_{final}=0.45\pm 0.05$. The coefficient of friction is not a material property but a value linked to many boundary conditions, however the COFs obtained here are similar to those reported by Dudley D. Fuller (Columbia University) data boards [13].

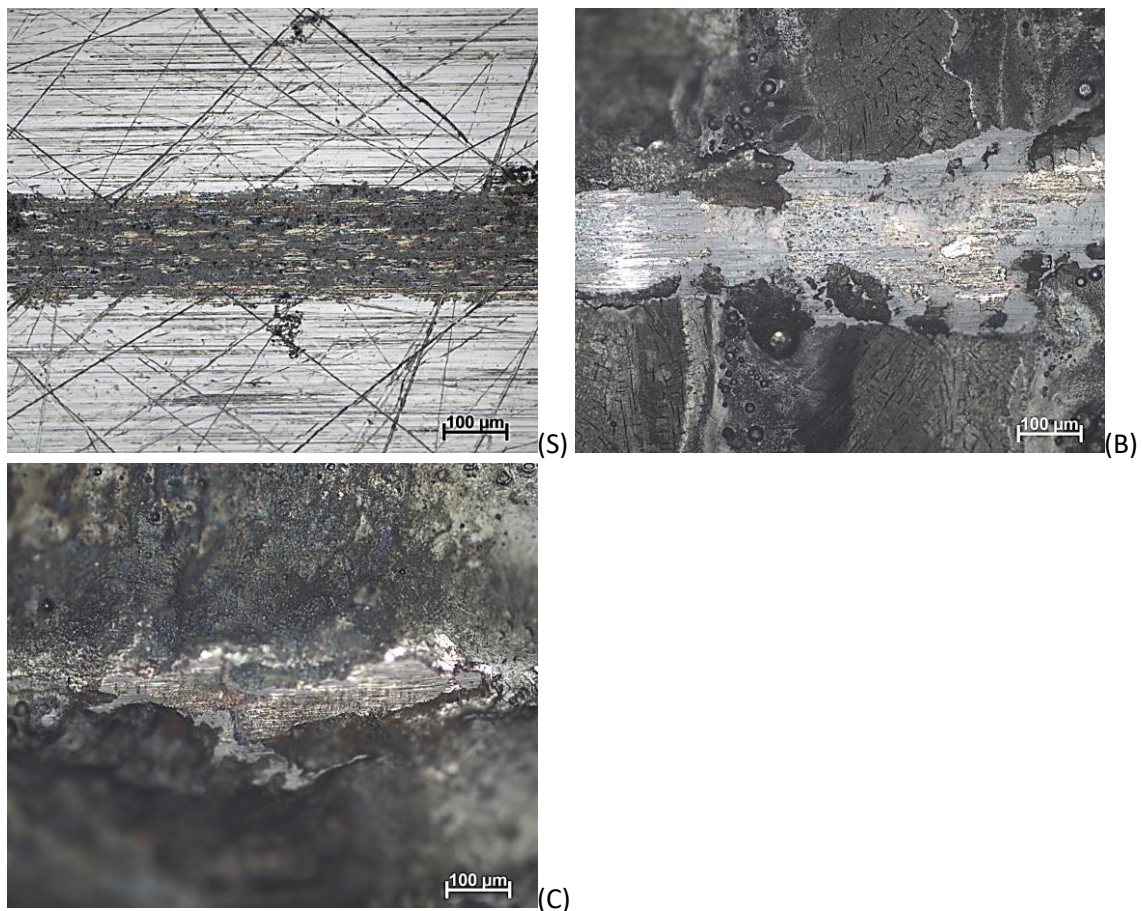
Figure 5 presents some images representative of the surface damage after the reciprocating tests. The untreated surface (S) presents a scratch after 3500 s with a width of approximately 0.26 mm. As measured by the equipment profilometer, the resulting wear was $2.81 \times 10^{-5} \text{ mm}^3/\text{N/m}$ for the S-condition. In the other conditions, the equipment was unable to estimate the final wear because of the surface waviness and roughness. The scratch marks are very irregular in both B and C conditions, unrespect to the direction L or T, and some images (as these in Figure 5) indicate that some of hard metal was welded to the scratched surfaces.

Figure 5. Representative images of the surface damage for the conditions S (substrate, untreated), B and C.

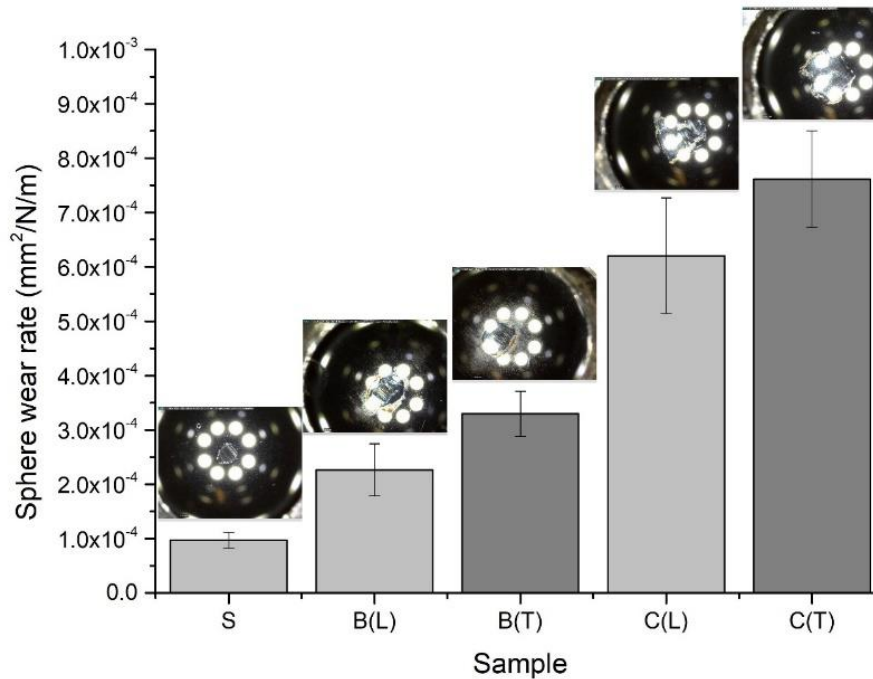
When comparing the surface wear in the hard metal spheres after the tests in different conditions (Figure 6) it is clear the LSH steel, even softer than the ball, grinded part of the counter body. The ball damage increased almost linearly from S to C(T) which corroborates the assumptions of cementite third body as part of the tribological system. Cementite hardness is known as being below tungsten carbide hardness (typical constituent of the hard metal ball), i.e. approximately 1000 HV compared to 1300 HV [14]. However, the carburized surface (Figure 5C) takes advantage of the wavy topography of the laser beam fabricated tracks to better grind the counter body, as can be seen in Figure 6.

Figure 6. Sphere wear rate as a function of the sample type and relative orientation to the laser path (L and T). The images represent the observed damage after the tribological tests.
