# High-Resolution Short-Circuit Fault Localization in a Multi-Layer Integrated Circuit using a Quantum Diamond Microscope

P. Kehayias,<sup>1,\*</sup> J. Walraven,<sup>1</sup> A. L. Rodarte,<sup>1</sup> and A. M. Mounce<sup>2</sup>

<sup>1</sup>*Sandia National Laboratories, Albuquerque, New Mexico 87185, USA*

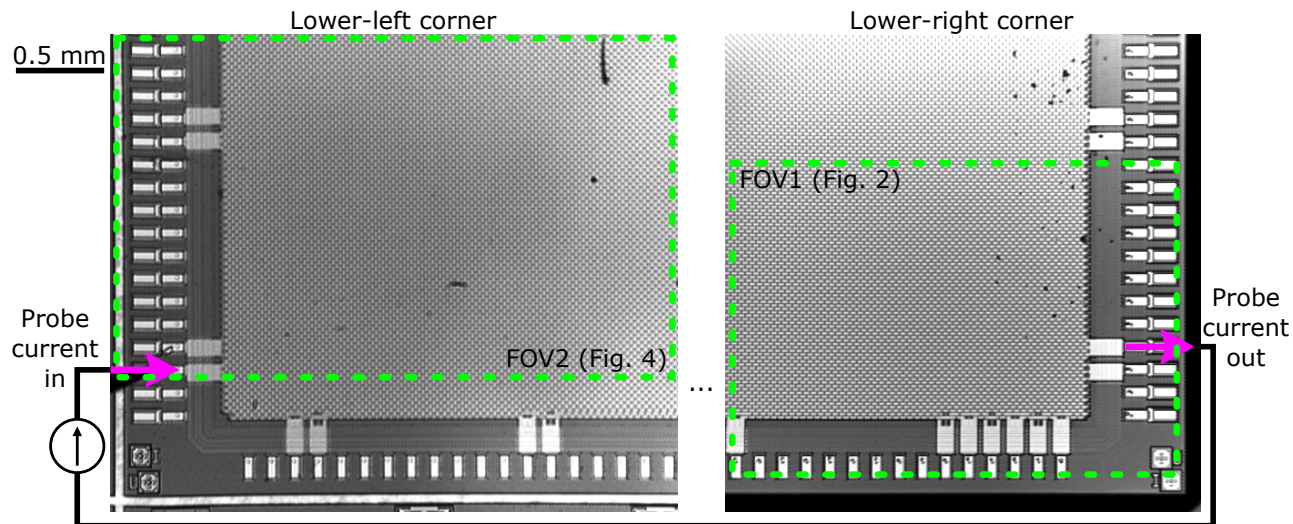
FIG. 1. Photos of the lower-left and lower-right corners of the DUT, which we investigate in this work. We apply a probe current to a pad near the lower-left corner, after which it flows through the DUT and is collected from a pad near the lower-right corner. The green boxes indicate the fields of view (FOV) shown in later figures.

Figure 1 shows optical images of the lower-left and lower-right corners of the DUT, where we searched for short-circuit faults. We present the results of two such dice. The fields of view being imaged are indicated as FOV1 and FOV2 for Die 1 and Die 2, respectively. We applied a test current between two pads using probe tips, then used NV magnetic imaging and TIVA imaging to search for short-circuit faults.

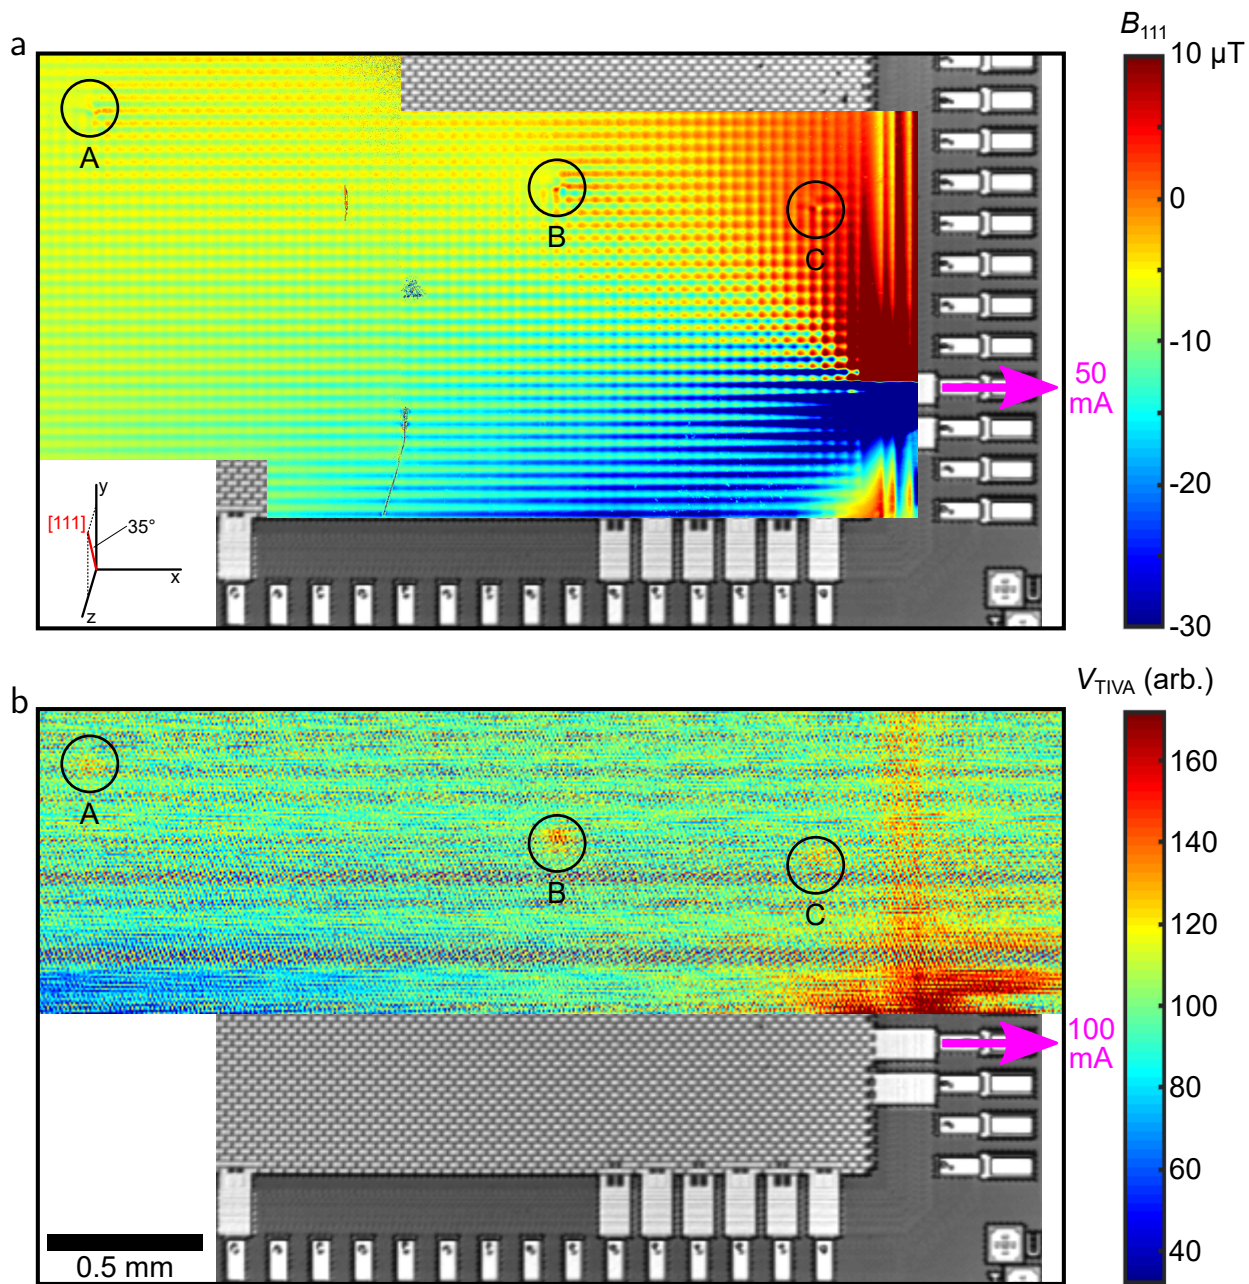
FIG. 2. (a) NV magnetic image with a 50 mA test current, with Faults A-C circled. The extra scratch marks are due to defects in the diamond surface. (b) TIVA image with a 100 mA test current, showing Faults A-C in the same locations.

Figure 2 shows two overlaid NV magnetic images and a TIVA image near the lower-right corner of a die (FOV1). We applied a 50 mA test current for the NV magnetic imaging experiments and a 100 mA test current for the TIVA imaging experiment. As the applied current disperses from the input pad and converges towards the output pad, it creates a grid pattern in the magnetic images similar to the grid pattern of Layers 4 and 5. The grid pattern contains defects caused by

current traveling between Layers 4 and 5 along the  $z$ -axis, indicating short-circuit faults (labeled Faults A, B, and C). For comparison, the faults in the TIVA images appear as circular features (where laser heating at the fault location modifies the resistance) on top of a nominally-uniform background.

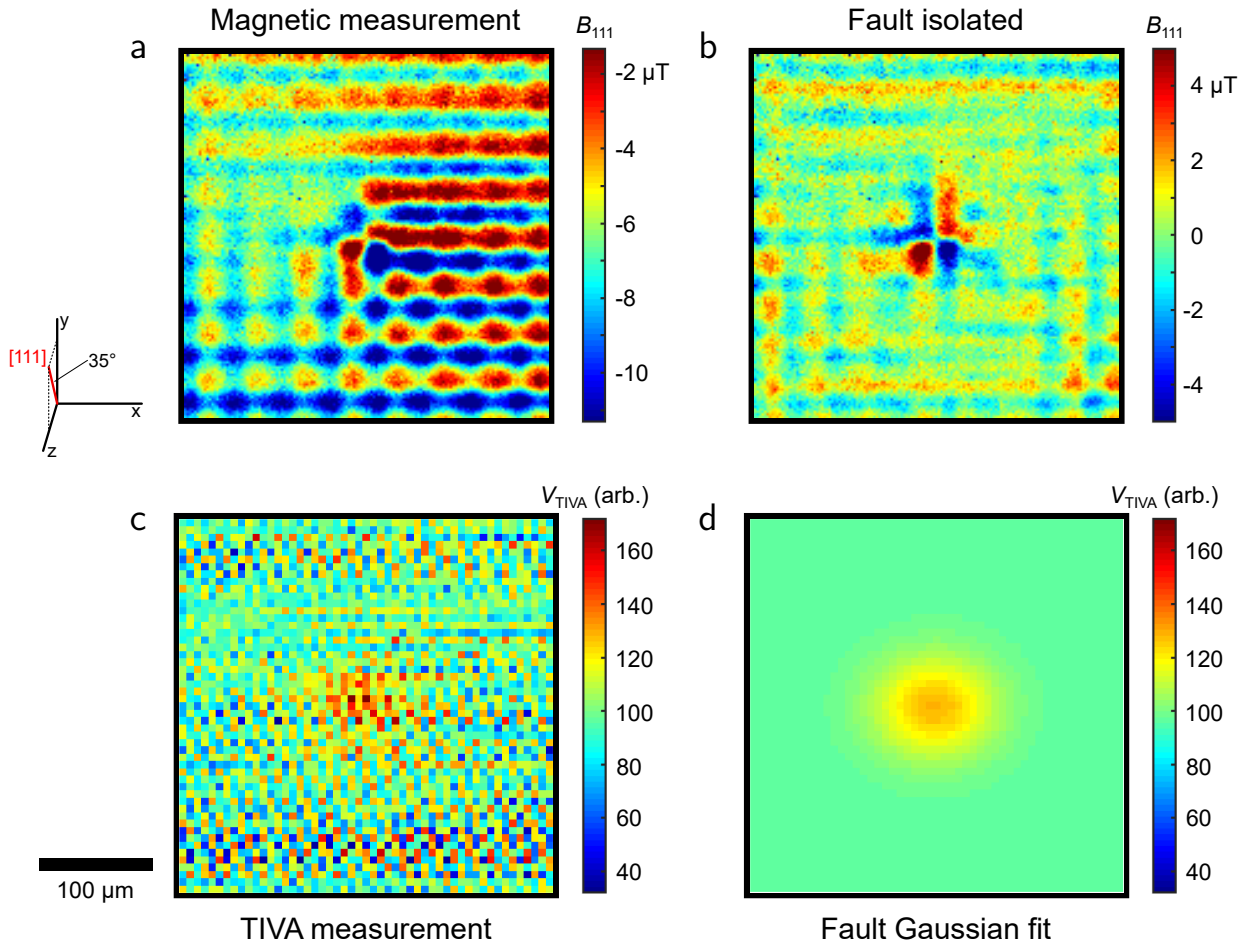
FIG. 3. (a) QDM magnetic image for Fault B. (b) Magnetic image after suppressing the background magnetic fields, removing the grid pattern in the Fourier transform and removing a quadratic background field. From this image, we extract a  $B_{\text{fault}} \approx 7.7 \mu\text{T}$  fault amplitude when applying a 50 mA test current. (c) TIVA image for Fault B. (d) 2D Gaussian fit for the TIVA image, from which we extract  $V_{\text{fault}} = 32$  and  $\delta V = 19$  for the fault amplitude and noise floor when applying a 100 mA test current. Note that both methods had a 20 minute experiment duration, but the TIVA imaging experiment had  $2\times$  larger test current,  $\sim 3\times 3$  larger pixels, and almost  $4\times$  larger area.

In Fig. 3a-b, we evaluate  $B_{\text{fault}}$  for Fault B. This is nontrivial to evaluate because we have to separate the  $B_{\text{fault}}$  amplitude from the grid pattern superimposed on the fault, and both have a comparable amplitude. To separate them, we took the Fourier transform of Fig. 3a and set the amplitudes of the frequency compo-

nents from the grid pattern to zero. After calculating the inverse Fourier transform (with a suppressed grid pattern), we removed a quadratic background magnetic field. These fault isolation steps yield the magnetic field map of the isolated fault in Fig. 3b. Fault B has a 7.7  $\mu\text{T}$  amplitude when using a 50 mA test current, which leads to  $\text{SNR}_{\text{QDM}} = 5.1$  for a 1 A test current, 1 s measurement duration, and  $1 \times 1 \mu\text{m}^2$  pixel size.

In Fig. 3c-d, we evaluate  $V_{\text{fault}}$  and  $\delta V$  for Fault B. We fit the fault image with a 2D Gaussian function to find  $V_{\text{fault}} = 32$  and  $\delta V = 19$  in arbitrary units. Applying the relevant normalization factors, we get  $\text{SNR}_{\text{TIVA}} = 0.15$  for 1 A test current, 1 s measurement duration,  $1 \times 1 \mu\text{m}^2$  pixel size, and  $2.74 \text{ mm}^2$  image area.

For NV magnetic imaging, Fault B has a location uncertainty of a few microns, indicated by the width of the cross shape in Fig. 3b. Note that the  $\{x, y\}$  location of a fault within the  $8 \mu\text{m} \times 8 \mu\text{m}$  overlap between the traces in Layers 4 and 5 cause very different magnetic images. Simulating this phenomenon and comparing to the experimental magnetic images can yield a fault position uncertainty significantly smaller than the  $16 \mu\text{m}$  periodicity for these conducting layers. For the TIVA image, the 2D Gaussian in Fig. 3d has a standard deviation of  $34 \mu\text{m}$ . This standard deviation provides an estimate for the spatial resolution, though the centroid uncertainty can be made arbitrarily small with sufficiently-good SNR. Overall, we conclude that our QDM spatial resolution is  $\sim 10\times$  better than the TIVA imaging spatial resolution, though both could be enhanced with additional hardware improvements and post-processing efforts.

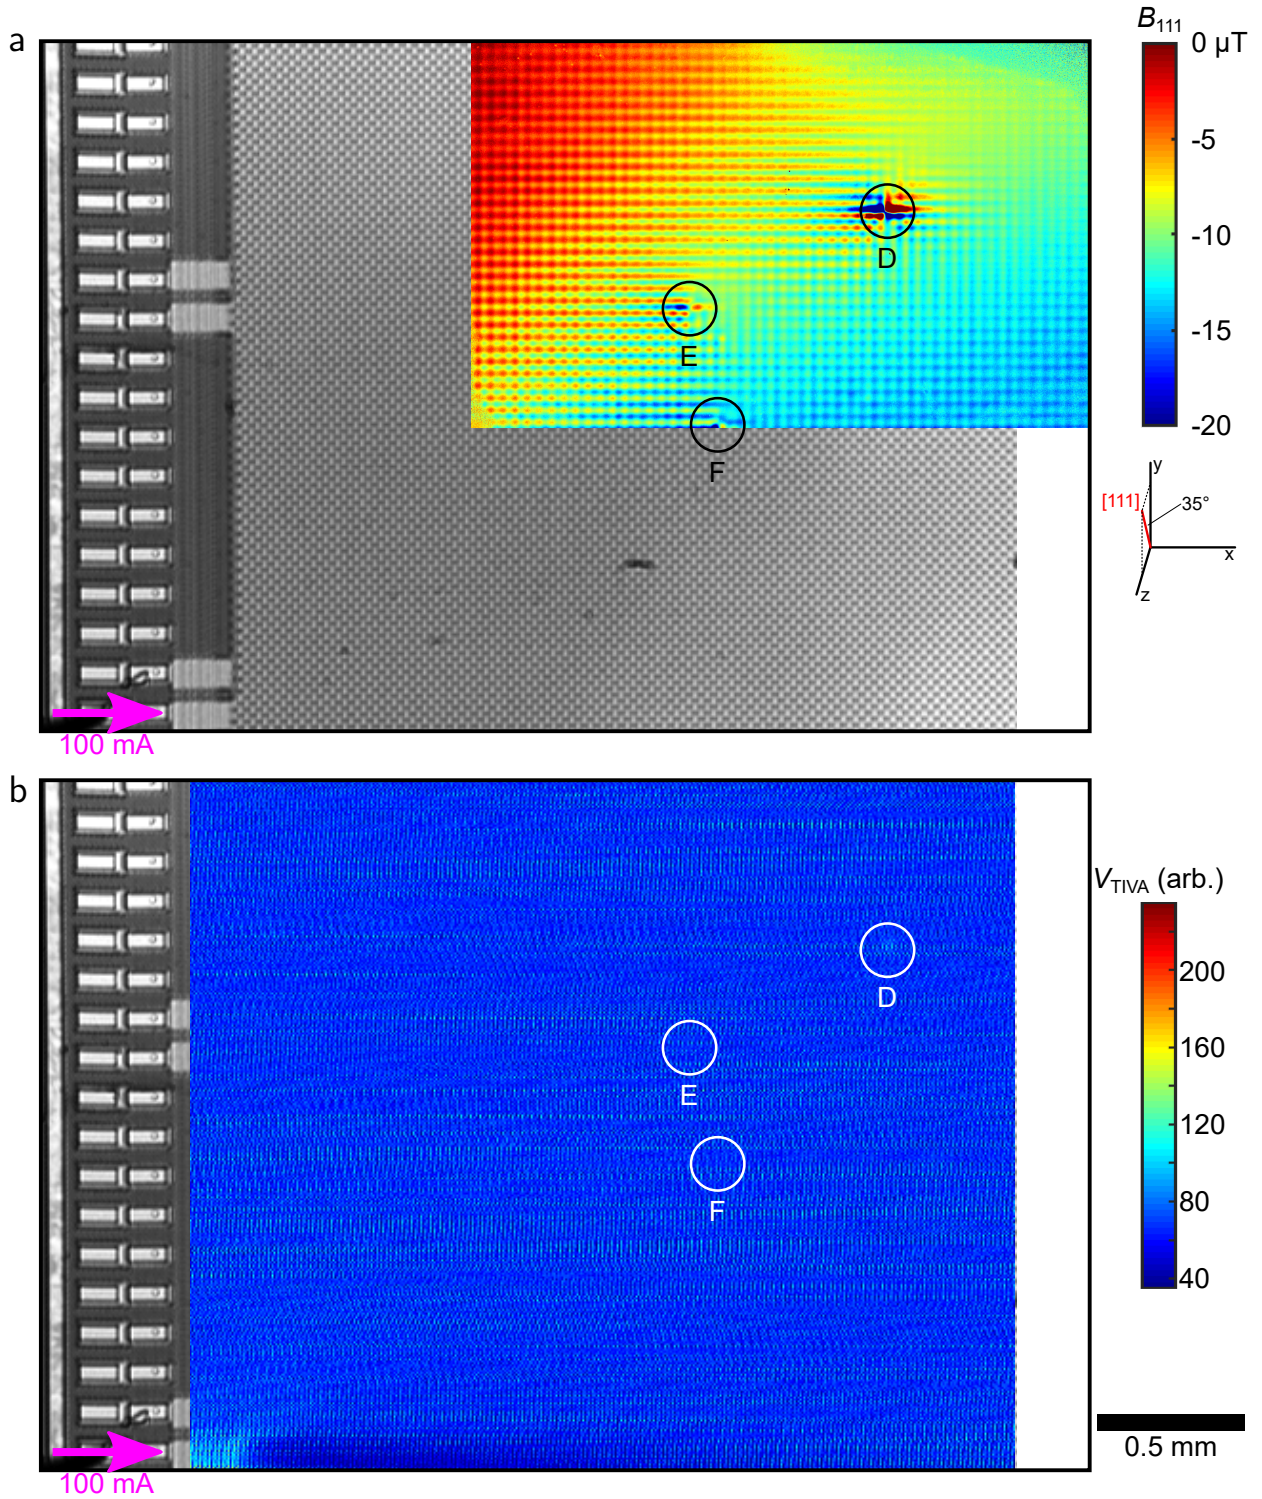
FIG. 4. (a) QDM magnetic image for FOV2, showing Faults D-F. (b) TIVA image for FOV2, showing the same three fault locations. Fault D is visible, but Faults E and F are too weak to see.

Figure 4 shows magnetic and TIVA images for a second die, in an area closer to the middle of the die where the currents are weaker. We applied a 100 mA test current for both the NV magnetic imaging and the TIVA imaging experiments, and we see three additional short-circuit faults, labeled Faults D, E, and F. Both techniques see a strong short-circuit fault (Fault D), though it is barely visible in the TIVA image. Furthermore, the NV magnetic image sees two additional faults (Faults E and F), which have magnetic field amplitudes that are

$\sim 20\text{-}40\times$  weaker than that of Fault D. Faults E and F are too weak to see in the TIVA image, confirming our earlier finding that  $\text{SNR}_{\text{QDM}}$  is better than  $\text{SNR}_{\text{TIVA}}$ . Given knowledge of their locations from the magnetic image, we were later able to locate them after several

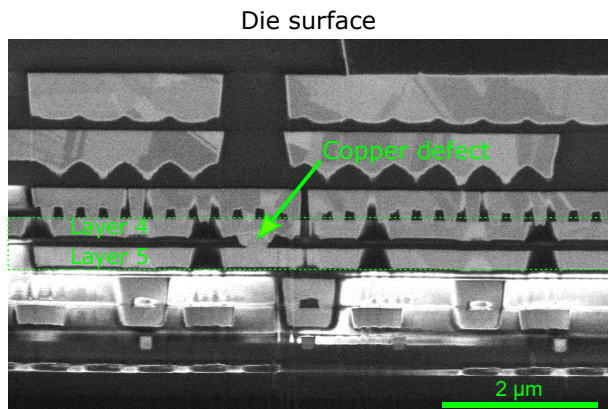
FIG. 5. A scanning optical microscope (SEM) image of a die cross-section showing Fault F, which is caused by a copper defect between Layers 4 and 5.

sections. Figure 5 includes a cross-section for Fault F, showing the copper defect causing a short between the conducting layers.

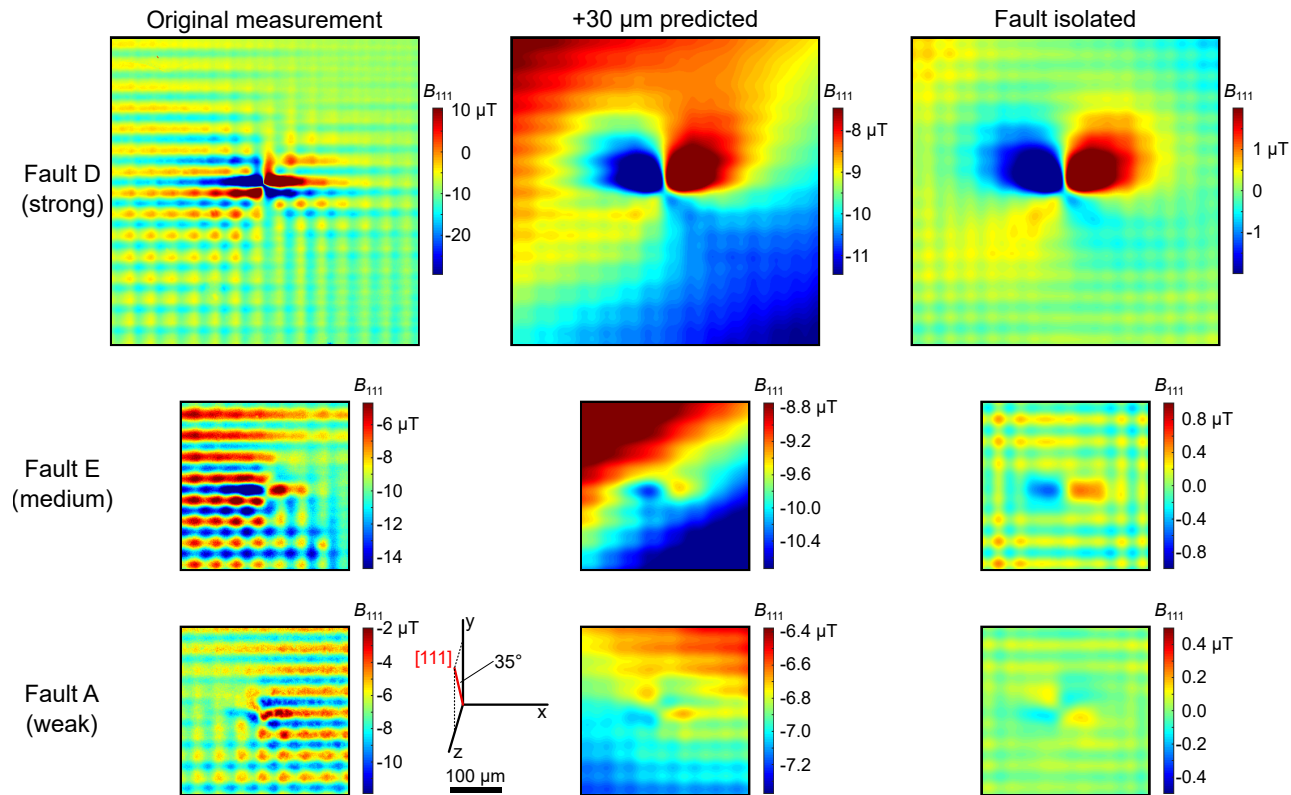
FIG. 6. Magnetic images for Faults D, E, and A, representing strong, medium, and weak-amplitude faults. Using the measured magnetic images (left column), we simulate the magnetic images if the die was part of an HI device, with an additional  $30\ \mu\text{m}$  die on top (middle column). We applied the same fault isolation post-processing to remove the background ripples and gradients as in Fig. 3 (right column).

The DUTs imaged in Fig. 2 and Fig. 4 are intended to be part of an HI device, with an additional 30 μm die to be mounted on top. To simulate the magnetic images for short-circuit faults if they were measured in an HI device, we calculated the expected magnetic field images with 30 μm of additional standoff distance [6], shown in Fig. 6. We evaluated the anticipated performance for three typical fault magnetic amplitudes: strong (Fault D), medium (Fault E), and weak (Fault A). As expected, the grid patterns and fault features become weaker and coarser, but fortunately the fault features are still visible with the added standoff distance, especially after using the fault isolation steps described above. This suggests that NV magnetic microscopy could also work well for HI devices, despite the increased standoff distance. However, since weak magnetic features become more difficult to isolate from the background magnetic field with increasing standoff distance, minimizing the measurement standoff distance is always preferable. Despite these limitations, Fault D (which has a large  $B_{\text{fault}} \approx 120 \mu\text{T}$  amplitude and a small background gradient) should be visible as far as

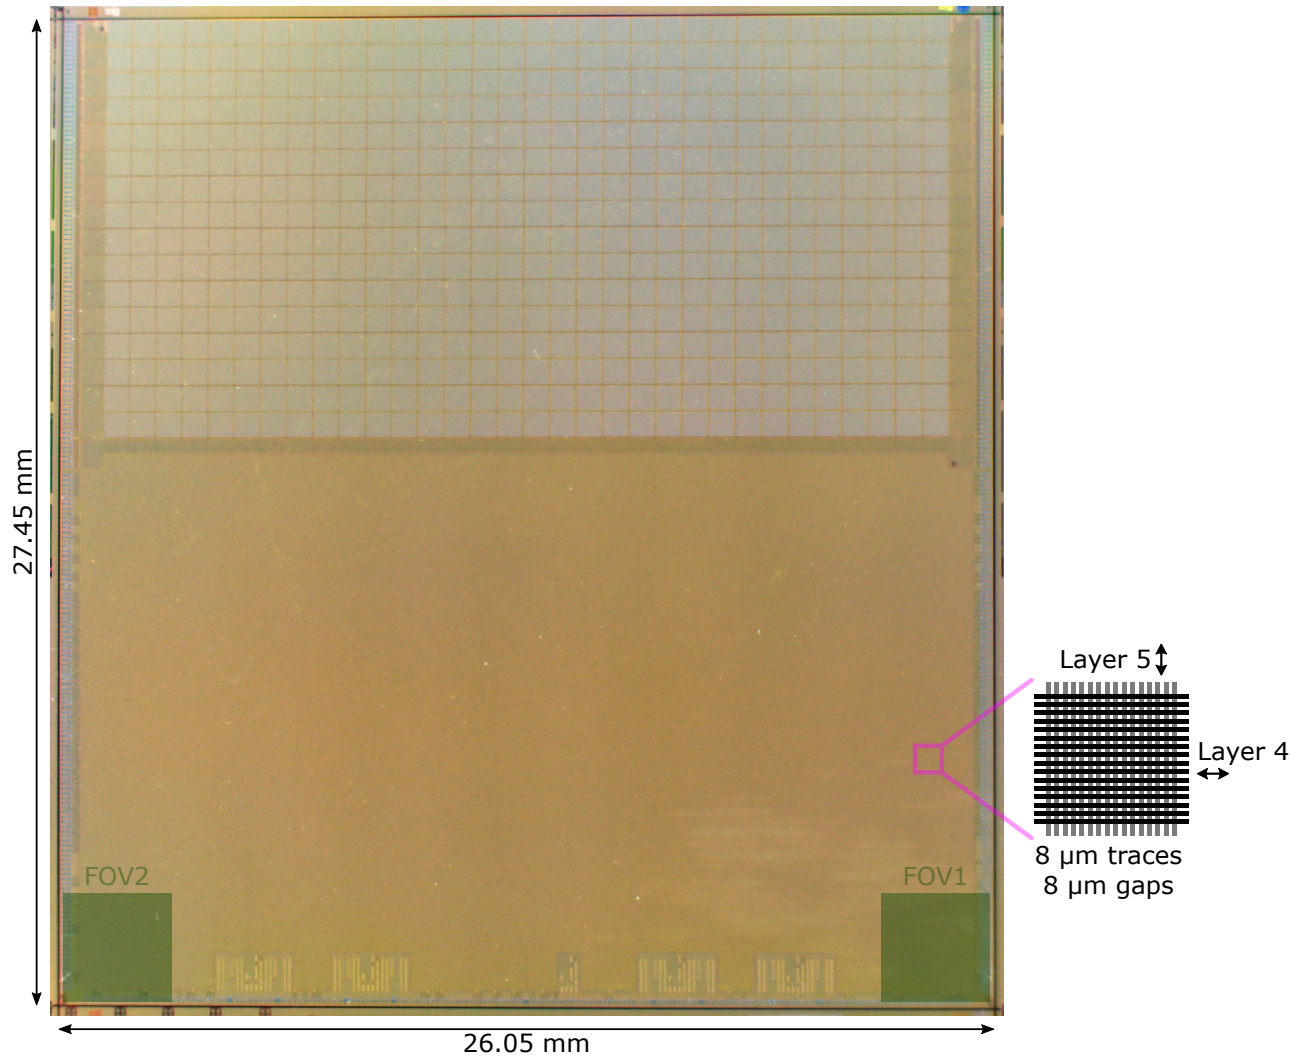
**Supplementary Figure S1.** Image of the device under test (DUT) used in this work, an ASIC with multiple conducting layers. The fields of view examined in this work (FOV1 and FOV2) are highlighted in green, and the inset shows the grid layout for the relevant conducting layers (Layers 4 and 5).

Figure S1 shows a photo of an example die studied in this work. Die 1 and Die 2 were made on a silicon wafer, and we performed the experiments on the DUTs before wafer dicing. Internally, the DUT has multiple metal layers, and our work involved searching for short-circuit faults between the power planes in Layers 4 and 5. These layers contain orthogonal rows and columns arranged in a grid pattern, as shown in the Fig. S1 inset. We applied test currents through probe tips placed on the relevant pads.

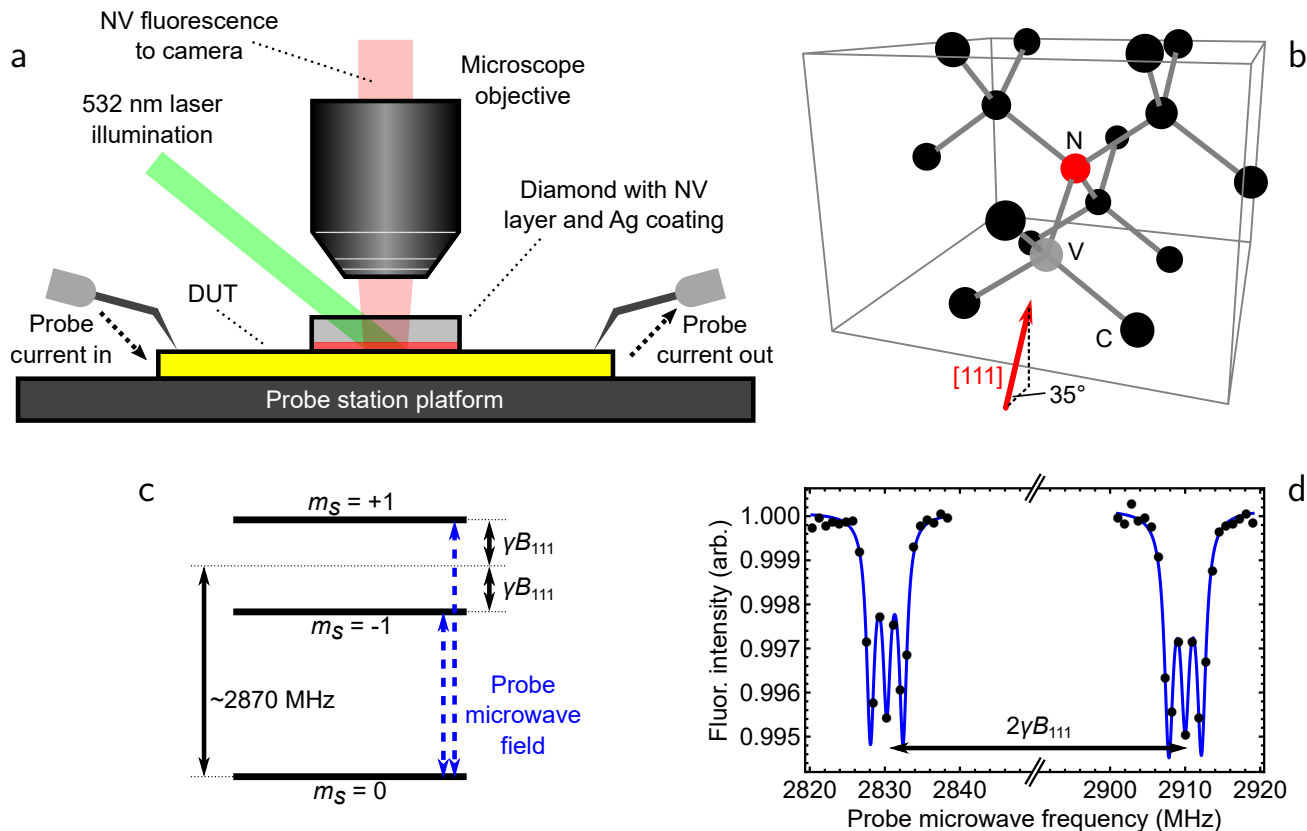
**Supplementary Figure S2.** (a) Schematic of the combined QDM/probe station setup for measuring a DUT, in this case an ASIC die. A diamond sample with a surface NV layer (red stripe) is placed on top of the DUT, illuminated with 532 nm laser light, and the NV fluorescence is imaged by the microscope. The microwave wire and bias  $B_{111}$  magnetic field are not shown. (b) NV center in the diamond carbon lattice, with an arrow showing the [111] crystallographic direction. (c) Energy level diagram of the NV ground-state magnetic sublevels, indicating the  $\pm\gamma B_{111}$  Zeeman effect and the zero-field splitting ( $\sim 2870$  MHz). (d) Example single-pixel ODMR spectrum; each lineshape is split into three peaks due to the  $^{14}\text{N}$  hyperfine interaction [S6].

Our QDM setup combines an optical fluorescence microscope (used for magnetic imaging) and a probe station (used to apply test currents to the DUT), as shown in Fig. S2a. In the QDM setup, we place a  $4 \times 4 \times 0.5 \text{ mm}^3$  diamond sample (Sample A in Ref. [S1]) with a  $4 \text{ }\mu\text{m}$  sheet of magnetically-sensitive NV centers on top of the DUT (Fig. S2b). The NV electronic ground-state magnetic sublevels are sensitive to the magnetic field  $B_{111}$  along the N-V axis (the [111] crystallographic direction), leading to the  $m_s = 0$  to  $m_s = \pm 1$  transition frequencies being shifted by  $\pm \gamma B_{111}$ , where  $\gamma \approx 28 \text{ GHz/T}$  is the NV gyromagnetic ratio. We illuminate the NV layer using  $532 \text{ nm}$  laser light from the side of the microscope objective, which pumps the NVs into the  $m_s = 0$  sublevel. Applying a resonant microwave field drives NVs from the  $m_s = 0$  to the  $m_s = \pm 1$  sublevels, reducing the NV fluorescence emission. Sweeping the microwave frequency and imaging the NV fluorescence with the microscope, we obtain an optically-detected magnetic resonance (ODMR) spectrum for each pixel in the microscope field of view. By fitting the ODMR spectra for each pixel to extract the center frequencies, we obtain a  $B_{111}$  map detected by the NV layer [S2].

In this setup, we used a static  $1.5 \text{ mT}$  bias field along the N-V axis, and subtracted the magnetic field maps acquired using equal and opposite test currents applied to the device to remove any contributions to the magnetic images other than the test current (such as the bias magnetic field). We used  $200 \text{ mW}$  of laser power, and imaged a  $1.31 \times 2.09 \text{ mm}^2$  area with a  $1.09 \text{ }\mu\text{m}$  pixel size and a  $20 \text{ minute}$  typical experiment duration. Finally, to prevent the laser light and NV fluorescence from generating photocarriers in the DUT, we applied a protective coating ( $5 \text{ nm Ti}$ ,  $150 \text{ nm Ag}$ , and  $150 \text{ nm Al}_2\text{O}_3$ ) to avoid altering the internal currents in the DUT with stray light [S3].

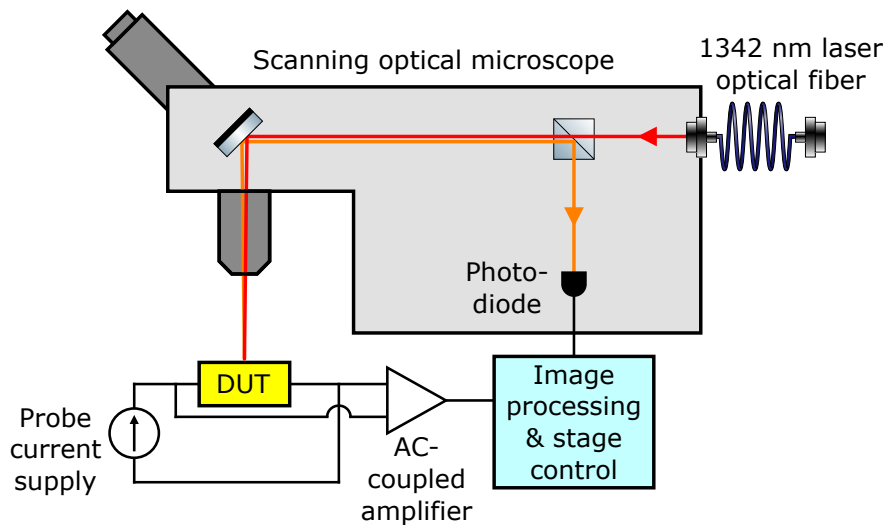
**Supplementary Figure S3.** Schematic of our TIVA setup. We illuminate the DUT with 1342 nm laser light (red beam), and we measure the reflected light (orange beam) with a photodiode. While applying a constant current to the DUT, the voltage across the DUT is also recorded. The scanning optical microscope apparatus moves across the DUT surface, imaging the reflected light intensity and TIVA voltage at each pixel.

Thermally-induced voltage alteration (TIVA) is a technique for localizing defects in semiconductor ICs (Fig. S3) [S4, S5]. Illuminating the DUT with a Nd:YVO<sub>4</sub> continuous-wave monochromatic laser ( $1342 \text{ nm}$ ,  $0.924 \text{ eV}$ ) with a photon energy below the silicon band gap ( $1.14 \text{ eV}$ ) causes localized heating, generating voltage gradients from thermal gradients (Seebeck effect) without creating electron-hole pairs or photocurrents. For TIVA imaging, localized heating from the focused laser beam alters the resistance of a short-circuit fault, producing a change in the IC power demand. Increased sensitivity is achieved when the DUT is under constant-current biasing. As we scan the laser beam across the DUT surface, we record the changes to the applied voltage and power demand, which indicates the heating (and fault) locations.

We used a laser-scanning microscope (Checkpoint InfraScan 400TDM) to map the thermally-induced voltage changes and the corresponding reflected laser intensities, allowing us to spatially localize the defect sites. For our measurements, we typically used  $140 \text{ mW}$  of  $1342 \text{ nm}$  laser light, a  $3.21 \times 3.21 \text{ mm}^2$  scan area with a  $6.27 \text{ }\mu\text{m}$  pixel size ( $512 \times 512$  pixels), and a  $20 \text{ minute}$  measurement duration. After finishing the scan, the instrument provides

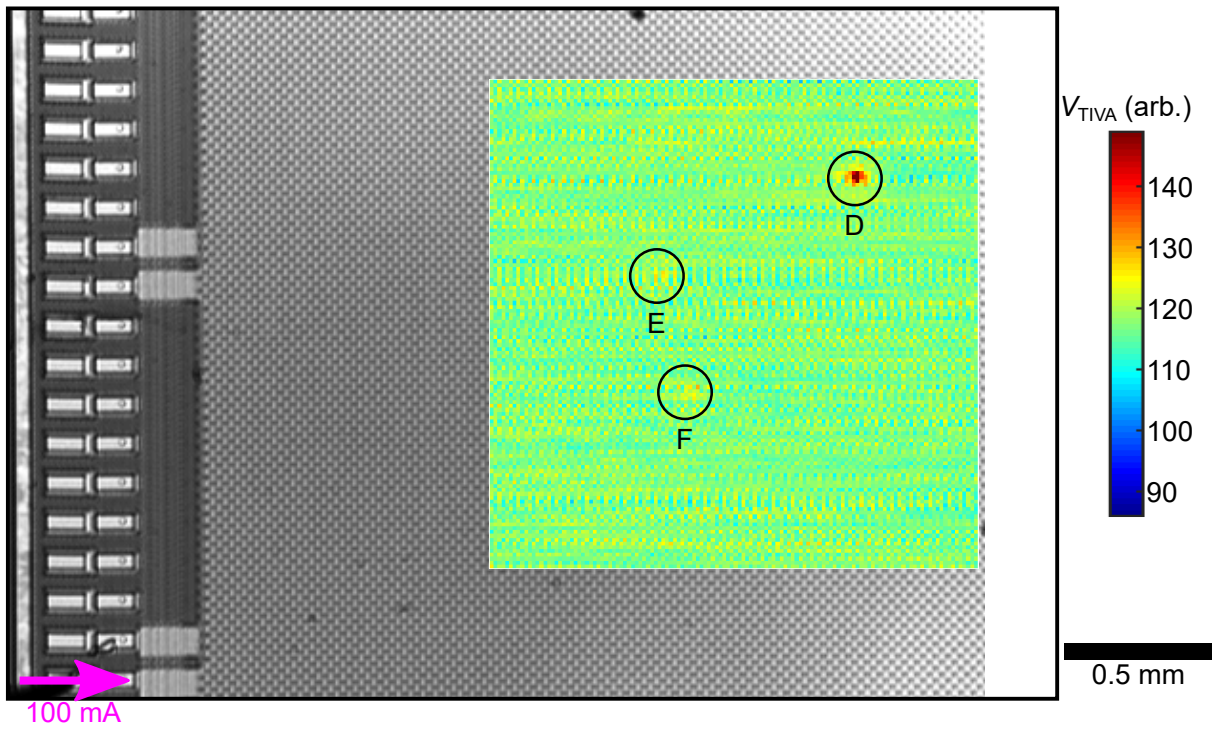
**Supplementary Figure S4.** TIVA image of FOV2 with an improved noise floor ( $4\times$  smaller scan area,  $3\times$  longer averaging time,  $4\times 4$  pixel binning). Faults E and F (which are clearly visible in the NV magnetic image) are barely visible despite these improvements, showing that NV magnetic imaging is able to find weaker faults in less time than TIVA imaging.

To check whether Faults E and F in FOV2 could feasibly be detected in a TIVA imaging experiment, we modified the TIVA imaging experiment to improve the noise floor. We used a  $4\times$  smaller scan area,  $3\times$  longer averaging time, and  $4\times 4$  pixel binning, totalling a  $\sim 14\times$  SNR enhancement. Figure S4 shows the resulting TIVA image. Despite these enhancements, Faults E and F are barely visible in this TIVA image. However, this confirms the fault positions are consistent with the NV magnetic image (Fig. 4a in the main text).
