Inconsistencies between the forces from code live load models and real traffic on truss bridges

Abstract

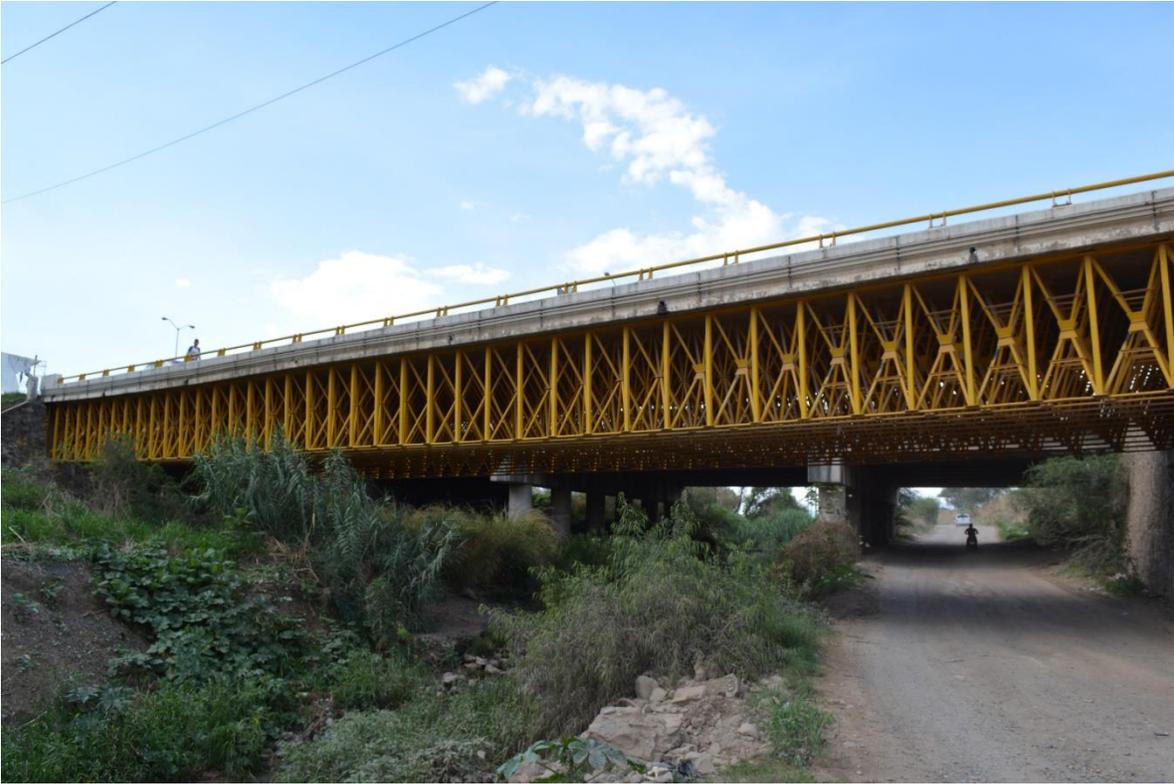
Figure 1 Tridilosa Bridge

Tridilosa became very popular. Tridilosa bridges are mainly composed of two parts: (1) a three-dimensional steel truss, and (2) a reinforced concrete slab over the truss. Figure 1 shows an example of Tridilosa bridge. To date, many Tridilosa bridges have exhibited severe fatigue problems and, in most cases, they have been replaced by prestressed concrete girder bridges. Nevertheless, a few Tridilosa bridges remain in operation, such as the one shown in Figure 1. Unlike Tridilosa bridges which tend to exhibit fatigue problems, girder bridges perform much better for practically the same conditions. This aspect is considered relevant by the authors. Consequently, one of the possible causes of this phenomenon is investigated in this study.

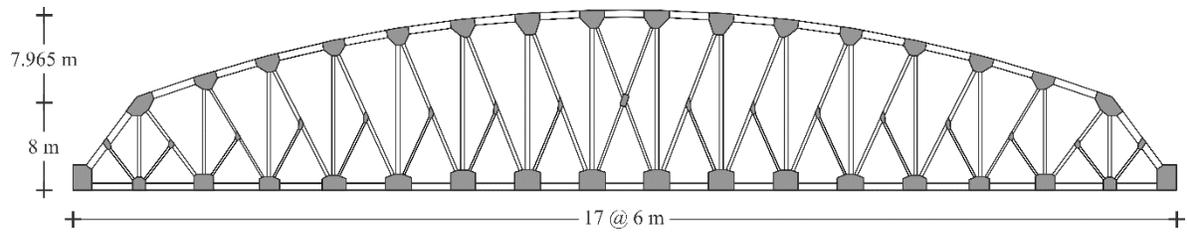
Figure 2 Main truss of "El Infiernillo" bridge

federal 37 (toll) highway, between Guerrero and Michoacán states in the southwest of Mexico. The total length is 360 m divided in 8 spans, three at each extreme of the bridge having an approximate length of 26 m, and other two central spans with a length of 102 m. The extreme spans are built of prestressed concrete girders; the central spans correspond to camelback trusses, as schematically shown in Figure 2. The bridge allows two-lane traffic (one lane for each direction) crossing the reservoir with a dam of the same name (“*El Infiernillo*”), a main hydroelectric facility in Mexico given its power generation capacity. The main trusses are connected with by transversal floor trusses in the lower nodes. The transversal trusses support a concrete slab over steel stringers, forming the composite system over which the asphalt road surface is placed. As shown in Figure 2, the geometry of the main trusses of “*El Infiernillo*” bridge is similar to that of many other bridges. Consequently, the conclusions could be applicable to other truss bridges.

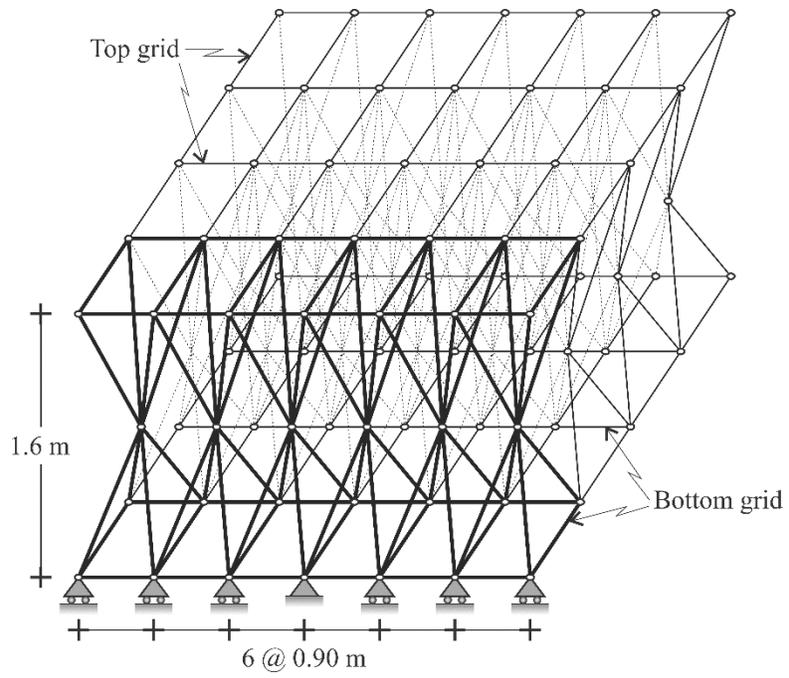
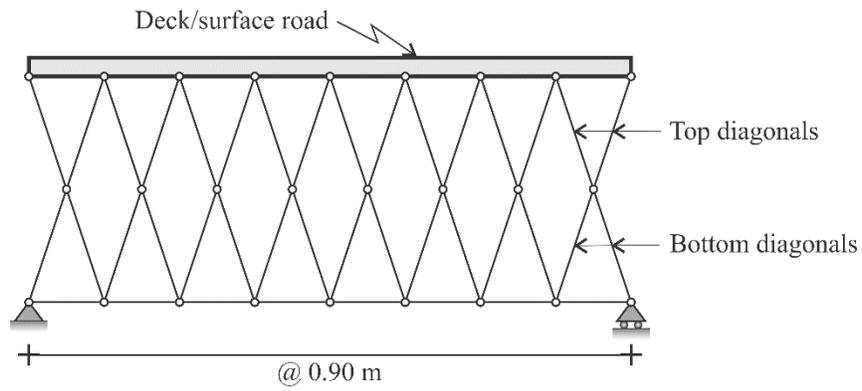
a) Isometric transversal view

b) Longitudinal view

Figure 3 Geometry of Tridilosa-type bridges

Additionally, two Tridilosa-type bridges with 9 m and 18 m long spans, like the ones schematically showed in Figure 3, are used to inspect the inconsistencies of employing code live load models to obtain element forces in these bridges. This is also aimed at exploring whether induced forces on structural elements caused by code live load models, in comparison to those by actual traffic, are one of the main reasons why these bridges are more susceptible to fatigue issues.

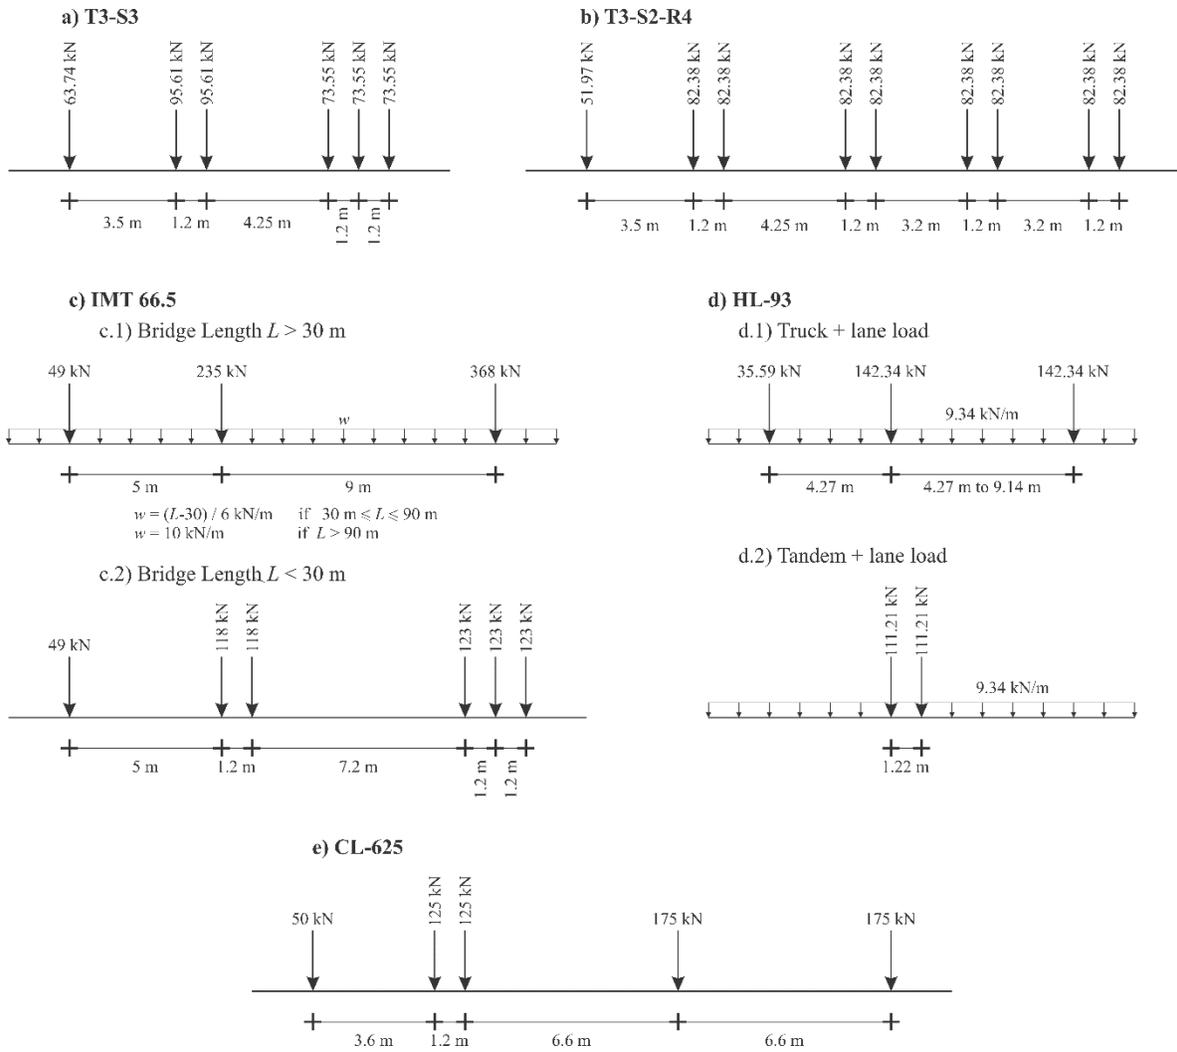
Figure 4 Code live load models

Several live load models defined in different bridge design codes are used to predict the element forces in the studied truss bridges. T3-S3 (Figure 4a) and T3-S2-R4 (Figure 4b) are considered (IMT/SCT 1999) since these live load models were widely used to design Tridilosa-type bridges; they correspond to actual truck configurations in Mexico. Also, the T3-S2-R4 model was used to design “*El Infiernillo*” bridge. The IMT 66.5 (Figure 4c) defined in IMT/SCT 2004 is also considered, which was developed based on traffic surveys carried out in the 1990s in Mexico. Also, the HL-93 (Figure 4d) and CL-925 (Figure 4e) models defined by the American (AASHTO 2017) and Canadian (CAN/CSA 2014) standards, respectively, are used.

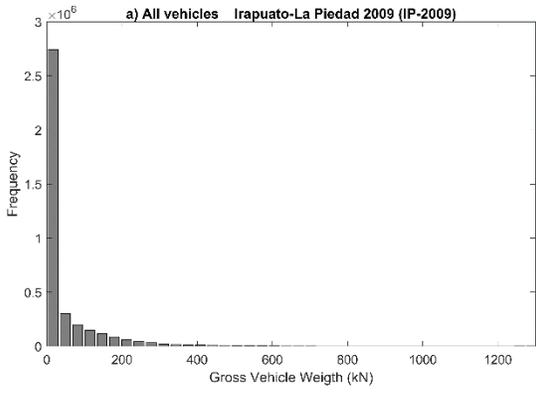
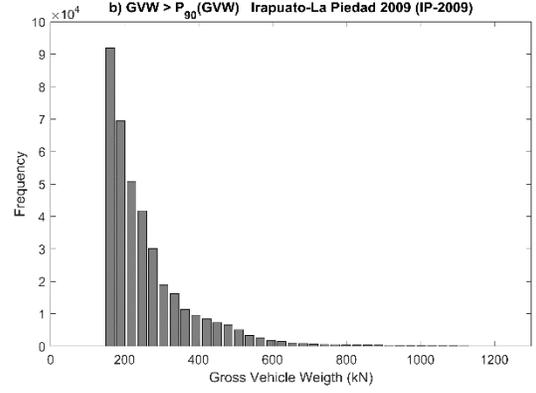
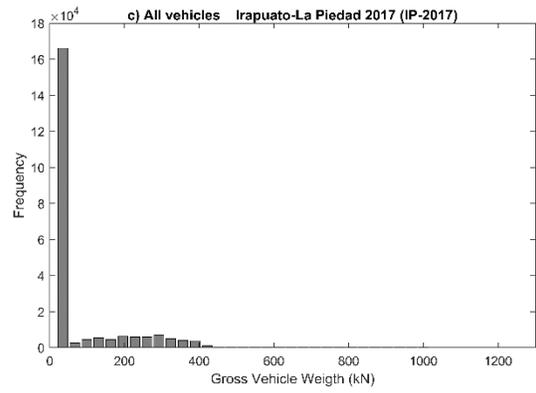
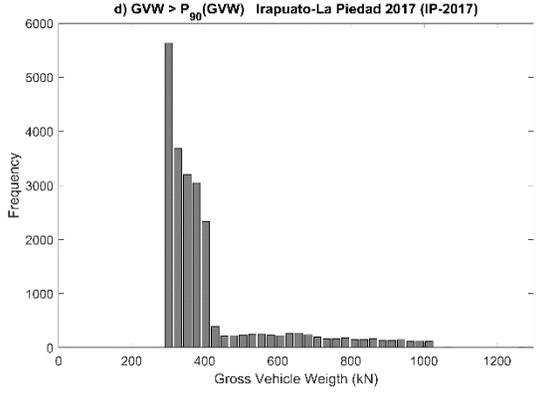
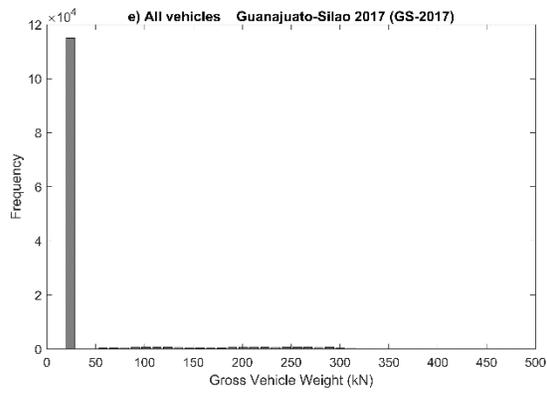
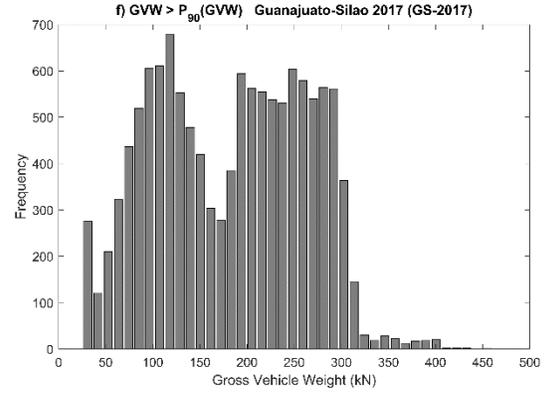
Figure 5 GVW distribution for used WIM databases

Three WIM databases for bridges analyses are used. The first one has been used in previous works (García-Soto *et al.* 2015 and 2020) and was recorded in a four-lane highway connecting the cities of Irapuato and La Piedad (45 federal highway in central Mexico) during January to March 2009 encompassing 3,834,961 vehicles recorded by permanent WIM stations. Figure 5a shows the histogram for all vehicles in this database according to their Gross Vehicular Weight (GVW), while Figure 5b shows histogram for vehicles with $GVW > P_{90}(GVW)$, *i.e.*, the distribution of 10% heaviest vehicles in the database. For convenience these WIM data will be identified hereinafter as IP-2009.

The second database was recorded in the same highway for one week (January 24th – 30th, 2017) encompassing 226,488 vehicles recorded by temporal WIM stations. Figure 5c shows the histograms distribution for all vehicles according to their GVW. As in the previous case, Figure 5d shows the vehicle distribution with $GVW > P_{90}(GVW)$. These WIM data will be defined hereinafter as IP-2017.

The third database was recorded in a two-lane road connecting the cities of Guanajuato and Silao (central Mexico, 110 federal road) for one week (January 16th – 22nd, 2017) encompassing 127,218 vehicular data recorded also by a temporal WIM equipment. Figures 5e and 5f shows the GVW data distribution in histograms in the same way as previously presented. As can be noted, being a highway which allows lighter traffic, the vehicle weights are considerably lower than those for the above-mentioned databases. As in the previous cases, for convenience these WIM data will be identified hereinafter as GS-2017.

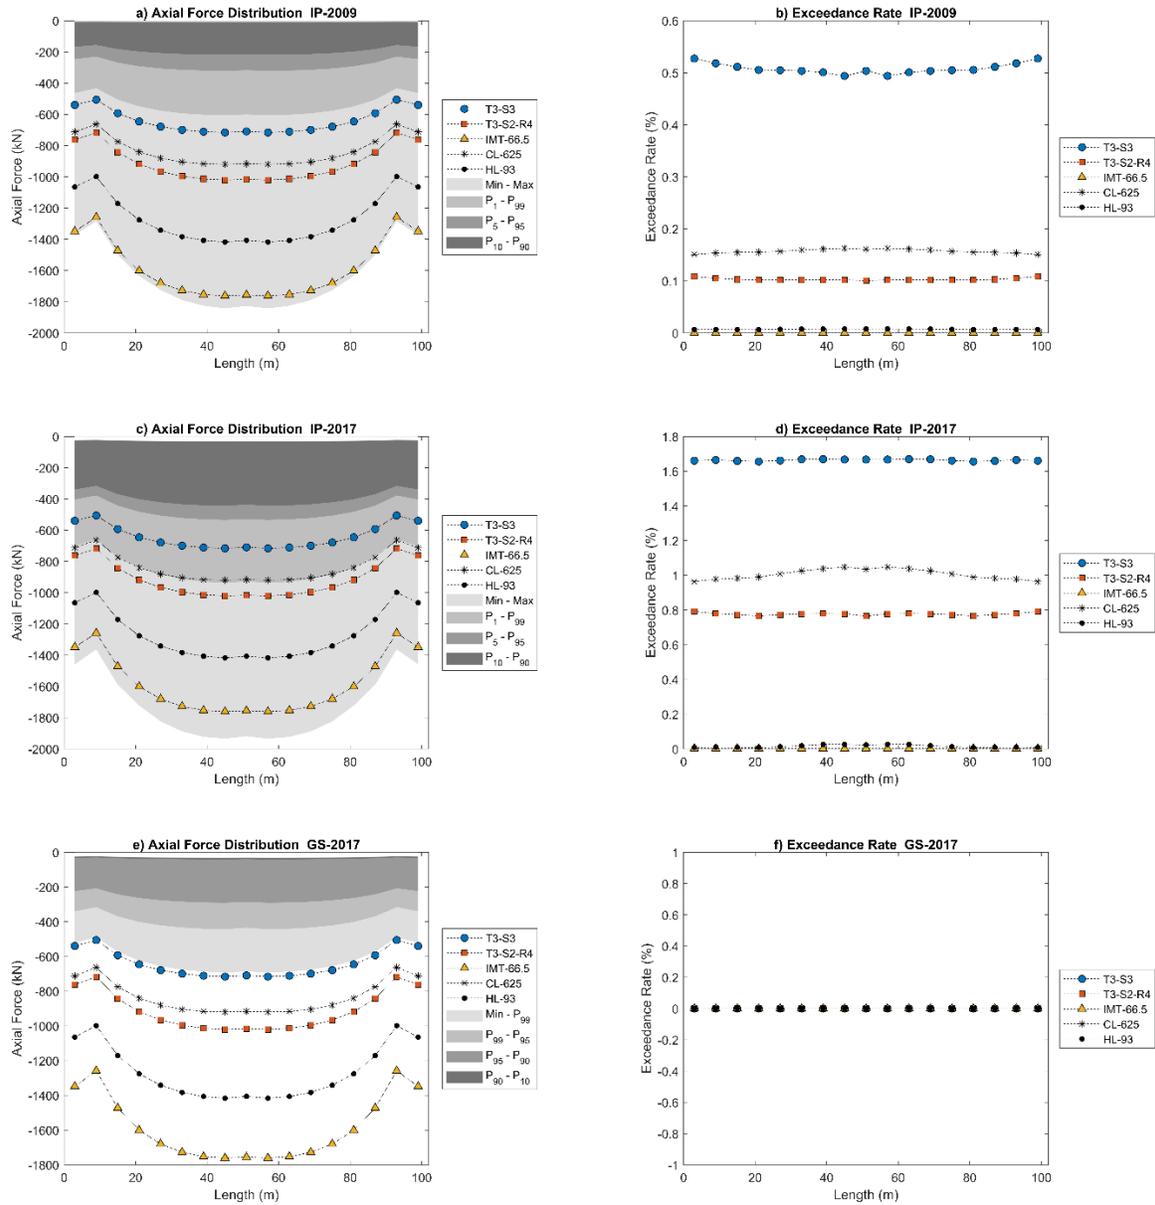
Figure 6 Results for top chord of "El Infiernillo" bridge

A good live load model should adequately estimate force magnitudes in all bridge elements during its service life. As the magnitudes and frequencies of actual live loads evolve on time, it is not surprising that estimated force magnitudes from code live load models are exceeded by actual vehicles; however, the number of times which estimated forces from a code live load model are exceeded by traffic should remain approximately constant in all bridge elements, which is shown in Figure 6 for the top chord of “*El Infiernillo*” bridge.

The left side of Figure 6 shows the forces acting on top chord elements along the bridge for IP-2009 (Figure 6a), IP-2017 (Figure 6c) and GS-2017 (Figure 6e). The convention that compression and tension forces are negative and positive, respectively, is adopted. A scale of gray colors is used to represent the force distribution acting on each member along the bridge for the used databases; lighter gray (15% gray) is used to represent the range in which the minimum and maximum values of acting forces on elements along the bridge are presented. Lower and upper limits of gray at 25% are used to represent the 1% and 99% of the largest forces, (*i.e.*, P_1 and P_{99} respectively; this convention is adopted for other percentages). In the same way, lower and upper limits of gray at 40% represent the P_5 and P_{95} force value distribution. P_{10} and P_{90} force value

distribution are represented by lower and upper limits of darkest gray (65% gray). Forces distributions are on the negative side because top chord elements are subjected to compression forces only. Since limits for lower value forces can be very close, the way of presenting the results for each database allows a better visualization of the largest force values acting on elements. Figures 6a, 6c and 6e make clear the fact that only a very small fraction of the heaviest trucks causes the largest forces in the chord; although this could be expected, the figures allow to inspect this issue at a glimpse. The force values caused by each code live load model considered are plotted with markers. All presented results are unfactored. The study is neither intended to discuss the adequacy of each model to capture the actual forces from the databases, nor to be calibrated to represent truss forces for given return periods (extrapolation or analysis of extremes is out of the scope of this study). The use of code live load models is rather envisaged to inspect whether the models approximately capture the shape of the real element forces; if this is possible, a calibration task to reach desired extrapolated values will be feasible. In fact, it can be observed in Figures 6a, 6c and 6e that all the models adequately follow the trend of the maximum compressions (for the top chord). We will come back to this aspect for other truss elements later.

The right side of Figure 6 illustrates the number of times (in percentage) that vehicle induced forces from the database exceed the value for each live load model, *i.e.*, the exceedance rates for structural elements along the bridge are shown; Figure 6b for IP-2009, Figure 6d for IP-2017 and Figure 6f for GS-2017. As can be noted, exceedance rates are practically uniform for top chord elements for all code live load models, which can be associated with a uniform probability of failure for those bars. Thus, if exceedance rates would be too large to reach a selected reliability level, a recalibration of live load factors for design force combinations is expected to lead to uniform reliabilities, for all truss elements along the top chord of the bridge (for all code models considered). As can be seen in Figures 6b, 6d and 6f, the exceedance rate values are directly related to the GVW in each database, leading to null exceedance rates for GS-2017, since in this database there are only light vehicles, which do not generate greater forces than code live load models. It becomes evident that different live load models (and/or live load factors) should be prescribed for highways with different traffic characteristics. Similar results for the bottom chord of “*El Infiernillo*” bridge are observed for all databases considered, except that tensions instead of compressions are obtained, and they are not shown for brevity.

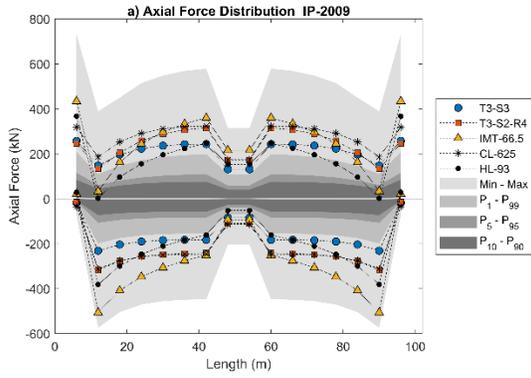
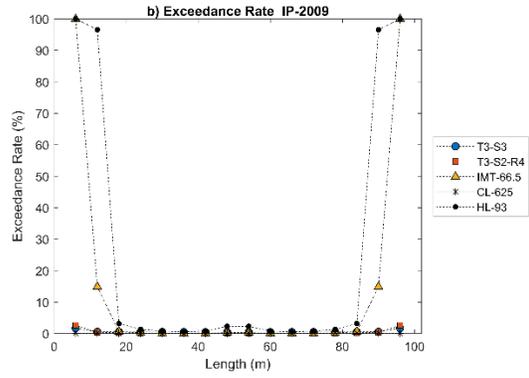
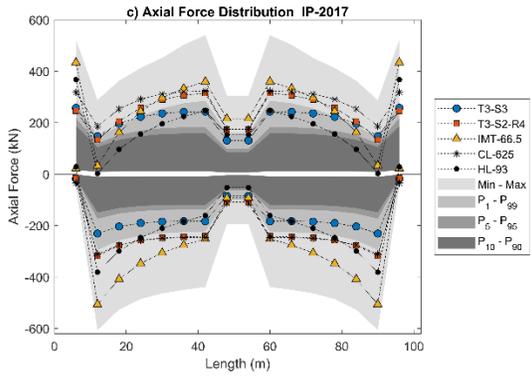
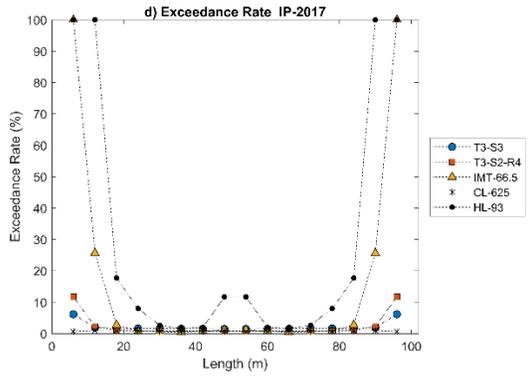
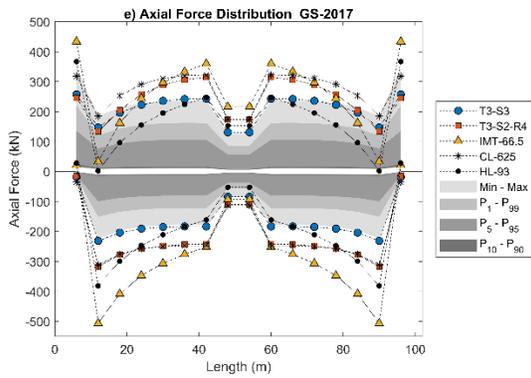
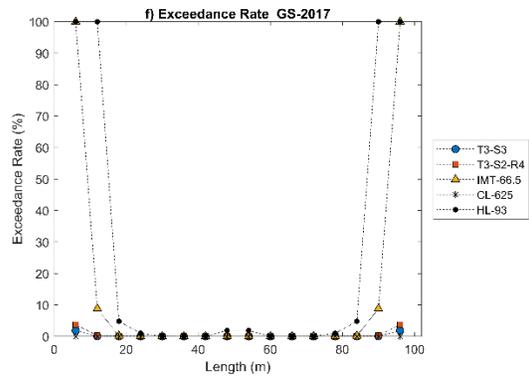
Figure 7 Results for vertical elements of "El Infiernillo" bridge

So far, no relevant inconsistencies in the ability of truck models to capture (at least in relation to the trends shape) the realistic truss element forces are observed. However, Figure 7 illustrates results for vertical truss elements in “*El infiernillo*” bridge and, unlike top chord elements, which are subjected to compression forces only, vertical elements are subjected to load reversals, so two force distributions are shown on the left-hand side of Figure 7 (for the three WIM datasets, analogously to Figure 6), positive for tension forces, negative for compression. For these vertical truss elements, the exceedance rates are no longer uniform along the bridge; moreover, for IMT-66.5 and HL-93 models, there are elements with 100% of exceedance rates (as shown in the right-hand side of Figure 7). This occurs because those live load models include uniformly distributed loads, leading to some members to be always in tension or compression, being these models unable to adequately represent the load reversals that occurs when running the vehicles in the databases along the bridge. Similar trends as those in Figure 7 are found for the diagonal truss elements and are not shown for brevity. Overall, Figure 7 shows that code live load models do not capture the range variation of forces in vertical elements (or diagonals) as uniformly as in chord elements (differences are not discussed in detail for each model but they can be inspected in the figure). Therefore, a not so uniform reliability level (Garcia-Soto et al., 2015 and 2020) would be expected for different bridge truss elements. It is considered that there is room for improvement of current available code live load models by using optimization techniques with information like the one presented in Figures 6 and 7, and even to propose live load models specifically developed for truss bridges, given the obtained results and the fact that something similar was found for continuous bridges (Garcia-Soto et al., 2020) and the results for the Tridilosa-type bridges discussed in the following.

The fact that structural elements exhibit non-uniform exceedance rates along the bridge (Figures 7 to 9) implies that elements with higher exceedance rates have a greater probability of excessive deformations, fatigue, cracks, etc., *i.e.*, they are expected to have more critical conditions associated with different limit states.

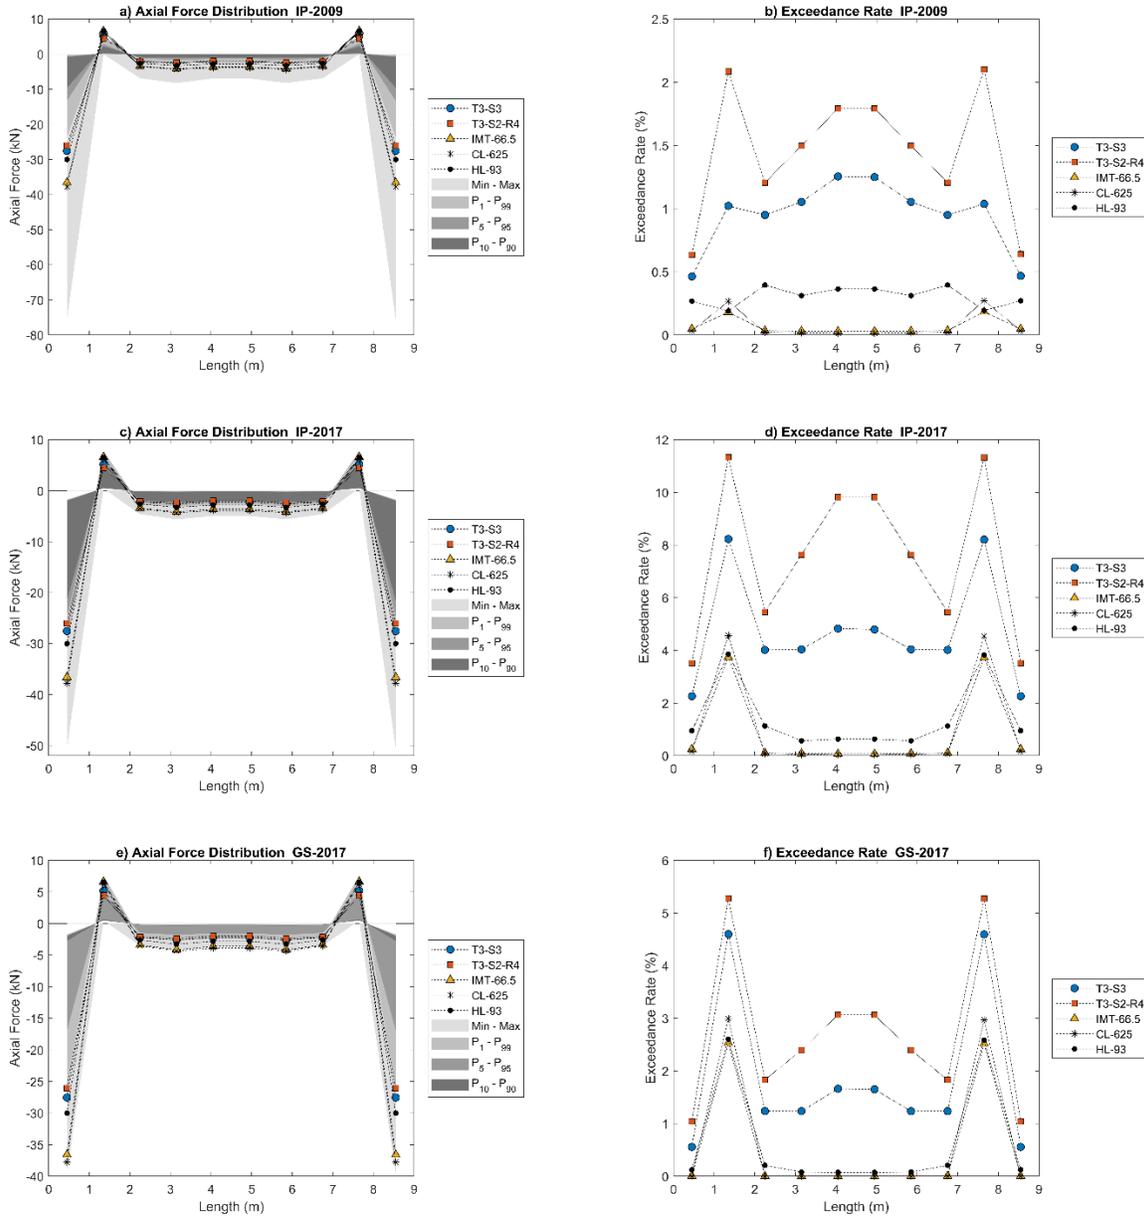
Figure 8 Results for bottom diagonals for 9 m long Tridilosa-type bridge

Figures 8 and 9 show the results for bottom diagonals for Tridilosa-type bridges of 9 m and 18 m span length, respectively. As can be noted, the following elements to those connected at supports (*i.e.*, second and penultimate diagonal members) have the highest exceedance rates for all databases. It should also be noted that highest exceedance rates are not related directly with GVW as in the top chord of “*El Infiernillo*” bridge. This may occur since vehicles in IP-2017 and GS-2017 databases have higher loads per axle, although the GVW is not necessarily heavier. In addition, these cases correspond to short bridges, where heavier and longer vehicles do not entirely fit on these bridges.

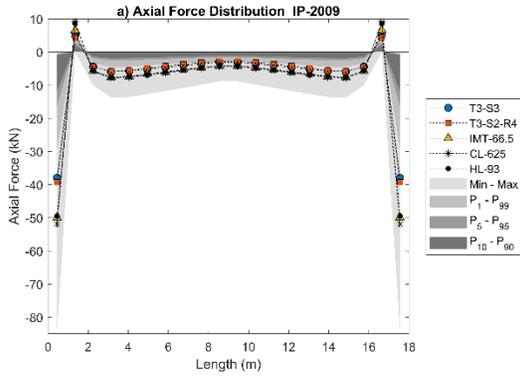
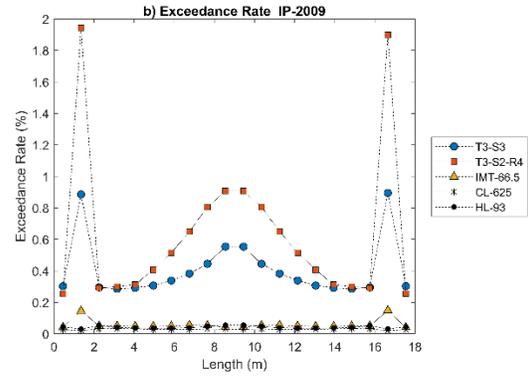
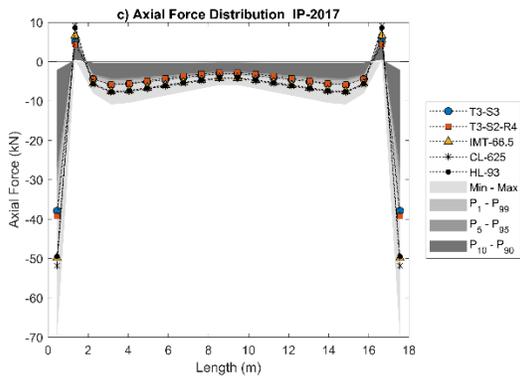
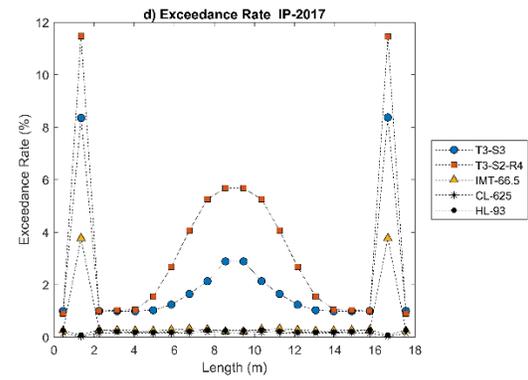
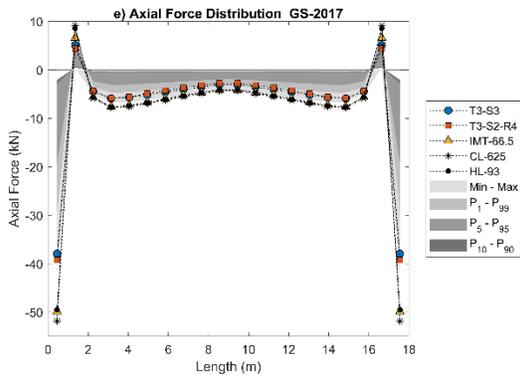
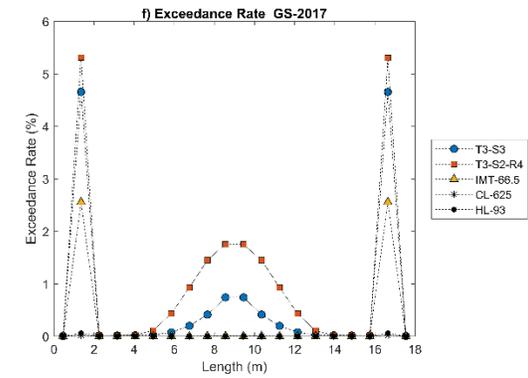
Figure 9 Results for bottom diagonals for 18 m long Tridilosa-type bridge
