Coherent Fourier Scatterometry for detection of killer defects on silicon carbide samples

Jila Rafighdoost, Dmytro Kolenov, and Sylvania F. Pereira

Optics Research Group, Imaging Physics Department, Faculty of Applied Sciences, Delft University of Technology, Lorentzweg 1, 2628 CJ Delft, The Netherlands

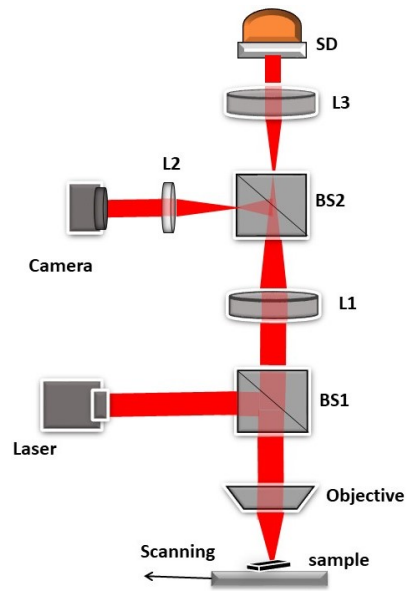
Figure 1: The schematic of the CFS setup. The sample is placed on the stage with a piezo-electric translator, BS1 and BS2: 50-50 non-polarizing beamsplitters, L1, L2, and L3: positive lenses; Camera: CCD camera used for localizing features on the sample; SD: split detector (bi-cell silicon photodiode). A collimated and uniform He-Ne laser is used as the coherent source. The split detector is aligned perpendicular to the scan direction of one line of the raster scan.

Scatterometry-based techniques utilize the properties of scattered light to extract information about the object being illuminated. In our implementation, we use coherent light from a laser source to illuminate the object and observe the scattered light in the far field. The details of the setup are shown in Figure 1. A collimated He-Ne laser with a wavelength of $\lambda = 632\text{nm}$ passes through a non-polarising 50-50% beam splitter (BS1). The input light is linearly polarized in arbitrary direction before it passes through the beam splitter BS1 (hereby we note that the polarization direction has negligible effect on the detection of the defects). The light then is focused on the sample plane by a high numerical aperture objective (NA=0.9). In this approach, the high numerical aperture objective allows us to illuminate the sample and collect the diffracted field in a large number of angles in one shot.

The sample is mounted on a 2D piezo-electric stage (Physik Instrumente P-629.2CD) that is programmed to be moved in the lateral direction in raster scan mode. The focus position can also be adapted with a 1D piezo-electric stage (Physik Instrumente P-620.ZCD). Given that the focus depth is very short ($\sim 1\mu\text{m}$), one can focus the light onto different depths within the sample. The reflected and scattered field is captured by the same objective lens and directed back to BS1. However, due to the small depth of focus, finding the correct focal plane is challenging. We solved this issue by allowing the reflected beam from the sample to interfere with a reference beam by placing temporarily a mirror at the open port of beam splitter BS1 (not shown in Figure 1). In this case, when flat interference fringes are observed between the two beams, we can ensure that the light is focused on the sample plane. The reference beam is then removed during the data acquisition. The back focal plane of the objective is imaged simultaneously into the camera and the split detector (ODD3W2 Bi-Cell Silicon Photodiode) using the telescope arrangements formed by lenses L1, L2 and L3. The camera is only used for general localization of features on the sample. The split detector is a bi-cell detector, i.e., a detector whose area is divided in two halves, with the latter being aligned perpendicular to the scan direction of one line of the raster scan. During the scan, the photocurrents of the two halves of the detector are subtracted from each other, resulting in a differential photo-current I_- that is recorded for every scan position. After the raster scan, a 2D mapping with the values of I_- for each scan position are plotted in a 2D graph. In order to interpret the scan maps, one can see that if there are no defects on the sample, the photo-current $I_- \sim 0$ (given that the scattered signal will correspond to the spurious reflection of the sample). However, when a defect passes through the focused light beam while the stage is being scanned, the far field will show asymmetries and will generate a non-zero I_- .

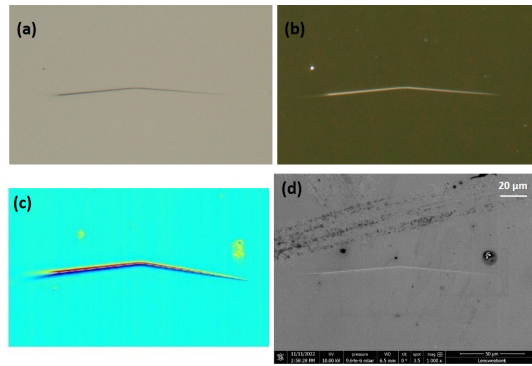
Figure 2: (a) and (b) BF and DF images of the stacking fault defect, respectively. (c) CFS scan map of the stacking fault defect, and (d) SEM image of the same defect.

Extended defects with a planar shape are generally classified into three different groups named, stacking fault, stacking fault propagated, and stacking fault complex. Stacking faults usually appear triangular with a distant outline on the surface of SiC wafers. Propagated stacking faults have a trapezoidal structure. Our sample did not contain any stacking fault propagated and therefore we only have results for the stacking fault. Here, Figure 2(a)-(d) show the BF and DF images, the CFS scattering map and SEM image, respectively. One can clearly see that although all methods are able to detect the defect, CFS shows a better visibility with respect to the background as compared to the other techniques. In addition, when comparing BF and DF images with CFS, the latter recovers the object even if it is not in one plane on the substrate but could extend deep into the substrate.

of the second Stacking Fault shown in Fig. 3(c) (BF) and Fig. 4(c) (CFS) by averaging the background ($I_{background}$) and taking the intensity of the defect (I_{signal}) at various points within the defect. The visibility is obtained from the expression $V = (I_{defect} - I_{background}) / (I_{defect} + I_{background})$. The values around the thinner tail region of the defect were $V = 0.06$ for BF and $V = 0.8$ for CFS. If one would take the brightest value within the defect (around the the middle of the defect), the visibility $V = 0.35$ for BF, while the corresponding value for CFS was $V \sim 1$. The visibilities of the other defects shown in Fig. 2, 3, and 4 are also in the same order.

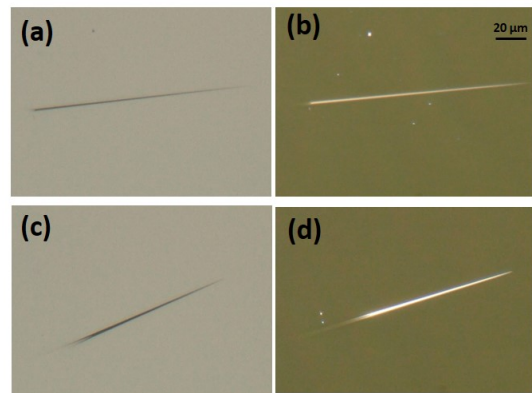
Figure 3: (a) and (c) BF images of different defects, and (b) and (d) DF images corresponding to (a) and (c), respectively.

The next detected defect was the Stacking fault complex, which is usually called carrot. This is also a major morphological defect that has a shape of a long and thin needle that gradually becomes even thinner at one end of the line. In Figure 3 we show images of two different carrots obtained with BF (Figure 3(a) and (c)) and DF images (Figure 3(b) and (d)). In Figure 4 we compare the detection of the same carrot defects using CFS (Figure 4(a) and (c)) and SEM (Figure 4(b) and (d)). Similar argument with the previous defect is also valid here. The thick head and thin tail of the defect is clearly visible with CFS and not so clear using the other techniques.

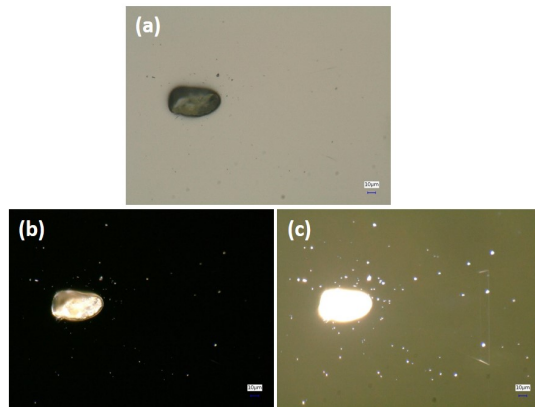
Figure 5: (a) is a BF image of the defect while (b) and (c) are also DF images of the same defects. (c) is saturated in order to see the entire defect.

Figure 5(a) shows the BF image of a polytype inclusion, while Figure (b) and (c) are both DF images with different powers. Figure 5(c) is saturated in order to reveal parts of the defect that are buried. Figure 6(a) shows the scattering CFS map and Figure 6(b) and (c) the SEM image of the same defect. The two SEM images are obtained at 10 and 30 KV, respectively to also highlight different parts of the defect. By comparing these images, one can see that with CFS, the triangle next to the big spherical defect is clearly revealed (see also the inset of Figure 6(a)) while all other techniques (BF, DF and SEM) fail to image it properly. We believe that this is due to two reasons: first, the contrast was too low, and second, the triangle is in a different depth than the downfall. This is one scenario where both optical microscopy and SEM would fail to have a comprehensive inspection due to the low penetration depth and/or low contrast. Therefore, when it comes to very narrow and features that lie partially outside the sample plane, CFS can outperform the conventional methods and become a complementary tool to them. The comparison between the results of all techniques indeed shows good consistency and demonstrates CFS's capability in visualizing and locating killer defects.

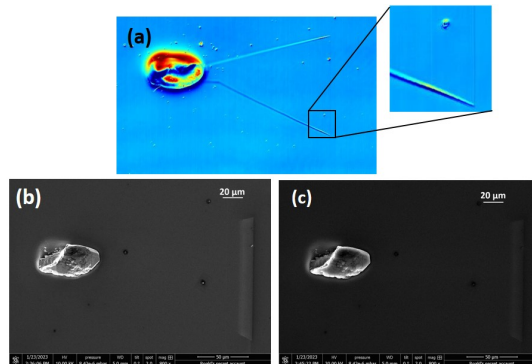
Figure 6: (a) CFS scan map, (b) and (c) are SEM images of the same defect with 10 and 30 KV, respectively. In the inset in 6(a) we highlight the parts of the defect that is not clearly observed with other techniques.
