PROCEEDINGS FOR TWEPP 2023 TOPICAL WORKSHOP ON ELECTRONICS FOR PARTICLE PHYSICS OCTOBER 1-6 2023 GEREMEAS, SARDINIA, ITALY

The quality control programme for ITk strip tracker module assembly

A. Tishelman-Charny on behalf of the ATLAS ITk Collaboration

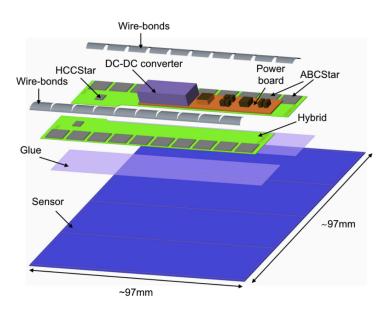
Figure 1: Diagram of a module [1]

Modules are composed of silicon strip sensors serving as active detection material, with PCBs directly glued on top: hybrids hosting ASICs, directly wire-bonded to individual strips for readout, and a powerboard to power module components. As an example, a diagram of a module is shown in figure 1

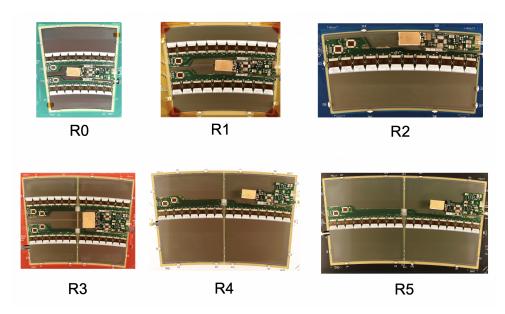
Figure 3: End-cap modules (not to scale). Note that ring modules R3-R5 contain two sensors.

Images of barrel and end-cap modules are shown in figure 2 and figure 3.

track occupancy is expected. In the end-cap disks, composed of petals, six module geometries are required in order to make up the petal shape.

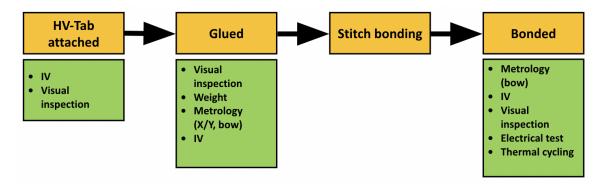
Figure 5: Module assembly and QC steps.

The module assembly and QC procedure, shown in figure 5, begins with the HV-Tab attachment step: the HV-Tab is an aluminum strip attached to the metal backplane of the sensor in order to provide HV for sensor depletion.

After each assembly step, the module is visually inspected in order to spot obvious issues. Step-specific assembly and QC steps are defined as follows: after attaching an HV-Tab to the sensor, an I-V curve is taken up to -700 V to catch HV-tabbed modules with early breakdown. A module fails the I-V step if it has a breakdown at > -500 V. While initially modules can work with a high signal-to-noise ratio while biased at -350V, ensuring they are operational up to -500 V allows for the possibility to increase their bias voltage at the end of life. Hybrids and powerboards are then glued to the sensor, where a similar weighing and metrology procedure is performed as is performed on hybrids. This is to ensure there is not too much or too little glue, and to ensure the electronics are properly positioned for optimal wire-bonding between the ASICs and strips. After stitch bonding for multi-sensor ring modules, the final wire-bonding is performed between the ASICs and the strips. Metrology is performed to ensure sensors have not bowed, and multiple electrical tests are taken: first, an I-V curve up to -550V is taken to measure leakage current and check for breakdown. During the development of this test, it was found that at each voltage step an average of 100 current measurements needed to be used to extract stable I-V curves. An electrical test is then performed to characterize the module's noise. This test consists of a measurement of each ASICs timing offset and pedestal, the injection of three test charges with varied thresholds for noise measurement, and the injection of ten test charges for a more precise per-channel noise measurement. Further detail can be found in section 3.2.6 of [2]. A module fails this test if > 2% of its channels are marked as bad, or if 8 consecutive channels are bad. Finally, each module is thermal cycled ten times from -35° C to $+20^{\circ}$ C, and a noise measurement is taken after cycling. If the post-cycling noise measurement fails, the module fails thermal cycling. This step is performed to ensure the module is operational after the repeated temperature changes expected during operation at HL-LHC.

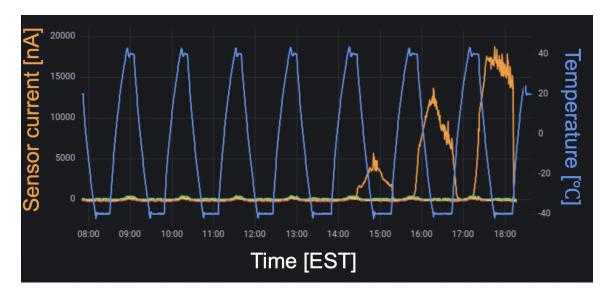
Figure 6: Sensor current vs. time during the first 7 cycles of a thermal cycle. Well-behaved sensor currents are drawn in green, yellow, and red.

During further development and testing of the module thermal cycling sequence, some modules were found to display increasing sensor current with consecutive cycles. An example is shown in figure 6.

During the 5th, 6th, and 7th thermal cycles of this long strip module's test, the sensor's current began increasing from about 5, to 10, and to 17 μ A. At the time, thermal cycling was performed with sensors biased at -350V throughout the sequence, including during temperature changes. Due to multiple instances of this behavior, and the fact that the detector is not expected to have HV on during temperature changes, the thermal cycling procedure was updated to only include HV powering during DAQ tests and not during temperature changes between cold and warm points.
