Development of A Full-Scale Approach to Predict Overlay Reflective Crack

Zehui Zhu^a and Imad L. Al-Qadi^a

^a Illinois Center for Transportation, University of Illinois Urbana-Champaign, Rantoul, IL, USA

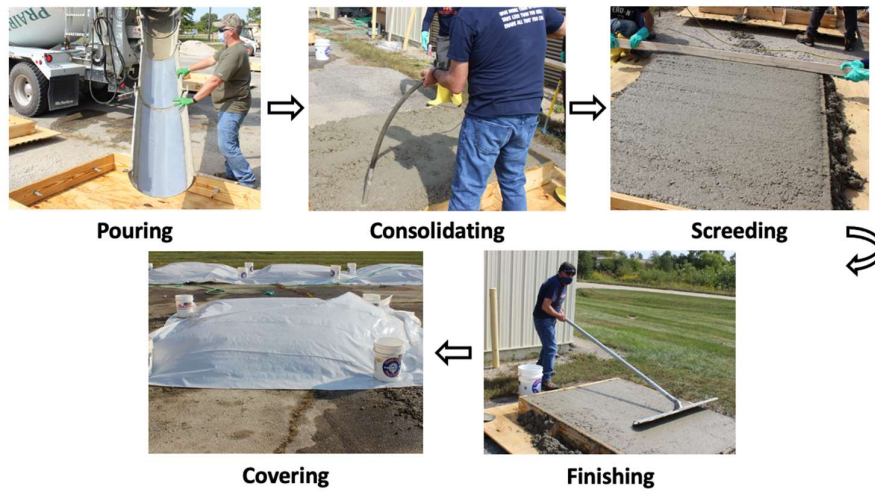
Figure 1. Portland cement concrete casting.

Portland cement concrete slabs measuring 1.8×1.8 m square and 178 mm thick were cast following the procedures illustrated in Figure 1. Field-cured specimens underwent testing for compressive strength, flexural strength, and modulus of elasticity (AASHTO T 22, 2022; AASHTO T 177, 2017; ASTM C469, 2022). The 14-day compressive and flexural strengths were 25.7 MPa (3,728 psi) and 7.1MPa (1,024 psi),

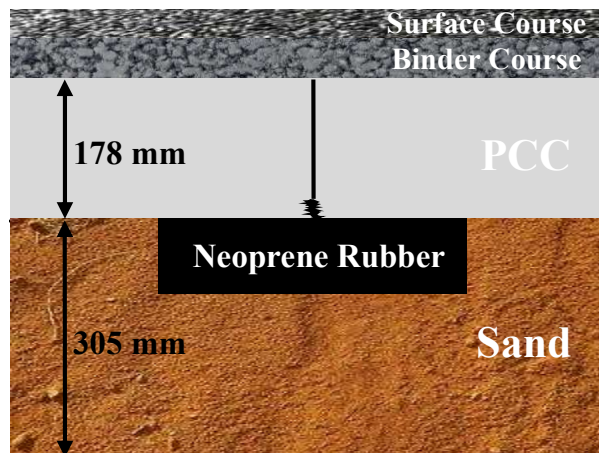
As presented in Figure 2, each test slab had four layers: a 305-mm fine sand subgrade, a 178-mm PCC slab, an AC binder course, and an AC wearing surface. Each test slab had a similar PCC slab and the same subgrade to ensure a fair comparison between AC overlay configurations.

Figure 2. Schematic of test pavements.

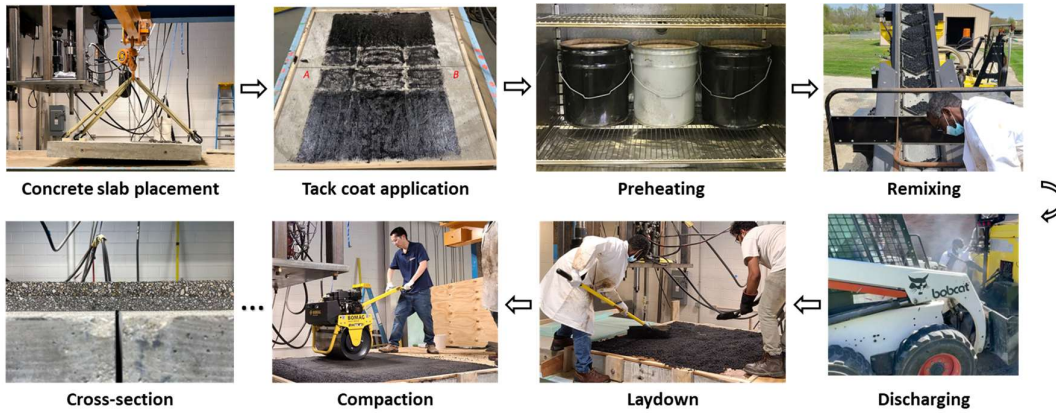
As presented in Figure 3, constructing a test pavement involves the following steps:

Figure 3. Test pavement construction.

- **PCC slab placement.** The PCC slabs were stored outside after casting. In preparation for testing, each slab was saw cut to around 152.4-mm depth, with a remaining unsawed portion of approximately 25.6-mm. The unsawed portion was left to provide sufficient strength for the concrete to withstand lifting during placement while maintaining the ability to easily crack after a few loading cycles. The joint was 8-mm-wide. The PCC slab was then brought indoors, and a crane was used to place the slab onto the test bed. The slab was finally situated on the subgrade. Note that the PCC slab center, 0.9 m wide, was in direct contact with the neoprene rubber sheet, while the rest was in direct contact with the sand subgrade.

- **Saw cutting.** A 300-mm of the AC overlay edge was cut and removed to create a smooth and clean cross-section to observe and measure reflective crack propagation.

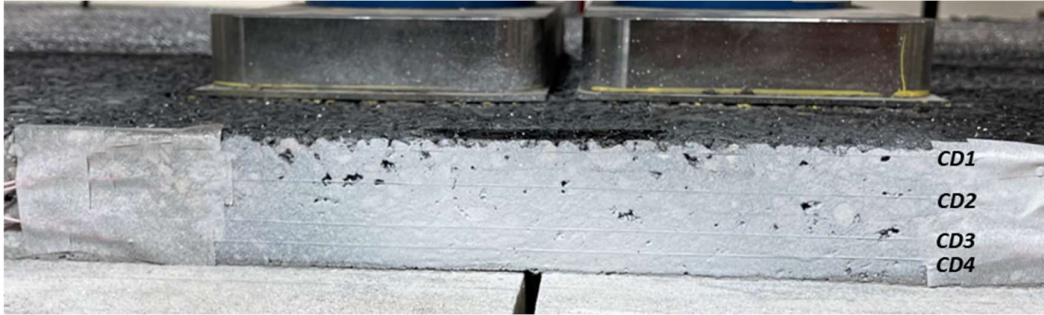
The crack detector (CD) is a single strand of copper wire. Any erratic change in the recorded voltage indicates a discontinuity, meaning a crack propagates through (Yin, 2015). The CD has been effectively employed in both small-scale and full-scale tests to quantify crack growth (Wagnoner et al., 2005; Yin, 2015). Multiple copper wires were glued on the clean and smooth surface of the potential crack zone, as presented in Figure 4. A thin layer of coating was applied afterward for protection. The copper wires were connected to a laboratory power supply. A data acquisition system was used to record output signals throughout a test.

Figure 4. Crack detectors glued on overlay edge.

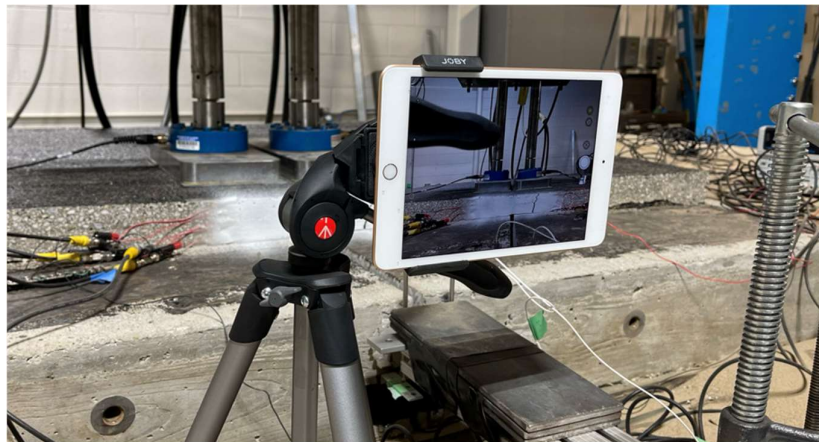
Crack detectors only provide localized information and may not describe the complex cracking phenomenon. Additionally, the occurrence of hairline cracks or wire fatigue may give false indications. To overcome this limitation, an iPad was used to take pictures of potential crack zones every 100 loading cycles (i.e., 70 sec) during the testing, as presented in Figure 5.

Figure 5. An iPad taking pictures during a test.

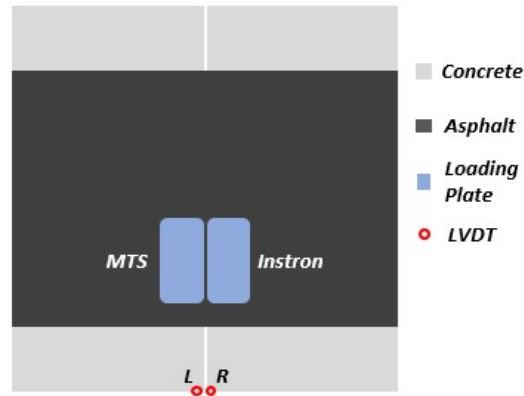
Two linear variable differential transformers (LVDTs) were used to measure the vertical movement of the PCC slab, as presented in Figure 6. LVDTs were placed at locations L

and R to measure vertical deflections of the PCC slab on both sides of the joint.

Figure 6. LVDT locations on the PCC slab.

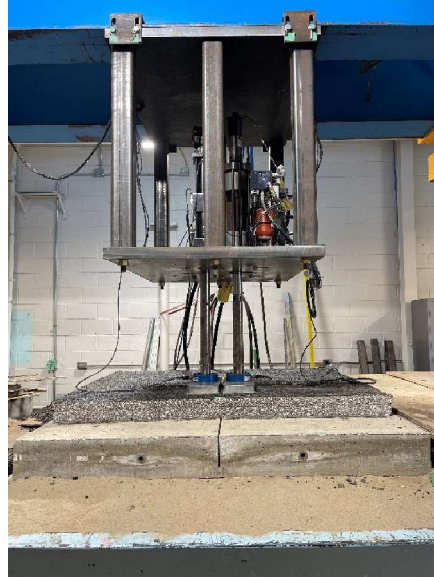
The loading system simulates a unidirectional dual-tire load. As presented in Figure 7, two rectangular loading plates measuring 381×178 mm were connected to two actuators (left and right) through rods and positioned on the AC overlay surface. Each loading plate represents a dual-tire assembly at 44.4 kN loading with a tire pressure of 650 kPa (Hernandez et al., 2017). The loading plate was positioned with a 152.4 mm spacing from the edge of the overlay. This distance was selected based on the experience reported by Perez et al. (2007) to facilitate the observation of crack propagation and prevent excessive creep of the material. The PCC joint was underneath the center of the gap between two loading plates, spaced at 25 mm. Each loading plate was associated with a load cell, which enabled the actuator to move the rod precisely to reach a desirable load. A pivot system was required to ensure a vertical load was applied on the AC. Both actuators were connected to the same hydraulic pump and received commands from the same controller system.

Figure 7. Hydraulic loading system.

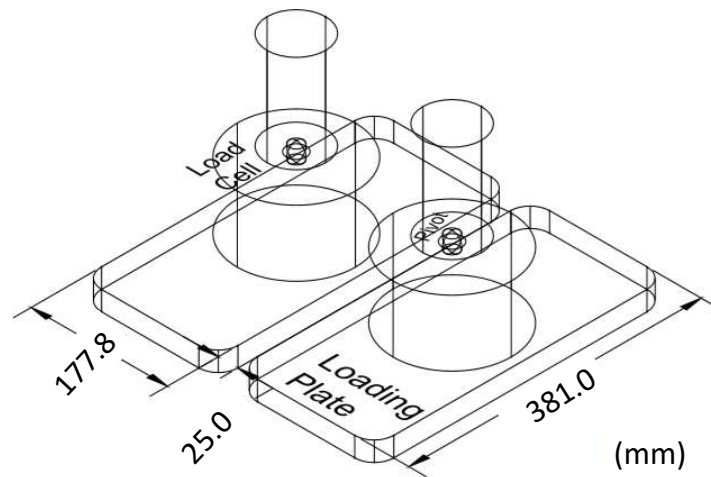
Figure 8. Loading plate configuration.

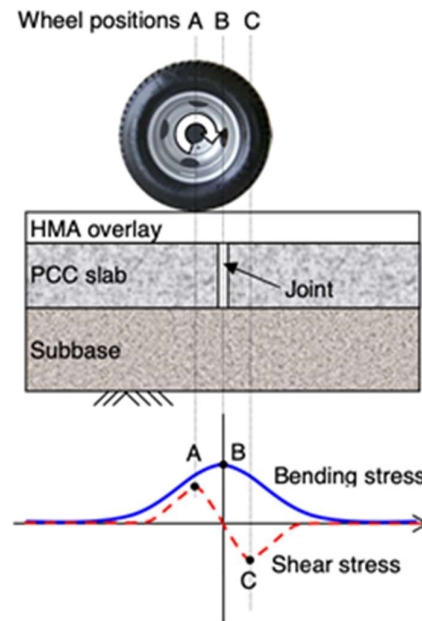
Traffic-induced reflective cracking exhibits a mixed-mode behavior. As shown in Figure 9, when the tire approaches and leaves the PCC joint, there is in-plane shear (mode II). However, when the tire is on top of the crack, there is an opening (mode I), which is more dominant. Therefore, it is crucial to have a test setup that can replicate

Figure 9. Reflective cracking mechanism caused by traffic loading.

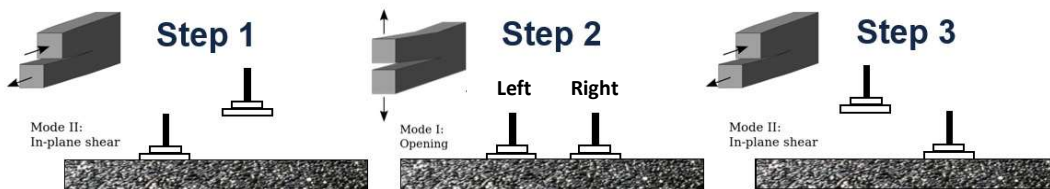
the actual tire pass. To achieve this, it is imperative to design a load pattern that considers both modes of fracture. As presented in Figure 10, a load cycle consists of three steps. In step 1 (tire approaching), only the left actuator applies loads; in step 2 (tire on top of the crack), both left and right actuators apply loads; and in step 3 (tire leaving), only the right actuator applies loads. Steps 1 and 3 mostly induce mode II (in-plane shear) fracture, while step 2 mainly leads to mode I (opening) fracture. A complete load cycle takes 0.42-sec, followed by a 0.28-sec rest until the next cycle starts. Figure 11 presents an example of two continuous load cycles.

Figure 10. Steps of a load cycle.

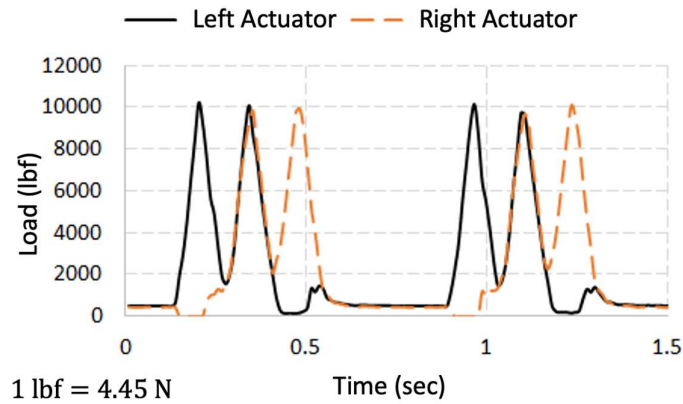
Figure 11. Load pattern.

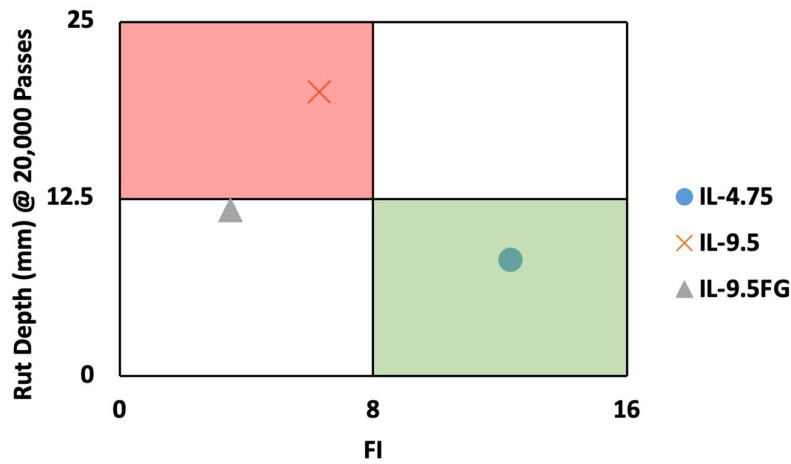
Figure 12 shows the balance mix design (BMD) interaction plot between rut depth and FI. IL-4.75 demonstrated good cracking and rutting resistance by falling

exclusively within the most desirable quadrant, visually distinguished by its green shading. Conversely, IL-9.5 exhibited high cracking and rutting potential.

Figure 12. 2-D interaction plot between rut depth and FI.

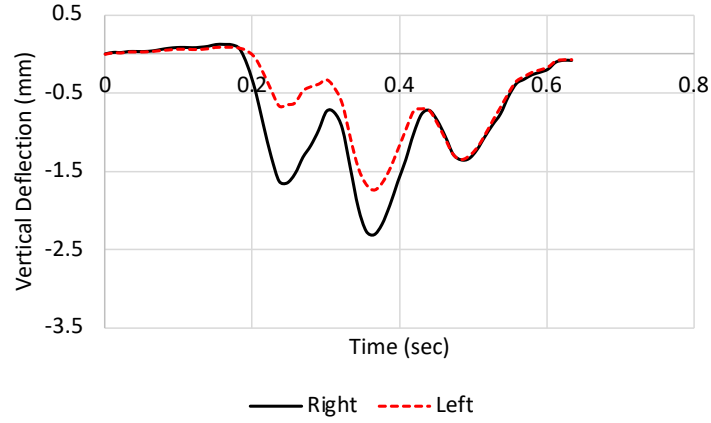
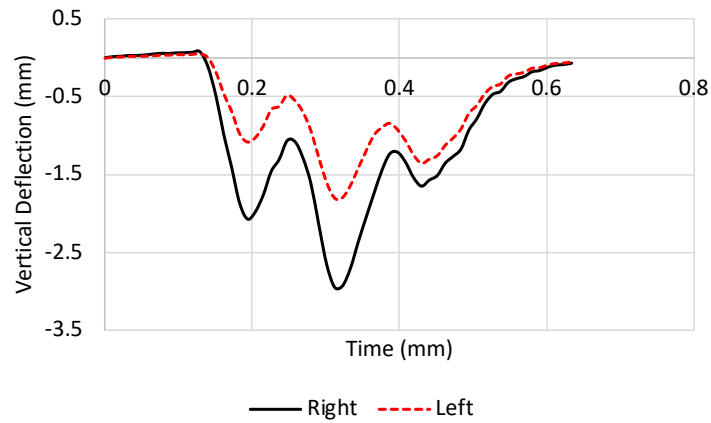
The LVDTs were placed on both sides of the joint to measure the movement of the PCC slab. Figure 13 compares the PCC vertical deflections of sections A and B of a loading cycle at the start of the test. Under equivalent loading conditions, it was observed that section B's PCC displayed a slight increase in deflection compared to section A, with similar load transfer efficiencies noted – 43.3% for section A and 52.0% for section B. The similar PCC deflections between sections A and B indicate that the underlying conditions of the overlays were similar. Hence, differences in reflective cracking behavior could be attributed primarily to AC overlay configurations. This finding confirmed the repeatability of the test protocol, as variables such as testing temperature, subgrade condition, and AC density, which are typically difficult to control in full-scale testing, were well-controlled in the proposed protocol.

The left half of the PCC slab had less deflection under loading step 2, which was most likely due to non-flat PCC bottoms resulting from wood frame distortion during PCC casting.

(a) Test section A

(b) Test section B

Figure 13. Vertical deflections of the PCC slab.

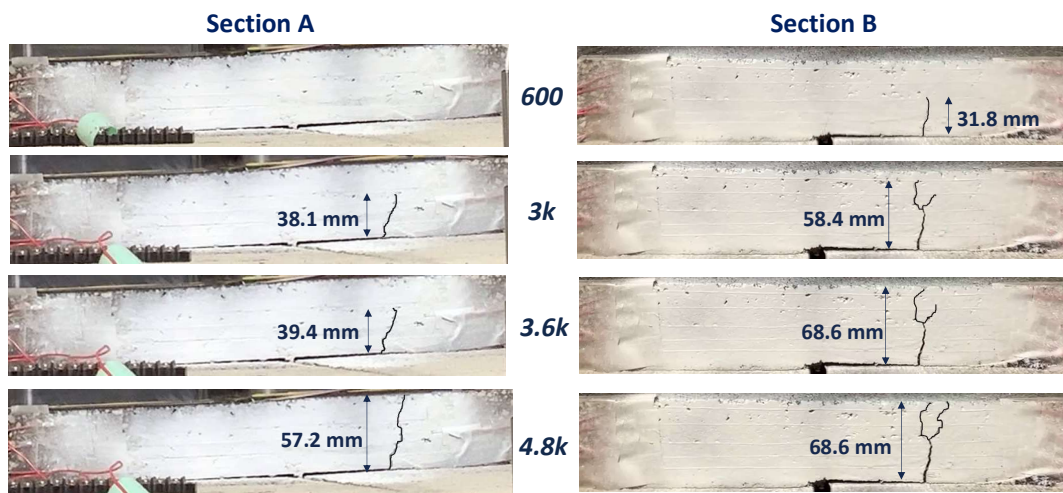
Figure 14 presents images of the overlay cross-section at various loading cycles. Reflective crack growth was documented. A reflective crack initiated at the bottom of the overlay for both sections and propagated upwards. The crack initiated on the right of the joint, near the end of the debonding area. The crack path did not follow a pure vertical trajectory, indicating a mixed-mode fracture. Although the binder course of section B was 12.7 mm thicker than section A, its relatively low binder content and low FI underscored the performance. Despite a relatively thicker structure, section B failed faster than section A.

* For better visualization purpose, cracks were marked with black lines.

Figure 14. Reflective crack growth.

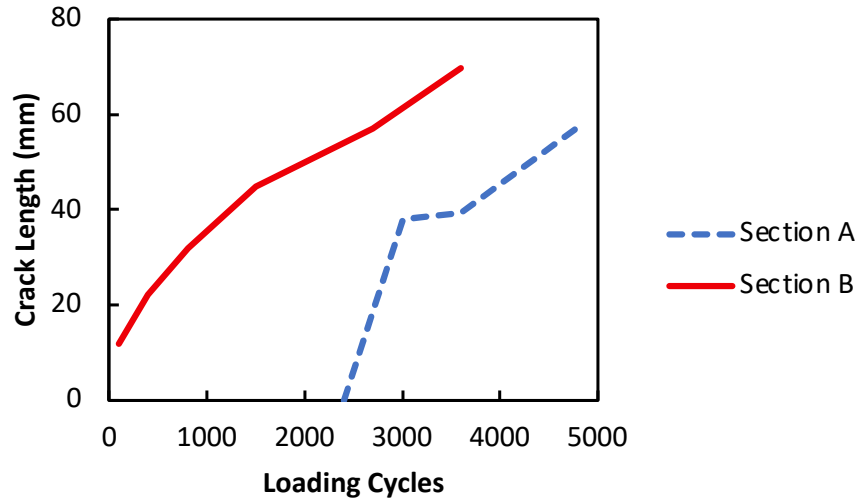
Figure 15 shows the reflective crack length versus the number of loading cycles. The average crack growth rate for sections A and B was 11.9 mm and 18.8 mm per one thousand cycles, respectively. The difference primarily is due to crack initiation. As a stress-absorbing layer, the high-FI IL-4.75 sand mix significantly delayed the reflective crack initiation and efficiently enhanced section A to control reflective cracking. These results agreed with those reported in the literature (Baek et al., 2011; Greene et al., 2016). Because sections A and B shared the same surface course, the crack growth rate was similar within the surface layer.

Figure 15. Reflective crack length versus loading cycles.
