Effects of H^- low beam irradiation and high field pulsing tests in different metals

This work studies the suitability of a set of different materials for manufacturing more efficient and durable radio-frequency quadrupole (RFQ) structures compared to that currently used in many linear particle accelerators, traditionally made out of copper. RFQs are susceptible to vacuum breakdowns caused by the exposure to high electric fields, resulting in surface degradation. Additionally, a further limitation of present-day copper RFQs is surface blistering under hydrogen ion beam exposure, due to beam halo losses. Irradiation is associated with a further reduction of the breakdown field strength of the metal surface thereby affecting the overall efficiency of the RFQ. The investigated materials, Cu-OFE, CuCr1Zr, CuBe2, Ti6Al4V, SS316LN, Nb, and Ta, were submitted to low-energy (45 keV) H^- irradiation and tested in a direct-current (dc) system with pulsed high voltage. For comparison, the maximum surface electric field was measured for both irradiated and pristine (nonirradiated) surfaces of the same material. The effects of irradiation on the surface of the materials, before and after being

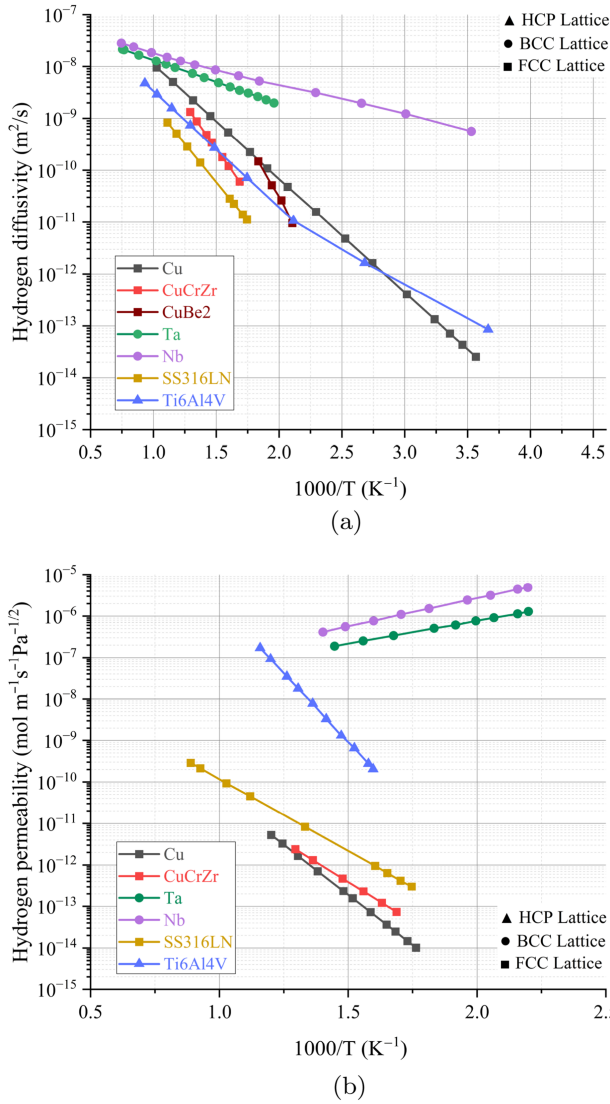
FIG. 1. (a) Compilation of hydrogen diffusion for different materials in function of reciprocal temperature, taken from different sources. Cu—[34], CuCr1Zr—[29], [25], CuBe2—[35], SS316LN—[29], Ti6Al4V—[36,37], Ta—[30], and Nb—[38], [30]. (b) Compilation of hydrogen permeability for different materials in function of reciprocal temperature, taken from different sources. Cu—[25], SS316LN—[29], CuCr1Zr—[29], [39], Ta—[40], Nb—[41], and Ti6Al4V—[42].

As hydrogen from beam bombardment accumulates inside the metal lattice, if its amount exceeds the solubility limit, the internal pressure within the material can exceed the tensile strength of the metal, resulting in the formation of blisters in the material surface. Data extrapolated from different sources have been compiled together, as shown in Fig. 1, with (a) and (b) representing the hydrogen diffusion and permeability in a material's bulk in function of

reciprocal temperature, respectively. Both coefficients for each material follow an Arrhenius-type equation. According to the literature, results for the same material can have substantial variability in terms of order of magnitude, as both diffusivity and permeability coefficients will vary from the purity of the material, contamination, and the measurement technique used in the experiments. Hydrogen diffusion is moderated by many factors, such as the size and accessibility of interstitial sites in the material, which differs from lattice to lattice, binding energy of H in the lattice, temperature, and impurities.

The copper alloys follow a similar behavior as Cu, which is expected as Cu is the main element of their composition. The hydrogen permeability of CuBe2 was not found in the literature, however, as just mentioned, this alloy should follow very closely the Cu permeability. Ti6Al4V also follows a similar behavior as pure Ti alpha based, more results can be found in [30–33].

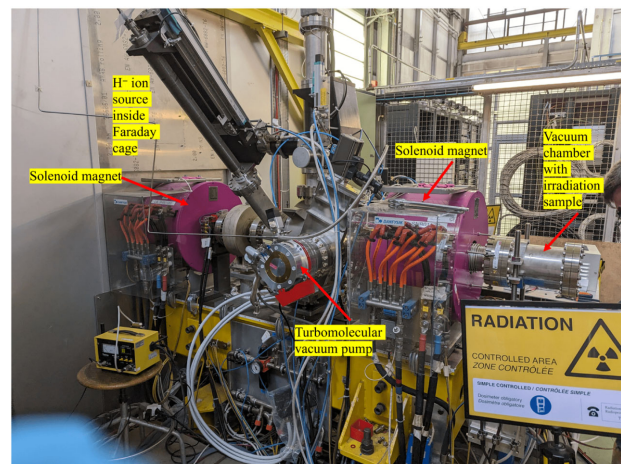
FIG. 2. Photograph of the irradiation setup at CERN, Geneva. The ion beam travels from the left to the right, having a chamber at the end dedicated for the mounting of one electrode.

Figure 2 shows the ion source irradiation facility used to irradiate all the samples. The electrodes are mounted using a dedicated chamber installed at the end of the structure. Specific details about the irradiation apparatus can be found in [3]. In the current RFQ at CERN, It has been reported that the maximum deposition of particles in the structure during operation is approximately 2×10^{11} p/s/mm² [3]. Taking into consideration this value and the beam loss profile along the RFQ, parameters for the irradiation of the samples under study were chosen. Low-energy H⁻ beam at 45 keV, corresponding to the energy of the beam entering the RFQ from the ion source, was used to irradiate one cathode of each material, each one with a duration of approximately 50 h. The pulse duration, repetition rate, and peak current were 600 μ m, 0.83 Hz, and 20 mA, respectively. This irradiation resulted in a deposition of 1.2×10^{19} H⁻ ions in each target over the entire irradiation, which represents approximately 10 days of beam losses during RFQ operation.

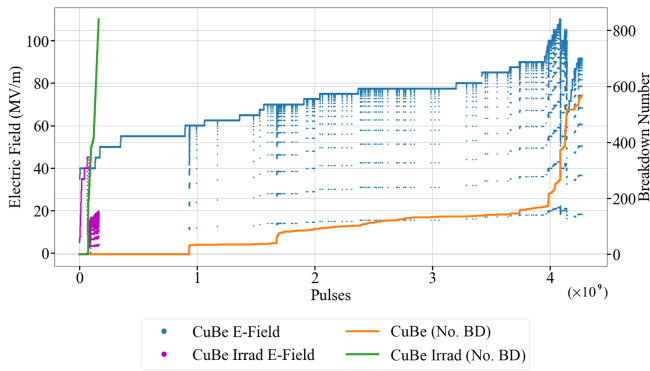
FIG. 3. Conditioning of the irradiated and nonirradiated pairs of CuBe2 electrodes.

Figure 3 shows the conditioning for CuBe2 electrodes irradiated and nonirradiated.

For the nonirradiated electrodes, a maximum field of 110 MV/m was reached. However, at high fields, breakdowns started to cluster at a specific location, where it appeared to be impossible for the field to remain stable. Taking into consideration that the stable field was directly affected by this cluster of breakdowns, a retest on new CuBe2 nonirradiated electrodes will be done in the future to assess whether the maximum and stable field can achieve higher results. In contrast with the results above, the irradiated pair has only reached a maximum field of 40 MV/m after approximately 100 million pulses as seen by the magenta curve in Fig. 3. The high number of breakdowns (green curve) at that field resulted in a sudden drop in voltage, leading to an unrecoverable condition. The irradiated electrodes did not recover back to the earlier maximum voltage, instead, the stable field ended up at approximately 17 MV/m.

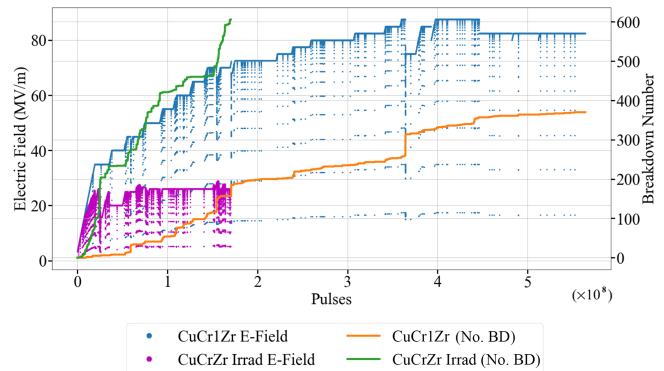
FIG. 4. Conditioning of the irradiated and nonirradiated pairs of CuCr1Zr electrodes.

Nonirradiated CuCr1Zr has reached a maximum field of 87.5 MV/m, as shown in Fig. 4. After reaching the maximum value, the electrodes experienced a sudden decrease in the field to 75 MV/m, and consequently, a big increase in the breakdown rate. After this, a retry of stepping up the voltage was done. The electrodes were able to reach the maximum field again and hold it for a longer period but ended up stabilizing at 82.5 MV/m. For the irradiated CuCr1Zr, this pair of electrodes has reached a maximum stable field of 26 MV/m. There was not any breakdown cluster registered during conditioning or observed in the surface analysis; however, the majority of the breakdowns were concentrated in the irradiated area.

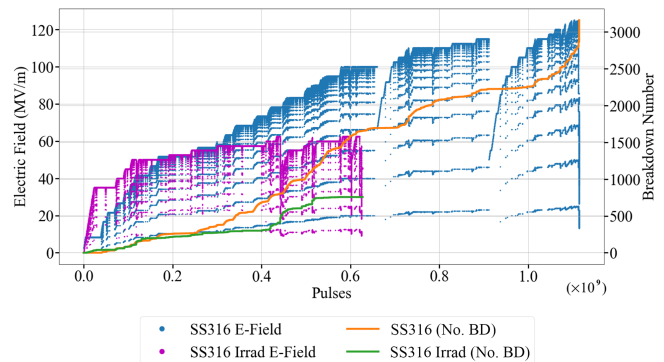
FIG. 5. Conditioning of the irradiated and nonirradiated pairs of SS316LN electrodes.

Figure 5 shows the conditioning for the irradiated and nonirradiated SS316LN electrodes. Stainless Steel non-irradiated electrodes have shown very good results in terms of conditioning, being the material that has reached the highest electric field, among all the tested materials.

During conditioning, the high voltage cable between the Marx generated and the connection to the chamber broke 2 times, due to the maximum voltage supported by the cable. In Fig. 5, this can be observed in the two reconditioning events at approximately 0.65 and 0.9 billion pulses in the blue dots. After replacing the cable with one that could hold the applied voltages, the electrodes were able to reach a maximum field of 120 MV/m. On the other hand, the irradiated electrodes only reached a stable field of 60 MV/m. When trying to increase the voltage applied, the electrodes reach the maximum field of 62.5 MV/m, but without being able to stabilize in that field and resulting in a

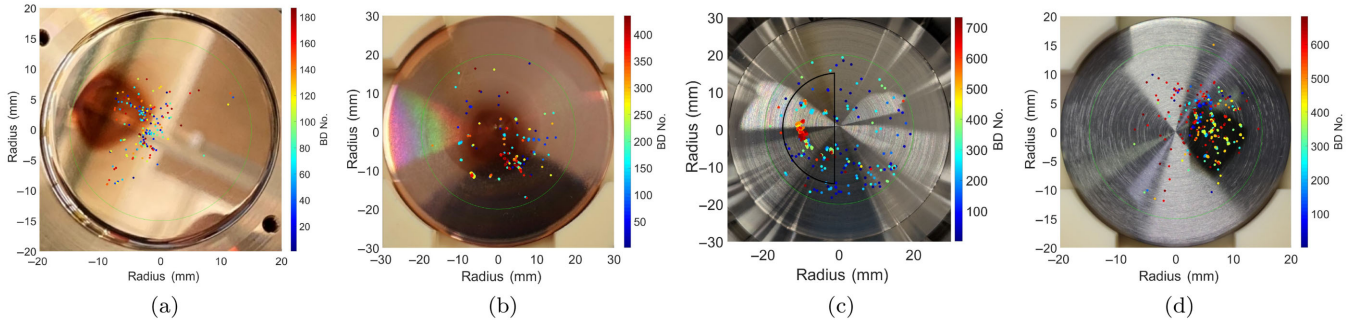
FIG. 6. Images taken before closing the chamber of the different irradiated cathodes overlaid with the breakdown locations after conditioning. Breakdowns are colored from dark blue to dark red as the first to last breakdown. (a) CuBe2, (b) CuCr1Zr, (c) SS316LN, (d) Ta. The green circles in all figures represent the coincident surface diameter of the anode electrode. The irradiated targeted regions can be seen as a darker color on the electrode surfaces. For the case of SS316LN, the irradiated region is not well distinguished and it has been marked with a black half-circle.

The deposition of particles from the irradiation is visible in Fig. 6(b) in the darkest circle region.

significant increase in the number of breakdowns. From Fig. 6(c), it can be seen that the large increase in breakdowns is locally coincident with the irradiated region. The irradiated region corresponds to the darkest half-circle seen on the left part of the electrode surface.

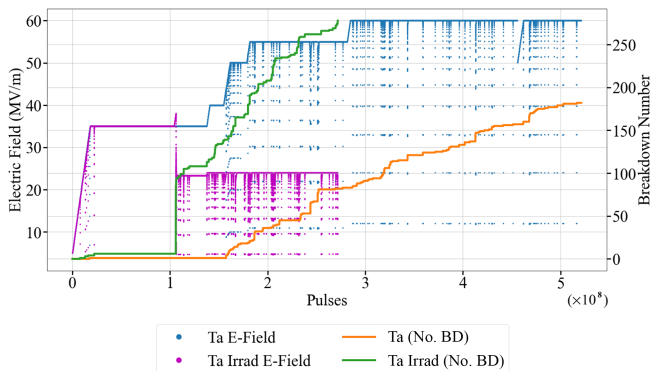
FIG. 7. Conditioning of the irradiated and nonirradiated pairs of Ta electrodes.

Figure 7 shows the conditioning of the irradiated and nonirradiated Ta electrodes. For the nonirradiated, the maximum and stable field reached was 60 MV/m. For the irradiated pair, the maximum field reached was 35 MV/m; however, after just 10^7 pulses, the field dropped to around 23 MV/m and was unable to recover from that value. After the conditioning, no cluster was observed on the surface of the electrodes; however, the effects of irradiation are very clear, showing the concentration of breakdowns mainly in the impact zone of the H^- beam. Figure 6(d) shows the locations of the breakdowns in the irradiated cathode, in which it can be observed that a larger quantity of breakdowns are concentrated in the irradiation zone.

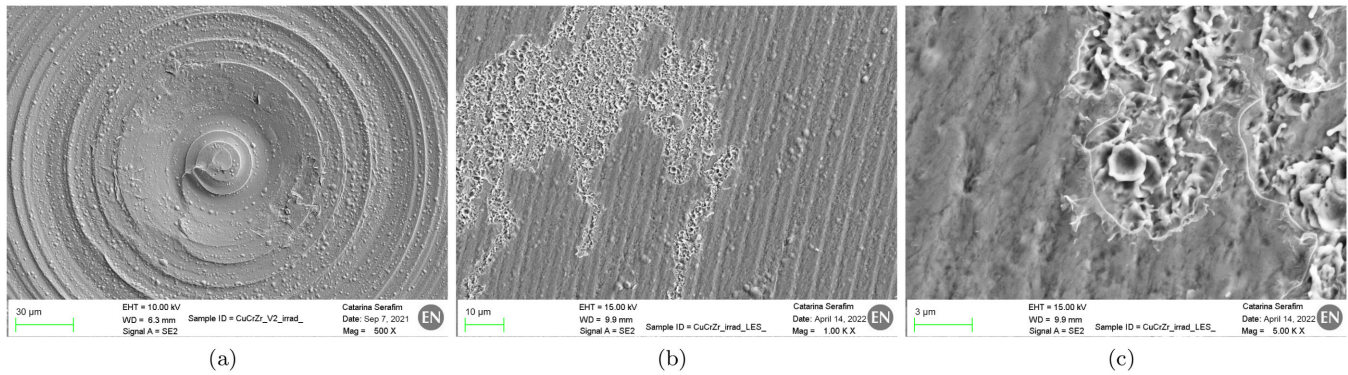
FIG. 8. SEM imaging, using secondary electron detector, of (a) center of CuCr1Zr electrode's surface after H⁻ beam irradiation and before LES testing. (b), (c) breakdowns in CuCr1Zr after H⁻ beam irradiation and LES testing.

For CuCr1Zr, it is observed that the blisters seem to follow the machining marks of the surface, as shown in Fig. 8(a). This effect is more visible in the center of the electrode surface, where the machining grooves are more

pronounced. Figures 8(b) and 8(c) shows the surface of the same electrode, after conditioning test. In Fig. 8(b), it can be seen a different contrast in surface coloring: the whiter region has a more rough surface where the multiple breakdowns are located. The more magnified Fig. 8(c)

shows the contours of a carbon layer surrounding the edges of the small breakdowns. More detailed findings regarding the carbon effects are discussed below.

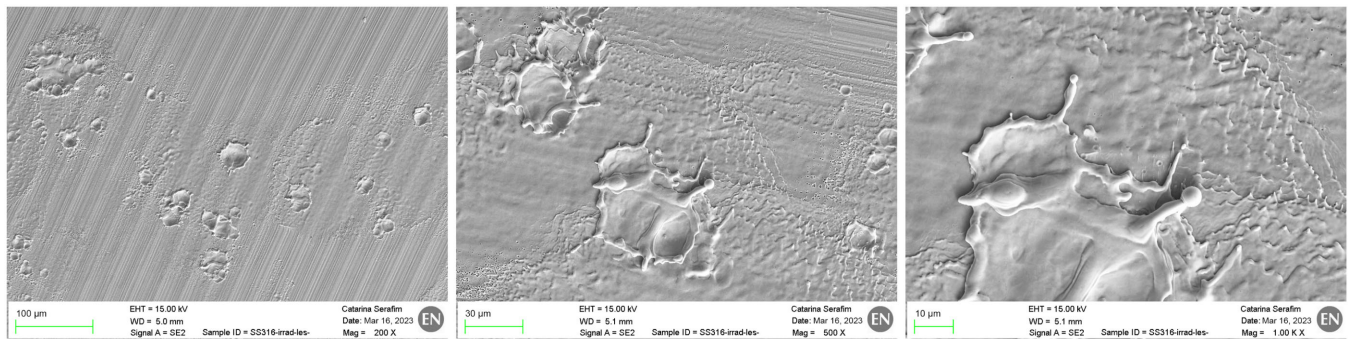
FIG. 9. Breakdown images, using secondary electron detector from SEM with different magnification, of SS316LN electrode after H⁻ beam irradiation and LES testing.

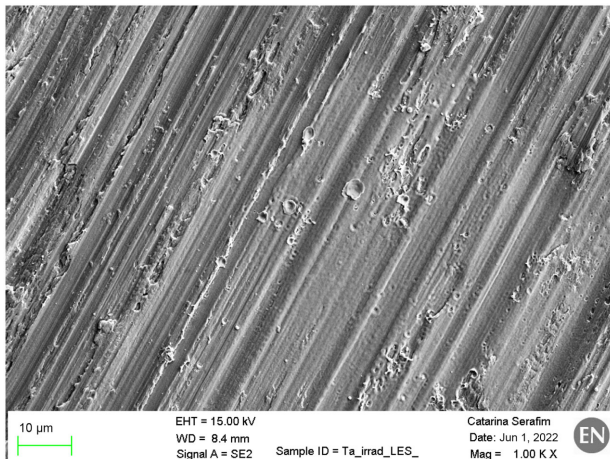
FIG. 10. Breakdown image, acquired using SEM secondary electron detector, on the tantalum electrode after H⁻ beam irradiation and LES testing

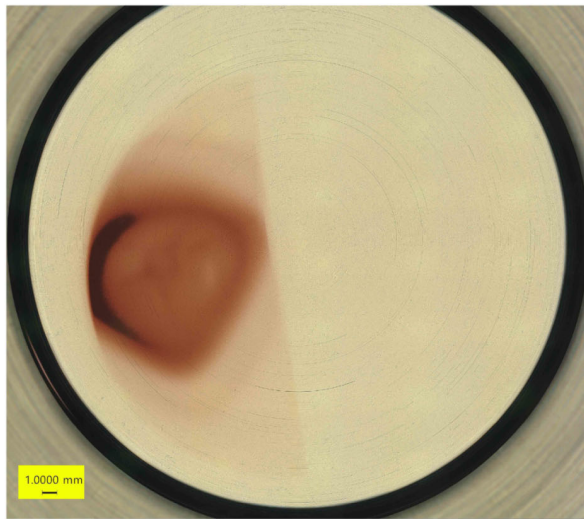
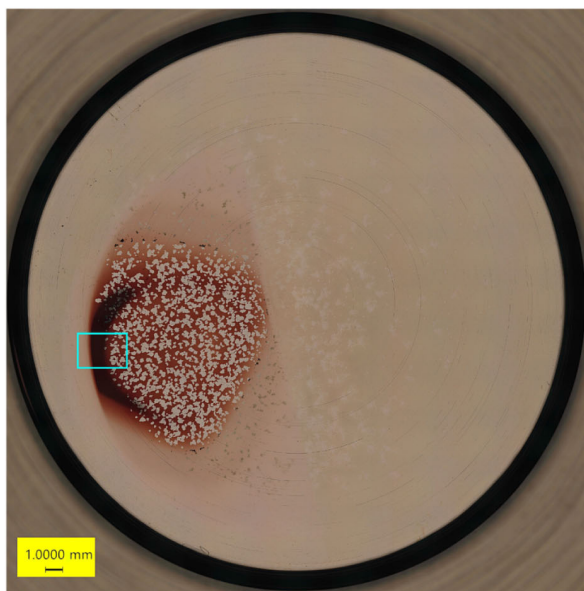
FIG. 11. Optical microscopy imaging of (a) CuBe₂ cathode after being exposed with irradiation and before conditioning test; (b) CuBe₂ cathode after being exposed with irradiation and after conditioning test. Blue square indicates the location of Fig. 12 on the surface of the electrode.

Figure 11(a) shows an optical image of the surface of the cathode electrode after it has been exposed to irradiation. The irradiated region is shown with a darker coloration, forming a half-circle shape, coincident with the gasket used during irradiation to limit the irradiated spot in the target. The darkest C-shape is where we had the highest deposition of particles, and it is where the highest density of blisters is found. After irradiation, LES tests were performed with this electrode. Figure 11(b) shows the state of the surface after the test, where the appearance of white spots covering the irradiation zone and its surroundings was observed.

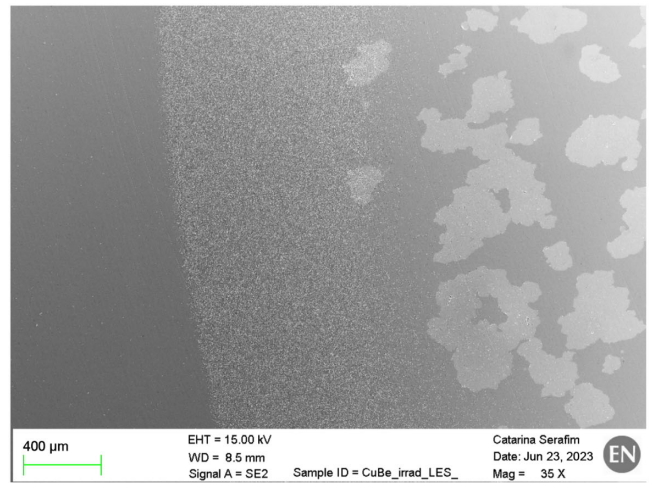
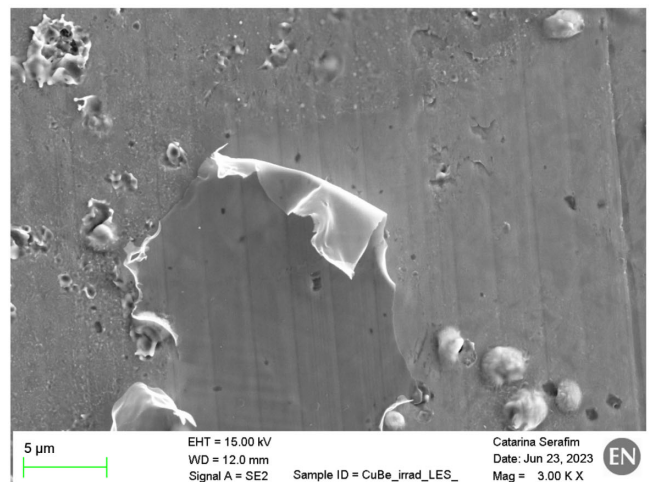
FIG. 12. (a) SEM imaging using secondary electron detector, with 35 \times of magnification, of CuBe₂ cathode after irradiation and LES test. (b) SEM imaging using secondary electron detector, with 3000 \times of magnification, of CuBe₂ cathode after irradiation and LES test, showing a layer of C partially removed from the surface.

Further analysis, using SEM and EDS, confirmed that the white regions represent the regions where carbon has been removed from the surface, designated as exfoliated regions. In SEM imaging, exfoliated regions appeared with a lighter contrast compared with the rest of the darker surface, as shown in Fig. 12(a).

The carbon layer is a fragile and thin layer, measured to have approximately 60 nm of thickness in the regions with higher ion deposition [61]. Figure 12(b) shows the carbon

layer peeling out from the surface (machining marks of the electrode surface are visible beneath the C layer). It becomes difficult to access the origin for the removal of the carbon. Analysis made postirradiation and pre-LES testing showed the carbon layer contamination without signs of degradation or cracking, which proves that the different regions where carbon has been removed appeared during the high voltage tests. At this stage, it is hypothesized that the initial stress from a vacuum arc or high-voltage exposure could have initiated a crack on the C layer, from which it triggered a peeling effect enhanced by the vacuum environment. Also, outgassing coming from the electrode could originate additional stress against the C layer, provoking cracking and peeling.

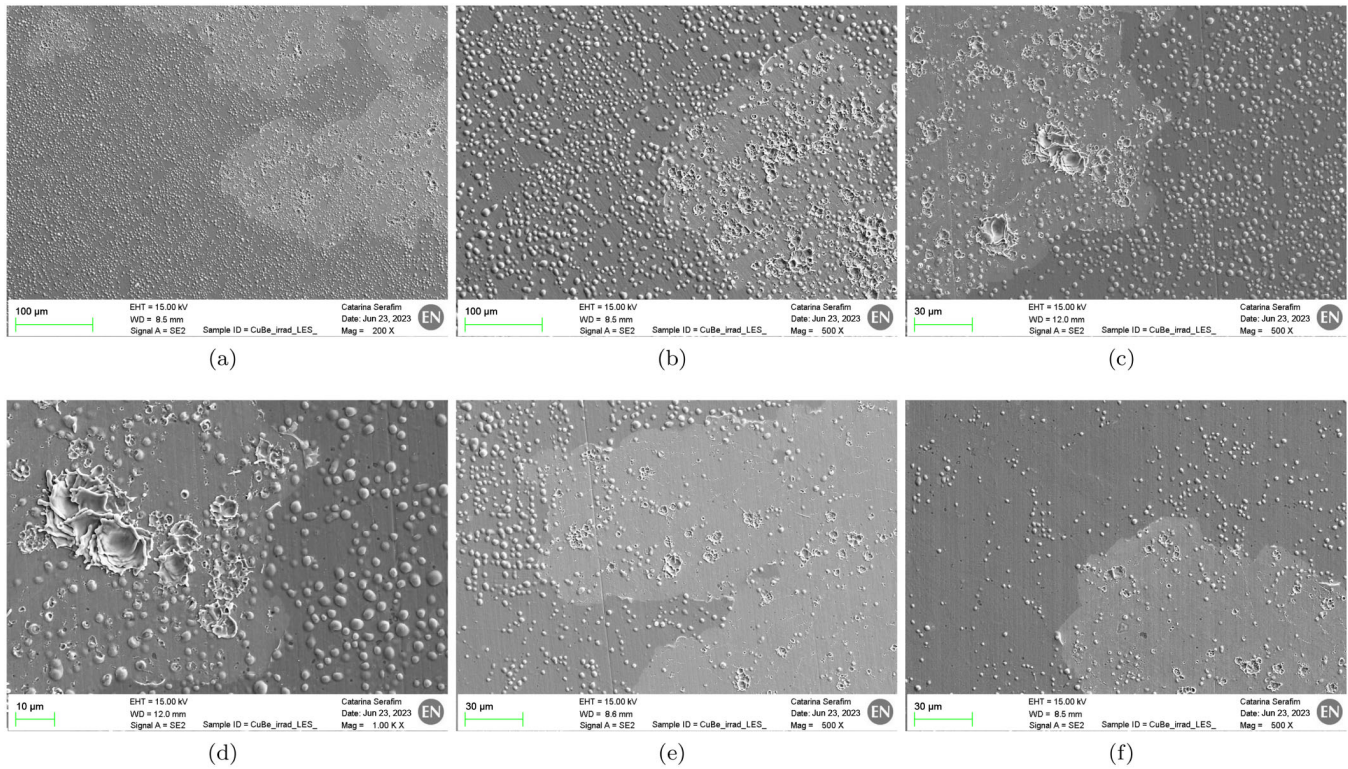
FIG. 13. (a)–(d) SEM imaging, using secondary electron detector, of CuBe₂ cathode after irradiation and LES test. The regions in focus were taken where there was the highest deposition of particles from irradiation. (e),(f) SEM imaging, using secondary electron detector, of CuBe₂ cathode after irradiation and LES test. The regions in focus were taken in the transition zone.

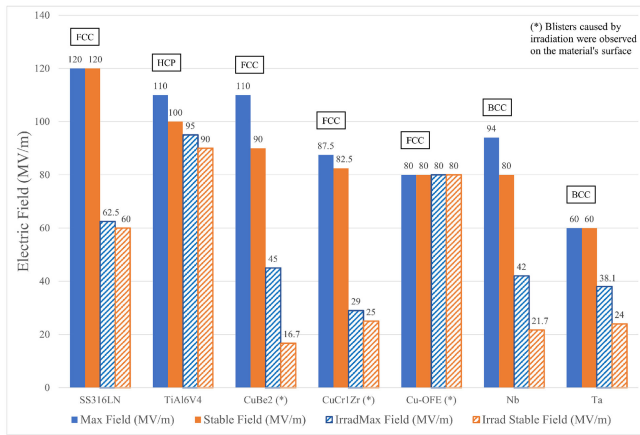
FIG. 14. Bar plot showing the results for all the tested materials in the LES system. The solid bars represent the results of nonirradiated electrodes. The lined bars represent the results for the irradiated electrodes. The blue and orange colors represent, respectively, the maximum and stable electric field achieved during testing.

Accounting for the results presented here and in [7], the final summary of all the materials in terms of surface electric field, when tested with LES system, was compiled together in Fig. 14, showing the results from all materials in order of best stable field achieved.
