Split-off dimer defects on the Si(001)2 × 1 surface

Dimer vacancy (DV) defect complexes in the Si(001)2 × 1 surface were investigated using high-resolution scanning tunneling microscopy and first principles calculations. We find that under low bias filled-state tunneling conditions, isolated ‘split-off’ dimers in these defect complexes are imaged as pairs of protrusions while the surrounding Si surface dimers appear as the usual “bean-shaped” protrusions. We attribute this to the formation of π -bonds between the two atoms of the split-off dimer and second layer atoms, and present charge density plots to support this assignment. We observe a local brightness enhancement due to strain for different DV complexes and provide the first experimental confirmation of an earlier prediction that the 1+2-DV induces less surface strain than other DV complexes. Finally, we present a previously unreported triangular shaped split-off dimer defect complex that exists at S_B-type step edges, and propose a structure for this defect involving a bound Si monomer.

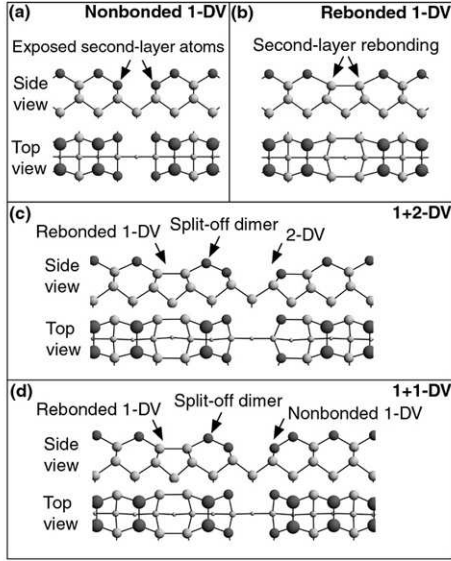
FIG. 1: Ball and stick models of dimer vacancy defects: (a) non-bonded 1-DV, (b) rebonded 1-DV, (c) 1+2-DV, and (d) 1+1-DV. Si atoms that have a dangling bond are shaded black. Height is indicated in the top views by the diameter of the balls, with the surface atoms having the largest diameter. The true minimum energy configurations for these structures involve buckling of the dimers in alternating directions along the dimer row. However, since the dimers switch between their two possible buckling orientations at room temperature, the atomic positions shown here represent the average positions of the atoms.

The simplest defect of the Si(001) surface is the single dimer vacancy defect (1-DV), shown schematically in Figs. 1(a) and 1(b). This defect consists of the absence of a single dimer from the surface and can either expose four second-layer atoms (Fig. 1(a)) or form a more stable structure where rebonding of the second-layer atoms occurs⁹ as shown in Fig. 1(b). While the rebonded 1-DV strains the bonds of its neighboring dimers it also results in a lowering of the number of surface dangling bonds and has been found to be more stable than the nonbonded structure.^{9,10} Single dimer vacancy defects can also cluster to form larger defects such as the double dimer vacancy defect (2-DV) and the triple dimer vacancy defect (3-DV). More complex clusters also form, the most commonly observed^{9,11} example is the 1+2-DV consisting of

a 1-DV and a 2-DV separated by a single surface dimer, the so-called “split-off dimer”. The accepted structure of the 1+2-DV, as proposed by Wang *et. al.* based on total energy calculations,⁹ is shown in Fig. 1(c) and consists of a rebonded 1-DV (left), a split-off dimer, and a 2-DV with a rebonding atom (right). Recently we have observed another DV complex that contains a split-off dimer, called the 1+1-DV, which consists of a rebonded 1-DV and a nonbonded 1-DV separated by a split-off dimer, as shown in Fig. 1(d).

To understand why split-off dimers appear as double-lobed protrusions we must consider the structure of these defects shown in Figs. 1(c) and 1(d). Normally Si(001) surface dimers appear as “bean-shaped” protrusions in STM images because the dangling bonds of each Si dimer atom mix to form a π -bond between the two dimer atoms. However, if we examine the split-off dimer structure closely (Figs. 1(c) and 1(d)) we see that unlike normal surface dimers, the split-off dimer has two nearest neighbor second layer atoms that each have a dangling bond. The separation distance between the split-off dimer atoms and these second layer atoms is sufficiently close to allow the formation of π -bonds. The resulting four-atom structure can therefore be referred to as a *tetramer*. We propose that the four dangling bonds of the split-off dimer tetramer interact primarily along the backbonds between the split-off dimer atoms and the second layer atoms to form π -bonds down the backbonds, as drawn schematically in Fig. 2(c). These two spatially separated π -bonds therefore lead to the double-lobed appearance of the split-off dimers under low bias filled-state tunneling conditions, which we confirm in section III with charge density calculations.

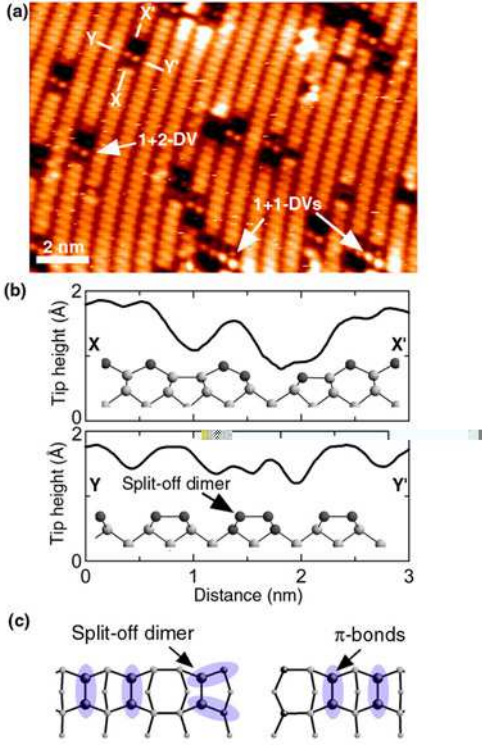
FIG. 2: A low bias filled-state STM image of a Si(001)2 \times 1 surface with split-off dimer defects is shown in (a). Tunneling conditions for this image were -1 V sample bias and 0.8 nA tunnel current. Line profiles are taken across a single 1+2-DV both parallel, X – X' (b), and perpendicular, Y – Y' (c), to the dimer row direction, as indicated in (a). The schematic (d) is a top view ball and stick model of a 1+2-DV with the approximate positions of π -bonds indicated by shaded ellipses.

Figure 2 shows an STM image of a Si(001) surface containing a $\sim 10\%$ coverage of split-off dimer defects. The majority of the defects in this image can be identified as 1+2-DVs, however, two 1+1-DVs are also present, as indicated. The most striking feature of this image is the difference in appearance of the split-off dimers in contrast to the surrounding normal surface dimers. Each split-off dimer in this image appears as a double-lobed protrusion, while the surrounding normal Si dimers each appear as a single “bean-shaped” protrusion, as expected at this tunneling bias.¹⁶ Line profiles taken across a 1+2-DV both parallel and perpendicular to the dimer row direction are shown in Fig. 2(b). The line profile parallel to the dimer row direction agrees with previously reported profiles over 1+2-DVs and fits well with the accepted structure,^{7,10} as shown by the overlayed ball and stick model. The line profile taken perpendicular to the dimer row direction, however, clearly shows that the split-off dimer of this defect is separated into two protrusions while the neighboring Si dimers are single protrusions. This is the first recognition and explanation of split-off dimers appearing as double-lobed protrusions.

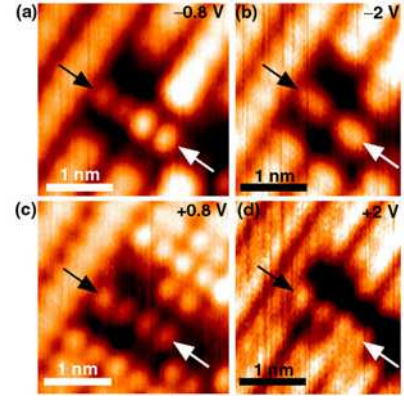
FIG. 3: Variable bias STM images of a 1+2-DV adjacent to a 1+1-DV. The split-off dimer of the 1+2-DV is indicated with a black arrow, while the split-off dimer of the 1+1-DV is indicated by a white arrow. All four images were acquired with 0.13 nA tunnel current and the sample bias for each image is (a) -0.8 V, (b) -2 V, (c) $+0.8$ V, (d) $+2$ V.

results, showing images where a 1+2-DV and a 1+1-DV located next to each other are observed at four different sample biases – two filled-state images and two empty-state images. In the filled-state image of Fig. 3(a) we see that at -0.8 V the split-off dimer of both the 1+2-DV and the 1+1-DV appear as double-lobed protrusions similar to those in Fig. 2(a). However, when the filled-state bias is increased in magnitude to -2 V, Fig. 3(b), the split-off dimers become single-protrusions and appear very similar to the surrounding normal Si surface dimers. This is because as the bias magnitude is increased towards -2 V, the dimer σ -bond and bulk states contribute increasingly to the tunneling current¹⁶ and the image of the split-off dimer reverts to the bean-shaped protrusion in the same manner as normal surface Si dimers. In both of the empty-state images, Figs. 3(c) and 3(d), acquired at $+0.8$ V and $+2$ V, respectively, the appearance of the split-off dimers is very similar to that of the surrounding normal surface dimers. This is because under empty-state tunneling conditions electrons tunnel into the π^* -antibonding orbitals of the dimers, resulting in the normal Si dimers appearing as double-lobed protrusions.¹⁷ It is therefore only under low bias magnitude

filled-state tunneling conditions that split-off dimers appear significantly different to the surrounding normal Si surface dimers.

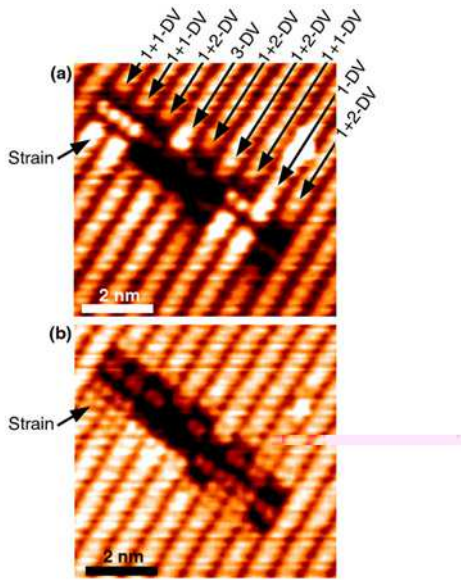
FIG. 4: Filled and empty-state STM images (-1.2 V, $+1.6$ V, 0.15 nA) of a short chain of DVs in a Si(001) surface. The individual defects are (from top left to bottom right): 1+1-DV, 1+1-DV, 1+2-DV, 3-DV, 1+2-DV, 1+2-DV, 1+1-DV, 1-DV, and 1+2-DV. Note the strain-induced brightening of the 1-DV and 1+1-DVs in the filled-state (a) and the corresponding darkening in the empty-state (b)

Another noticeable feature of Figs. 2(a) and 3(a) is the enhanced brightness of the 1+1-DV compared to the 1+2-DV. This is a reproducible effect that we attribute to an increased amount of surface strain induced by the 1+1-DV. Figure 4 shows a series of adjacent defects forming a short vacancy line channel in the surface. This channel is composed of individual 1-DV, 3-DV, 1+2-DV, and 1+1-DV defects (see figure caption). In the filled-state image, Fig. 4(a), there is a clear brightening of the dimers on one end of the 1+1-DVs and the dimers on both ends of the 1-DV, which is not present for the 1+2-DVs. In the empty-state image of the line of defect complexes, Fig. 4(b), we notice that there is a darkening of the same dimers that are enhanced in the filled-state image.

Owen *et al.*,¹⁰ have shown using low bias STM and first principles calculations, that the dimers neighboring a rebonded 1-DV are enhanced in low bias filled-state STM images due to the strain induced by the defect shifting the surface states upwards in energy toward the Fermi energy. This effect can be seen for the 1-DV in Fig. 4(a), where the neighboring dimers in the same row as the 1-DV are enhanced in intensity, with the magnitude of the enhancement decaying with distance from the 1-DV. A very similar enhancement can be seen around the 1+1-DV sites in this image, with the split-off dimer in particular appearing much brighter than the surrounding normal surface dimers. However, for the 1+1-DV only the dimers on one end of the defect are enhanced in in-

tensity while the dimers on the other end of the defect are not. This observation can be readily explained since the 1+1-DV is composed of a rebonded 1-DV adjacent to a nonbonded 1-DV (Fig. 1(d)) and Owen *et. al.*¹⁰ have shown that while the rebonded 1-DV results in strain-induced image enhancement, the nonbonded 1-DV does not. The observation of an asymmetric strain-induced enhancement of the 1+1-DV in Fig. 4(a) can therefore be taken as an experimental confirmation of the structure of this defect (Fig. 1(d)) and the first application of the method of Owen *et. al.*¹⁰ for identifying strain in more complex surface defect structures.

their tight binding calculations. In Fig. 4(b), we show an empty state image of the same line of defects shown in Fig. 4(a). Interestingly, in this empty state image the dimers that were enhanced in brightness surrounding the 1-DV and 1+1-DVs in the filled-state image are less bright than the surrounding Si dimers in the empty-state image. This suggests that the strain associated with these defects causes the lowest unoccupied molecular orbital (LUMO) of the adjacent dimers to also shift higher in energy, away from the Fermi energy.

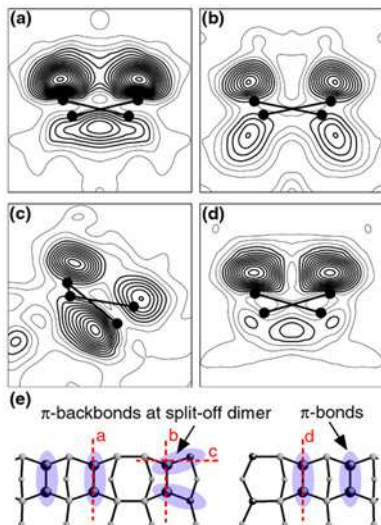
FIG. 5: Cross-section electron density plots for filled states within 0.25 eV of the highest occupied molecular orbital (HOMO) for several cuts through the 1+2-DV complex. The planes a,b,c and d through the top-view ball and stick model (e) indicate the direction and position of the cuts, and the shaded ellipses indicate the π -bonding as inferred from the electron density (see text). Each electron density plot is an average of both buckling configurations, and the atomic positions and bonds are shown as black balls and sticks. The slices are (a) rebonded 1-DV edge dimer, (b) split-off dimer, (c) split-off dimer backbonds, (d) 2-DV edge dimer.

In Fig. 5 we present a series of calculated electron density slices through various regions of the 1+2-DV marked by (a), (b), (c), and (d) in the ball and stick schematic. The charge density shown in the figure is the sum of the occupied Kohn-Sham orbitals within 0.25 eV of the highest occupied molecular orbital (HOMO). Taking into account the ~ 0.5 eV surface band gap of Si(001) and the n-type doping of the experimental samples, these states correspond approximately to the accessible states for a ~ 0.75 V sample bias and can therefore be directly compared to the experimental data in Fig. 3(a), which was acquired with a -0.8 V sample bias.

The four charge density slices in Fig. 5 show: Fig. 5(a) the 1-DV edge dimer, Fig. 5(b) the split-off dimer, Fig. 5(c) the backbond of the split-off dimer, and Fig. 5(d) the 2-DV edge dimer, as indicated schematically in Fig. 5(e). The charge densities of both buckling configurations of the dimers and backbond atoms are averaged, and the positions of the dimer and tetramer atoms are shown superimposed in both buckling configurations. In the case of the backbonds, the two configurations are not coincident, and so the atoms and bonds are shown in projection onto the plane in Fig. 5(c). The 1-DV edge dimer in Fig. 5(a) shows a clear three-lobed character with significant overlap between the up-atom

charge density of the two buckling orientations, and a single lobe beneath the plane of the surface at the midpoint of the dimer. Density functional calculations by Hata *et. al.*¹⁶ and tight-binding Green's function calculations by Pollman *et. al.*²² have separately identified this three-lobed feature as being characteristic of π -bonding in flip-flop dimers on the silicon surface, and we can therefore take this three-lobed feature as a signature of π -bonding in this work. The backbond of the split-off dimer in Fig. 5(c) connects a first-layer atom to a second-layer atom and also shows a three-lobed structure. By analogy with the surface dimer in Fig. 5(a) we characterize this bond as having π -character and have indicated this by the shaded ellipse (c) shown in Fig. 5(e). The split-off dimer itself in Fig. 5(b), however, does not exhibit three-lobed character. Instead, the split-off dimer has four lobes; two located above the up-atoms of the dimer in each buckling configuration, and a second pair of spatially separated lobes beneath the bond. The calculations thus show that π -bonding occurs down the backbonds of the split-off dimer, but not across the dimer itself. The absence of the π -bond across the split-off dimer correlates with the double-protrusions observed in the STM images. Finally, we also consider the charge density of the 2-DV edge dimer, Fig. 5(d), and note that it also exhibits three-lobed character, indicative of π -bonding. This gives the 2-DV edge dimer a bean-shaped appearance in the STM image, as for the 1-DV dimer in Fig. 5(a).

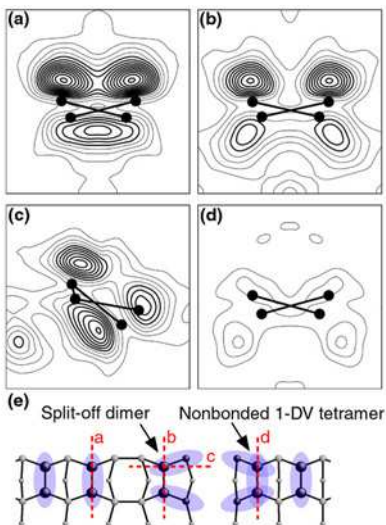
FIG. 6: Cross-section electron density plots for filled states within 0.25 eV of the HOMO for several cuts through the 1+1-DV complex. The planes a,b,c and d through the top-view ball and stick model (e) indicate the direction and position of the cuts, and the shaded ellipses indicate the π -bonding as inferred from the electron density (see text). Each electron density plot is an average of both buckling configurations, and the atomic positions and bonds are shown as black balls and sticks. The slices are (a) rebonded 1-DV edge dimer, (b) split-off dimer, (c) split-off dimer backbonds, (d) nonbonded 1-DV edge dimer.

A similar situation exists for the 1+1-DV charge density slices shown in Fig. 6. The first three charge density slices, Figs. 6(a) – 6(c), are analogous to the slices for the 1+2-DV As was the case for the 1+2-DV, the rebonded 1-DV edge dimer, Fig. 6(a) and the split-off dimer backbonds, Fig. 6(c) exhibit three-lobed π -like character, while the split-off dimer, Fig. 6(b) exhibits four-lobed character, consistent with an end-on view of π -bonding down the backbonds. Finally, another slice is presented in Fig. 6(d), which is through the nonbonded 1-DV edge dimer as indicated schematically in Fig. 6(e). It can be seen that the nonbonded 1-DV edge dimer appears quite different to the charge density slices discussed so far. In particular, we notice that the nonbonded 1-DV edge dimer has a much reduced charge density compared to the other slices, Fig. 6(a) – 6(c). Examination of the structure identifies strain as the characteristic that differentiates the dimer in Fig. 6(d) from the other dimers. Since the dimer in Fig. 6(d) is part of a tetramer, one might expect its appearance to resemble the split-off dimer which is also part of the tetramer shown Figs. 6(b) and 6(c). However, a detailed examination of the simulated structure reveals that the nonbonded 1-DV tetramer is relaxed, since there is one adjacent dimer present, while the split-off tetramer is highly strained because of the rebonding in the second-layer. Since the nonbonded 1-DV tetramer is much less strained, its occupied states lie further from the Fermi level, explaining the charge reduction observed in calculations in Fig. 6(d). As discussed in Ref. 25, the minimum

energy arrangement of the electrons in a tetramer is one where the π -states are delocalized across the four atoms, to form three bonding segments, as indicated by the ellipses in Fig. 6(e). The charge density slice of Fig. 6(d) is consistent with such an arrangement where the charge density is shared between π -like bonds on both backbonds and across the dimer atoms. We conclude that this charge density arrangement forms for the nonbonded 1-DV tetramer because it is allowed to relax. In the case of the split-off dimer, the tetramer is constrained by the rebonding and instead forms a higher energy configuration in which the π -bonds conjugate to form two π -bonds down its backbonds.

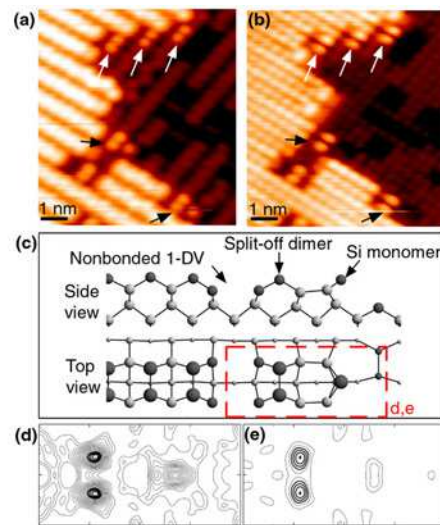
FIG. 7: (a), (b) Filled- and empty-state images (± 1.2 V) of DV defects at an S_B -type step edge. White arrows indicate S_B -DVs,²⁶ while black arrows point to a previously unreported defect that exhibits a third protrusion in the filled-state giving it a triangular appearance. We propose the structure (c) as a model for this defect. Calculated charge density slices at a constant z -height for the dashed region of (c) are shown in (d) and (e) (for Kohn-Sham orbitals summed over 0.45 eV below the HOMO and 0.45 eV above the LUMO, respectively). These contour slices are in good agreement with the STM images in (a) and (b), in particular predicting the correct spacing of 6.4 Å between the split-off dimer and third protrusion and also the disappearance of the third protrusion in the empty-state. The horizontal tic-marks in (d) and (e) indicate the dimer positions on the defect-free surface.

Having presented a detailed understanding of the electronic structure of previously observed split-off dimer defects in the Si(001) surface using both STM and first-principles calculations, we now turn our attention to elucidating the structure of a previously unreported split-off dimer defect. In Figs. 7(a) and 7(b) we show filled- and empty-state STM images of DV defects at a single-layer S_B -type step edge. At the top of these images white arrows indicate are three defects known as S_B -DVs, which are rebonded 1-DVs at the step edge, which leave a single split-off dimer as the last dimer before the lower ter-

race begins.²⁶ As was the case for the 1+1-DV and 1+2-DV, the split-off dimers in S_B -DVs appear as double-lobed protrusions under low-bias filled-state imaging conditions, Fig. 7(a). At the bottom of Fig. 7(a) two similar DV complexes can be observed, as indicated by black arrows, however these defects have a third protrusion giving them a triangular appearance. In empty-state imaging, Fig. 7(b), however, the additional third feature is not present. These triangular-shaped defects have not been reported on the Si(001) surface before and most likely arise due to the presence of W contamination.

Our proposed structural model of the triangular-shaped defects in Fig. 7(a) is shown in Fig. 7(c). This model consists of a nonbonded 1-DV defect at an S_B -type step edge, followed by a rebonded split-off dimer and a bound Si monomer. Swartzentruber has previously observed Si monomers on the Si(001) surface using high-resolution STM after depositing a few percent of a monolayer of Si atoms to the surface.²⁷ These monomers were bound at rebonded S_B -type step edges, confirming the minimum energy binding position predicted by first principles calculations. The binding position of the monomer in our proposed structure, Fig. 7(c), is essentially the same position observed by Swartzentruber, with the dif-

We have performed first-principles calculations to produce charge density contours for our proposed structure. Figure 7(d) shows a constant z -height contour slice taken 1.2 Å above the monomer for occupied Kohn-Sham orbitals within 0.45 eV of the HOMO. We see in this charge density contour slice the two lobes expected for the split-off dimer as well as a third lobe due to the bound monomer. Moreover, the distance between the split-off dimer lobes and the monomer lobe is 6.4 Å in agreement with the separation seen in the STM image. In Fig. 7(e) we show an empty-state slice taken at the same z -height and summed over Kohn-Sham orbitals up to 0.45 eV above the LUMO. In this contour the double lobe of the split-off dimer is still present but the monomer lobe is significantly lessened in intensity. The results of our first-principles calculations therefore give good agreement between our proposed structure and the observed
