# Characterization of Prototype BTeV Silicon Pixel Sensors Before and After Irradiation

**Abstract--** We report on measurements performed on silicon pixel sensor prototypes exposed to a 200 MeV proton beam at the Indiana University Cyclotron Facility. The sensors are of n<sup>+</sup>/n/p<sup>+</sup> type with multi-guard ring structures and p-stop electrode isolation on the n<sup>+</sup>-side. Electrical characterization of the devices was performed before and after irradiation up to a proton fluence of  $4 \times 10^{14}$  p/cm<sup>2</sup>. We tested pixel sensors fabricated from normal and oxygen-enriched silicon wafers and with two different p-stop isolation layouts: common p-stop and individual p-stop.

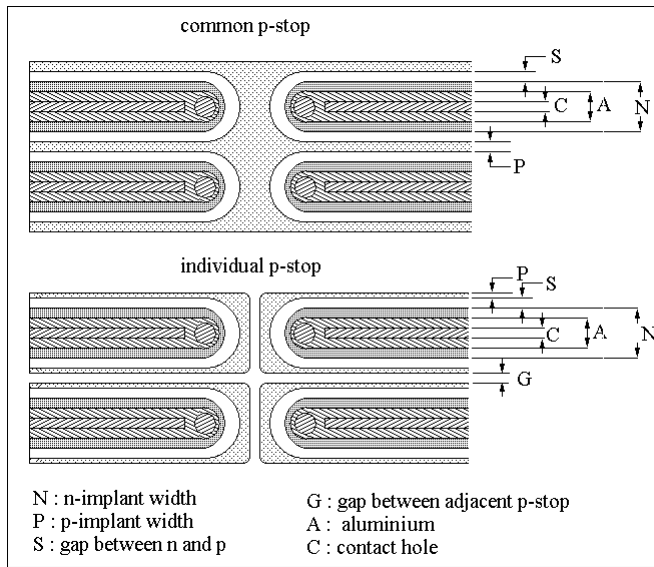
Fig. 1. Common p-stop and individual p-stop pixel sensor layouts.

The tested devices consist of silicon pixel sensors having two different layouts of p-stop electrode isolation: individual and common p-stops. For the individual p-stops there is a p-implant ring (atoll) around each pixel. For the common p-stop, there is a continuous p-implant along pixel columns and rows (see Fig. 1 for details).

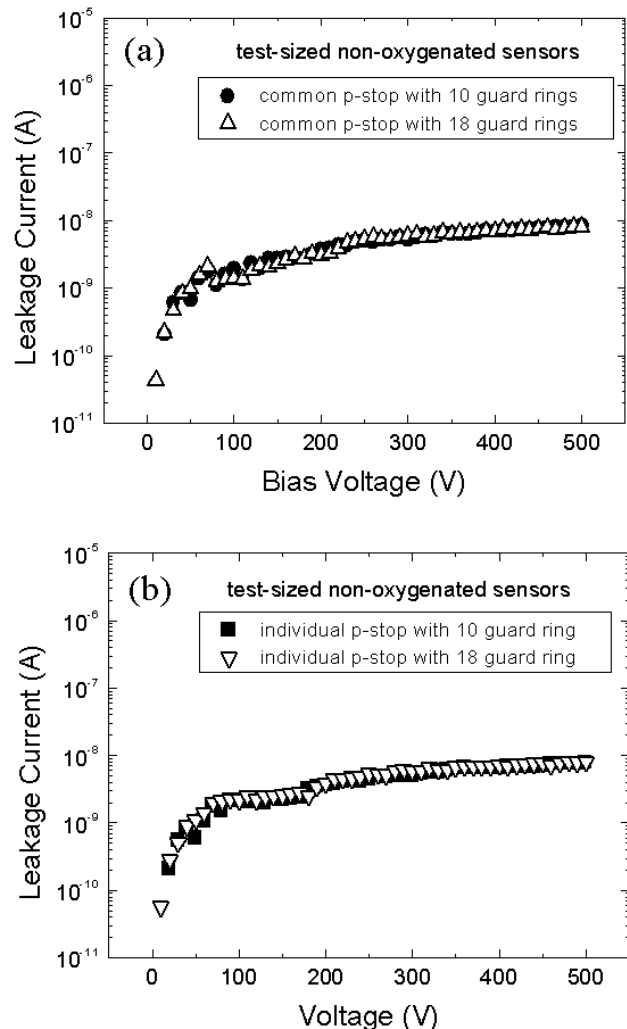
Fig. 2. I-V characteristics for un-irradiated test-sized pixel sensors from one non-oxygenated wafer: a) common p-stop pixel sensors, b) individual p-stop pixel sensors.

Fig. 2 shows the typical I-V curves for test-sized sensors from a non-oxygenated wafer before dicing. We made measurements on five different wafers (20 sensors in total) and, apart from a few sensors which show higher leakage current and relatively lower breakdown voltage, we found the same results for both types of pixel isolation layout. One would expect the individual p-stop layout to show lower breakdown voltage due to the presence of an electrical field gradient along the ‘‘atoll’’ that is not presents in the common p-stop layout. However, from our measurement of the leakage current and breakdown voltage, no significant differences were detected between the two isolation layouts. We also do not see any difference between the two guard ring structures.

Comparing Fig. 2 and Fig. 4, one can see that the breakdown voltage for the FPIX1-sized sensors is lower (typically just above 300V) than the test-sized sensors (700 V). This is likely due to the fact that the single cell in these sensors is characterized by different p implant widths. In fact, from Table I, we can see that for the FPIX1-sized individual p-stop sensors the separation between two adjacent p-stop rings is 3  $\mu\text{m}$  instead of 5  $\mu\text{m}$  for the individual p-stop test-sized sensors. For the FPIX1-sized common p-stop sensors the p-implant width is also 3  $\mu\text{m}$  instead of 9  $\mu\text{m}$  in the common p-stop test-sized sensors. The narrow line width does not conform to the design rules as specified by the vendor.

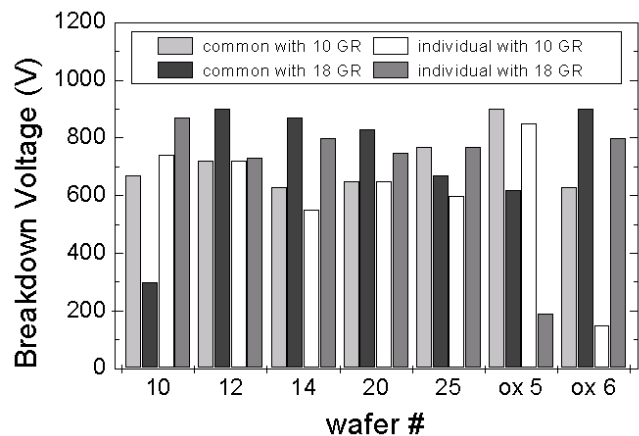
Fig. 3. Breakdown voltage for common and individual p-stop test-sized pixel sensors from oxygenated and normal SINTEF wafers. We present the result for the two different guard ring structures.

The breakdown voltage distribution for the test-sized sensors of these wafers has a median value around 700 V and this, together with the fact that the current is very small ( $\sim 10$  nA/cm<sup>2</sup> after depletion), shows the good performance of these sensors. Fig. 3 shows the breakdown voltage of different test-sized common and individual p-stop sensors from various

oxygenated (right two groups) and non-oxygenated wafers (left five groups). Only a few sensors have poor performance. The yield for this SINTEF wafer series is very high.

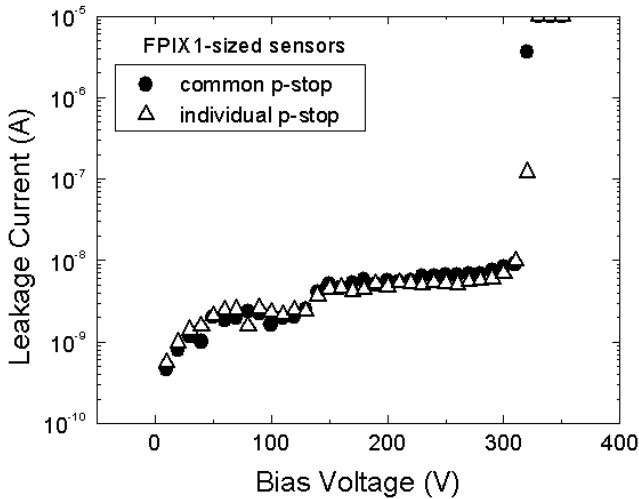
Fig. 4. I-V characteristics for FPIX1-sized sensors from a non-oxygenated wafer.

Fig. 4 shows the typical I-V curves for two FPIX1-sized sensors (one common p-stop and one individual p-stop) from one non-oxygenated wafer. We tested 15 FPIX1-sized common p-stop sensors and 20 FPIX1-sized individual p-stop sensors. Apart from a few sensors with slightly poorer performances (early onset of breakdown) most sensors tested show the same I-V characteristic.

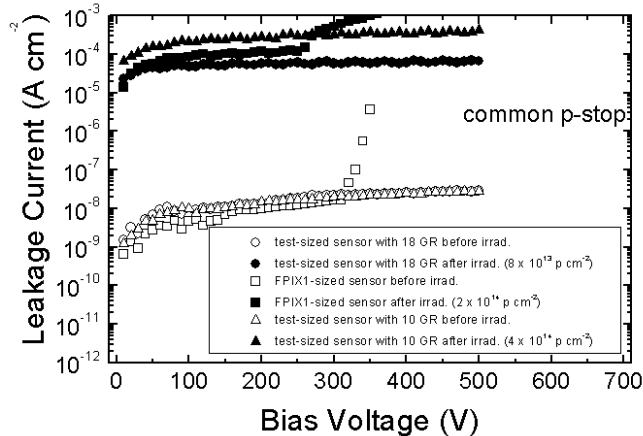
Fig. 5. Leakage current measurements before and after irradiation using non-oxygenated sensors. In this plot, the current is normalized to the sensors' active areas. These measurements were performed at 23 °C.

Fig.5 shows the leakage current measurements before and after irradiation for the common p-stop sensors. We found the same results also for the individual p-stop sensors that we irradiated. After irradiation the leakage current increases by several orders of magnitude, and, as expected, shows a nearly linear dependence on fluence. In fact, the increase of the leakage current  $\Delta I$  (i.e. the difference between the currents measured after and before irradiation) shows a linear dependence on the fluence:  $\Delta I = \alpha \Phi V$  where  $\alpha$  is the damage constant,  $\Phi$  is the fluence, and  $V$  is the volume. Fig. 6 shows the fluence dependence of the increase in leakage current normalized to volume. Each point corresponds to a common p-stop sensor and the current measured at room temperature (23 °C) was corrected to 20 °C. We obtained a value for the leakage current damage constant  $\alpha$  of  $(2.08 \pm 0.3) \times 10^{-17}$  A/cm. This is comparable to previous measurements [18]. However, it must be noted that these various measurements were taken under a wide variety of conditions.

As seen in Fig. 5, the current after irradiation increases by a few orders of magnitude. However, operating at lower temperature can alleviate this problem. The measurements shown in Fig. 5 were done at 23 °C. We repeated the same measurements at various temperatures (10 °C, 0 °C and -10 °C) and, as expected, we observed that the current decreases exponentially with temperature ( $I_{\text{leak}} \cong T^2 \exp(-E/2k_B T)$ ). Fig. 7 shows the comparison between data and the predicted dependence of the leakage current vs temperature. There is good agreement between the fit and the data. The current values are for two test-sized common p-stop sensors with 18

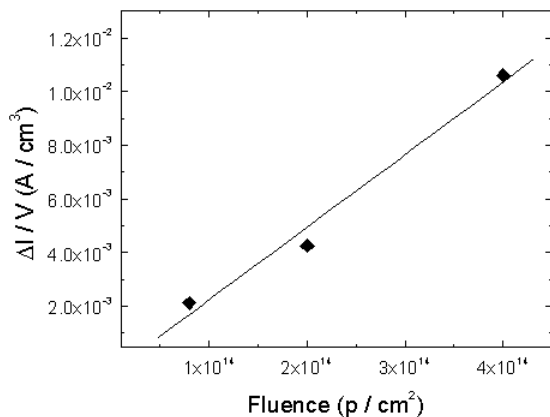
Fig. 6. Fluence dependence of the increase in leakage current. The current was measured at room temperature (23 °C).

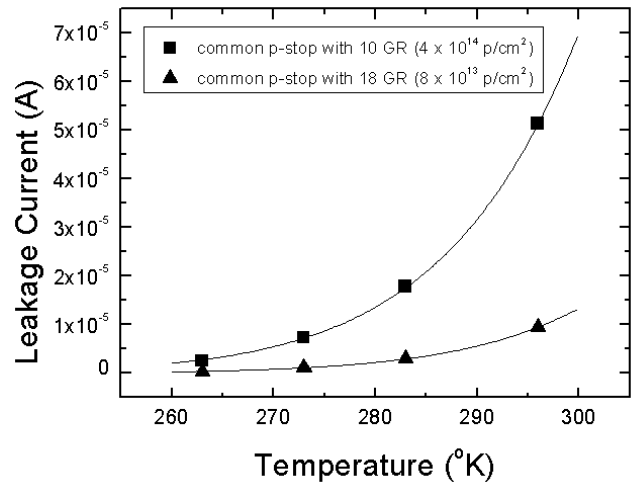
Fig. 7. Leakage current as a function of the temperature for two test-sized common p-stop sensors, one irradiated to 8 × 10<sup>13</sup> p/cm<sup>2</sup> and one to 4 × 10<sup>14</sup> p/cm<sup>2</sup>.

guard rings and are measured at the full depletion voltage (~80 V for the common p-stop with 18 guard rings and ~130 V for the common p-stop with 10 guard rings). We found that the values of the parameter  $E$  are 1.09 eV for the sensor irradiated to 4 × 10<sup>14</sup> p/cm<sup>2</sup> and 1.20 eV for the sensor irradiated to 8 × 10<sup>13</sup> p/cm<sup>2</sup>, compatible within the fit errors.

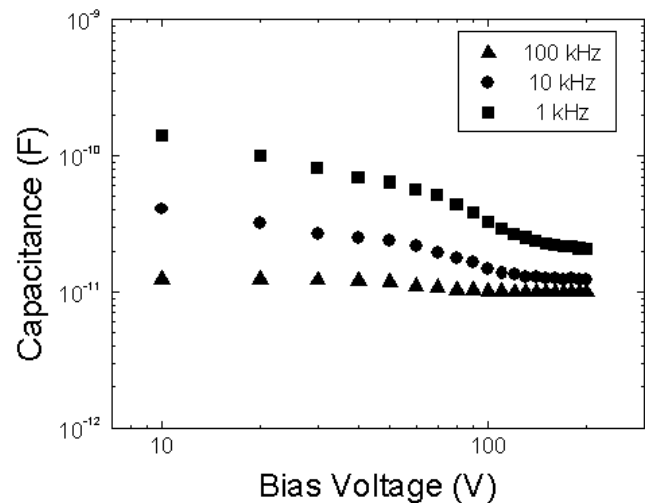
Fig. 8. C-V curves for an irradiated (4 × 10<sup>14</sup> p/cm<sup>2</sup>) test-sized individual p-stop sensor at various frequencies.

From Fig. 8 we can see not only the capacitance dependence on the frequency but that the depletion voltage increases as the frequency is decreased. The depletion voltage also decreases with decreasing temperature down to 0 °C or so, in agreement with results reported by another group [21].

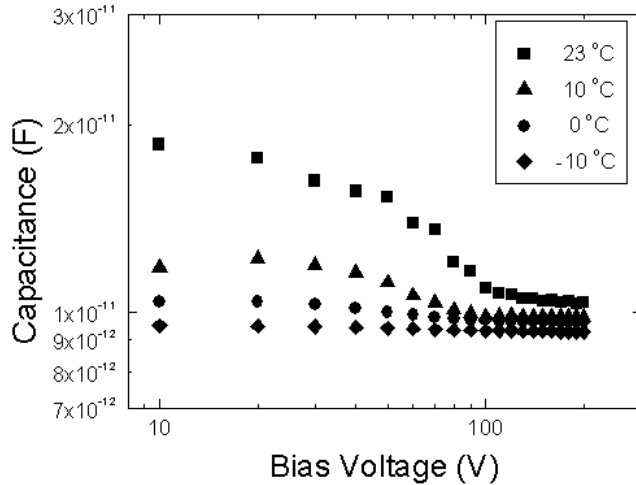
Fig. 9. C-V curves for an irradiated ( $4 \times 10^{14}$  p/cm<sup>2</sup>) test-sized individual p-stop sensor at various temperatures. Measurements were done at a frequency of 40 kHz.

The dependences of the depletion voltage and capacitance on the frequency and temperature were also studied. It is well known that after irradiation, CV characteristics have a strong dependence on measurement frequency [19]-[20] and temperature. Preliminary tests were performed on non-irradiated sensors and, as expected, we found no dependence of the C-V characteristics on the measurement frequency used. Fig. 8 shows the C-V measurements at three different frequencies and Fig. 9 shows measurements at four temperatures for an individual p-stop pixel sensor with 10 guard rings after irradiation to 4 × 10<sup>14</sup> p/cm<sup>2</sup>. A logarithmic change in frequency gives the same pattern of C-V curves as a linear change in temperature as reported by others [21]-[22].

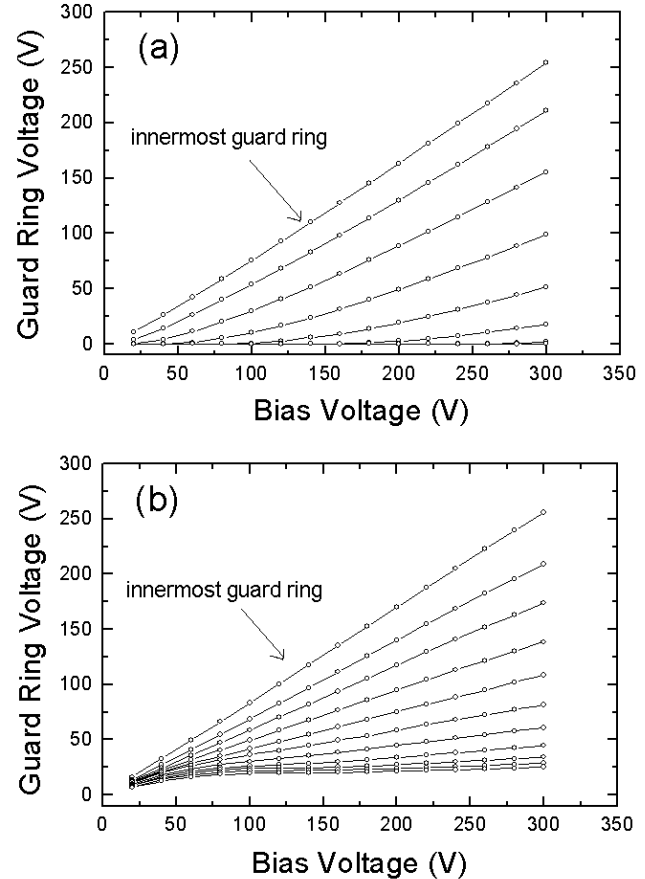
Fig. 10. Potential distribution over the 11 guard rings on the p<sup>+</sup> side before a) and after b) irradiation to  $2 \times 10^{14}$  p/cm<sup>2</sup> using an FPIX1-sized common p-stop oxygenated sensor.

We also studied the voltage distribution over the guard rings. In Fig. 10 we present the results for an oxygenated FPIX1-sized common p-stop sensor (11 guard rings) before and after irradiation. Results indicate that guard rings help to improve breakdown voltage by distributing the potential drop over a longer distance, thus reducing the electric field concentration near the junction boundaries. However, as we can see from the second plot, there is still a potential drop across the device edge after type inversion and more investigation is needed. We repeated the same measurements on a test-sized common p-stop with 18 guard rings irradiated to  $4 \times 10^{14}$  p/cm<sup>2</sup> and we also find a significant voltage drop.

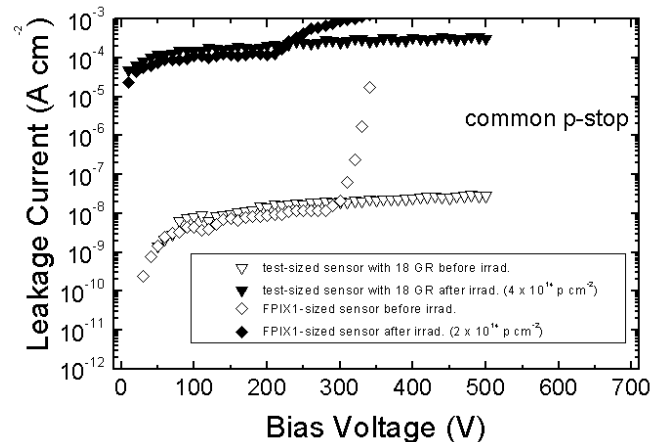
Fig. 11. I-V characteristics (at room temperature) before and after irradiation for oxygenated sensors. In this plot the current is normalized to the sensor's active area.

We irradiated four oxygenated sensors: two test-sized sensors and two FPIX1-sized sensors (See Table II for details.). Fig. 11 shows the I-V characteristics before and after irradiation (at room temperature) for the common p-stop pixel sensors. We found the same results also for the individual p-stop sensors that we irradiated. As we saw for the non-oxygenated sensors, the test-sized sensors have very good characteristics before and after irradiation (leakage current plateau, high breakdown voltage). The FPIX1-sized sensors on the other hand, have, also in this case, non-optimal performance in breakdown voltage.

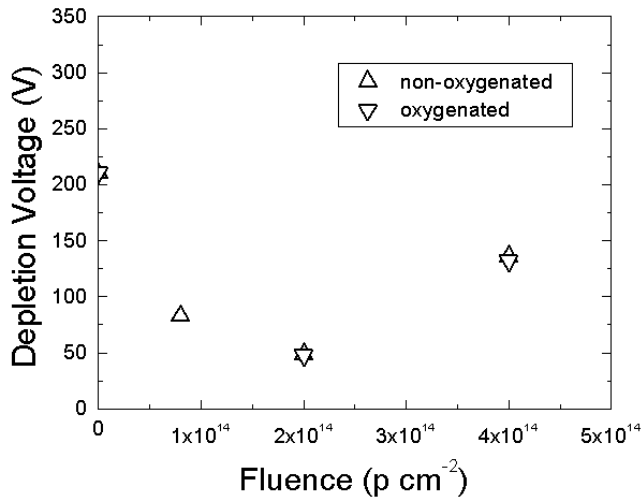
Fig. 12. Depletion voltage as function of proton fluences for normal and oxygenated sensors (270  $\mu\text{m}$  thickness).

Fig. 12 shows the dependence of the full depletion voltage on the proton fluences for the normal and the oxygenated sensors. We see that the full depletion voltage at  $4 \times 10^{14}$  p/cm<sup>2</sup> is still very low, lower than the value before the

irradiation. This characteristic is due to the low resistivity of the silicon. This result, together with the fact that the breakdown voltage is still high compared to the full depletion voltage, is very important for the BTeV experiment because we can have fully depleted detectors without biasing at very high voltage. Even though the breakdown voltage for the FPIX1-sized sensors is below 300V after irradiation, it is still well above the depletion voltage, even up to a fluence of  $4 \times 10^{14}$  p/cm<sup>2</sup>.

We still have some uncertainty on the type inversion point. However from Fig. 12 we can see that, after type inversion, the slope is similar for both oxygenated and non-oxygenated sensors. We can conclude that for these SINTEF sensors, no difference in electrical characteristics before and after irradiation between oxygenated and standard sensors have been observed. We found that the non-oxygenated sensors are as radiation hard as the oxygenated ones. This is in agreement with recent studies performed by other groups, which showed that while there is a large variation in the irradiation results obtained using standard silicon wafers from different foundries, the oxygenation process removes this variation. All the oxygenated wafers show the same performance after irradiation independent of foundry. As here, however, no difference in irradiation results between standard and oxygenated SINTEF diodes was found [23].
