Identifying high power breakdowns in accelerating structures with acoustic sensors

Nicolas Delerue
GLC Group, KEK

Talk given at the 9th Accelerator and Particle Physics Institute

APPI (Japan), February 2004

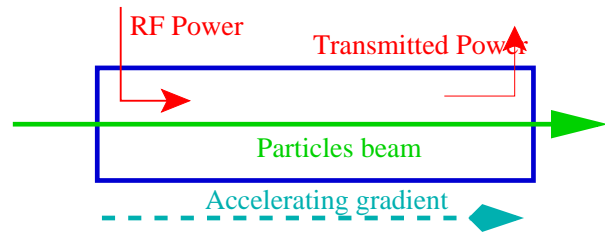
Figure 1: Scheme of an accelerating structure. The electromagnetic wave (red arrows) is inserted at the left of the structure and travels to the right, thus creating an accelerating gradient that will accelerate the particles beam. At the end of the structure the transmitted power is extracted and can be measured.

Accelerating structures are used in (mainly in LINACs) to accelerate particles. Usually a very high frequency (Radiofrequency) electromagnetic pulse is fed into the structure. This electromagnetic pulse will create, in the structure, an accelerating gradient that will accelerate the particles beam (see figure 1).

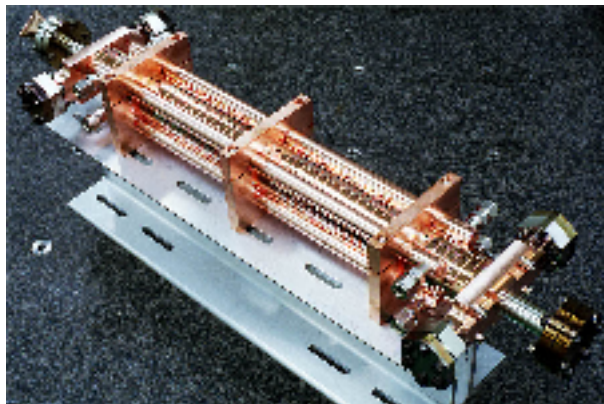
Figure 2: A x-band accelerating structure.

At KEK-B the typical power feed into a structure is 40 MW at 3 GHz (S-band) whereas the structure that should be used in the Linear Collider [1] (if warm technology is chosen) will be fed with 75 MW at a frequency of 11 GHz (X-band). A picture of an X-band accelerating structure is shown

on figure 2.

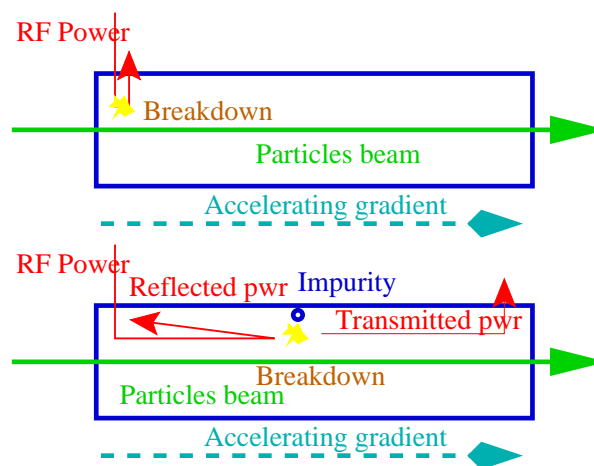
Figure 3: Breakdowns in an accelerating structure. Breakdowns can occur either at the input or output of the structure (top figure) or somewhere else in the structure, for example near an impurity at the surface of the structure (bottom figure). The timing with which power will be transmitted and reflected depends on the location of the breakdown.

When the energy concentrated on a given point of the structure becomes too high a spark will occur. This can happen at a location where, by design, the energy density is very high, like for example the input coupler of the structure (see figure 3 top) but this can also happen at a location where there is an impurity at the surface of the metal forming the structure (see figure 3 bottom).

- As shown on figure 3 when the breakdown occurs the incoming electromagnetic wave is reflected back to the input of the structure. If the breakdown occurs in the middle of the electromagnetic wave, then part of the wave will be reflected whereas the part that had already passed the location of the breakdown will be transmitted. Thus by measuring the shape of the reflected and transmitted waves, it is possible to deduce the location and the time (with respect to the beginning of the wave) at which the breakdown occurred. As the electromagnetic wave is often deformed, this method has a limited precision.

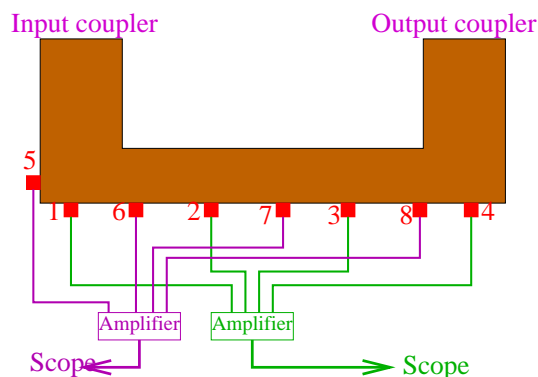
Figure 4: Layout of the 8 acoustic sensors installed on the C-band structure tested at KEK's main Linac.

There is one accelerating structure currently tested at the KEK main Linac. It has been equipped with 4 acoustic sensors, to which 4 extra sensors were added later as shown on figures 4, 5 and 6. Additionally after each breakdown informations about the RF wave are stored and available for analysis.

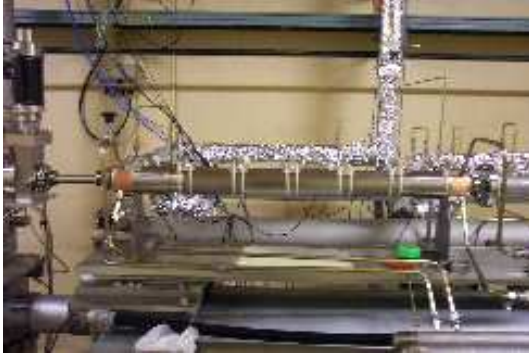
Figure 5: The C-band structure tested at KEK's main Linac. The acoustic sensors can be seen on top of the structure.

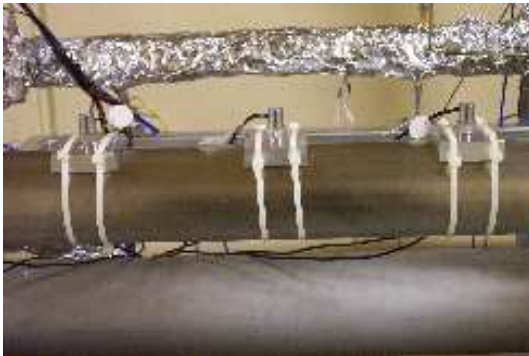
Figure 6: Zoom on 3 sensors installed on top of the C-band structure tested at KEK's main Linac.

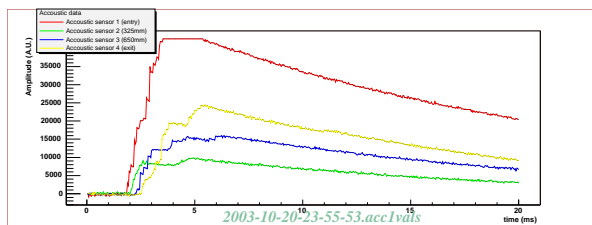
Figure 7: Example of acoustic data recorded during a breakdown at the C-band test stand. Each line corresponds to the noise recorded by a different sensor.

On figure 7 one can see an example of breakdown as recorded by the acoustic sensors. The signal is huge and thus easily distinguishable from the background noise. But extracting the breakdown location from this signal is not so easy. One could decide that the sensor the closest from the breakdown will receive the signal earlier (the travel path is shorter) or the more intense (the attenuation should be smaller).

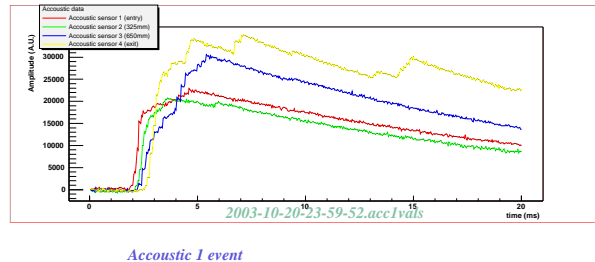
Figure 8: Example of acoustic data recorded during a breakdown. On this event one can see that the sensor receiving the signal first is not the one that receives the most intense signal.

Unfortunately on some events such as the one shown on figure 8 the sensor receiving the signal first is not the one that receives the most intense signal. Furthermore the order in which the sensors receive the signal will not always have a physical interpretation. Thus a double algorithm has been used to locate the breakdown: one is based on the time at which each sensor has received the signal and the other one is based on the intensity of the signal. Attempts to use either intensity or timing information to locate the breakdown between two sensors have not been successful.

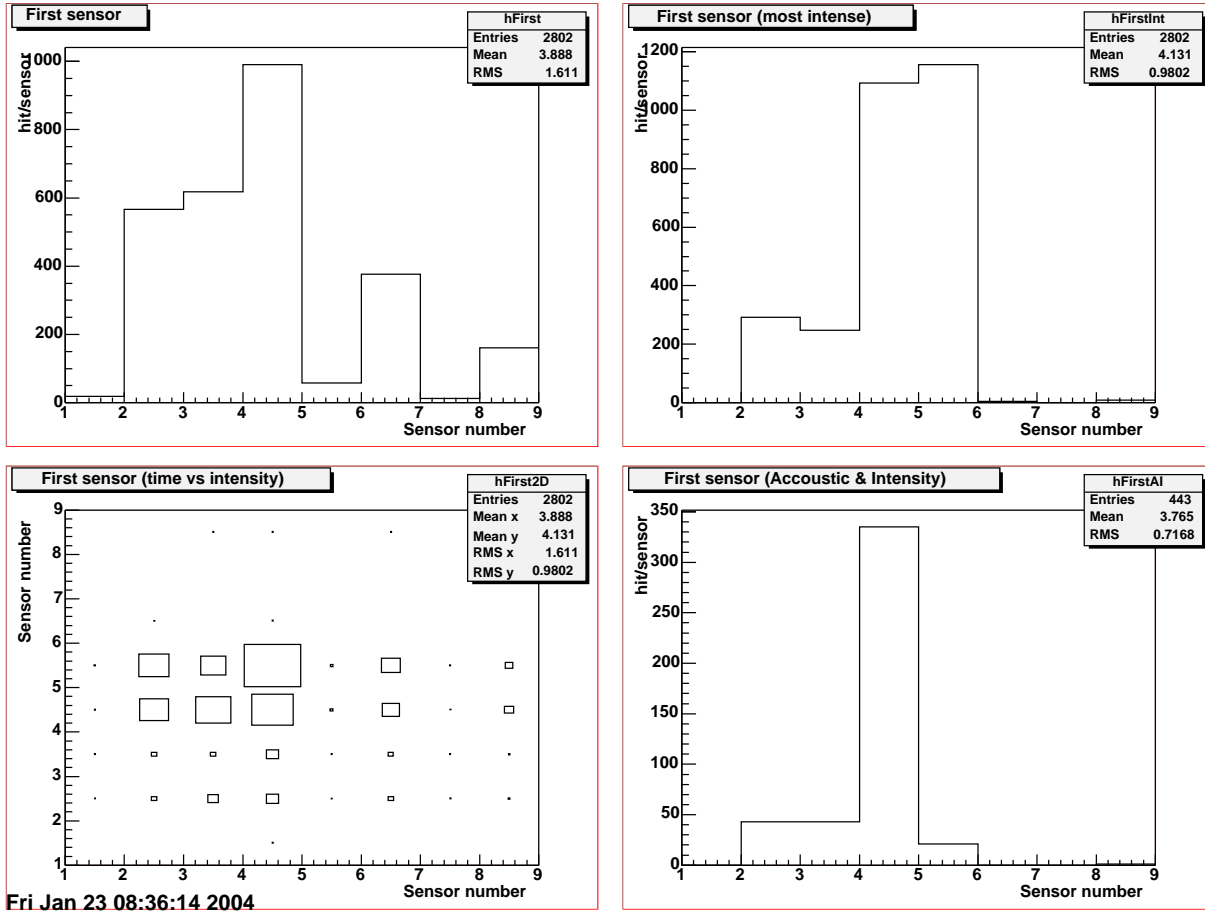
Figure 9: Analysis of the breakdowns recorded with the acoustic sensors. The upper left plot shows for each sensor the number of breakdowns where this sensor received the noise first. The upper right plot shows for each sensor the number of breakdowns where this sensor received the most intense signal. The lower left plot shows the correlation between the two upper plots, the horizontal axis corresponding to the sensor that received the noise first and the vertical axis to the sensor that received the most intense signal. The lower right plot shows for each sensor the number of breakdowns where this sensor received the signal first and also received the most intense signal.

The number of breakdowns recorded by each sensor can be seen on figure 9. The upper left plot shows the number of breakdowns that have reached a sensor first, the upper right shows the number of breakdowns that were the most intense for a given sen-

sor. The lower left plot shows the correlations between the two upper plots and the lower right plot shows when the number of breakdowns when timing and intensity information agree (golden events).

From this figure one can see that the breakdowns occur in the forward region of the structure as sensor 2 to 4 record the most intense signal. By looking at the golden events one can see that these events seems to be located inside the structure rather than at its edge as it is sensor 4 that records the more golden events.

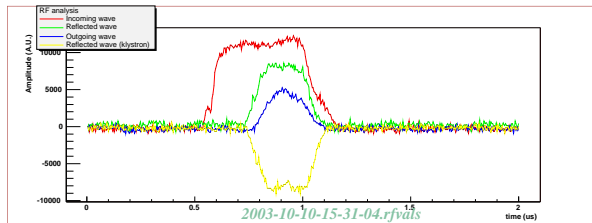
Figure 10: Example of RF data recorded during a breakdown. The red line corresponds to the incoming RF wave, the green line to the reflected RF wave, the blue line to the outgoing wave and the yellow line to the reflected wave at the klystron..

The analysis of the electromagnetic waves is more straightforward. The figure 10 shows an example of electromagnetic wave measurement during an event where a breakdown occurred. The difference between the time at which the outgoing wave (in blue) finishes and the time at which the reflected wave (in green) reaches the input of the structure provides information on the location of the breakdown: if the breakdown occurred close from the output of the structure the outgoing wave will have to

travel a much shorter distance than the reflected wave, thus the time difference between the two will be negative. On the other hand, if the breakdown occurs near the input coupler the reflected wave will have a short travel distance whereas the outgoing wave will have to travel a much longer path, thus the difference will be positive.

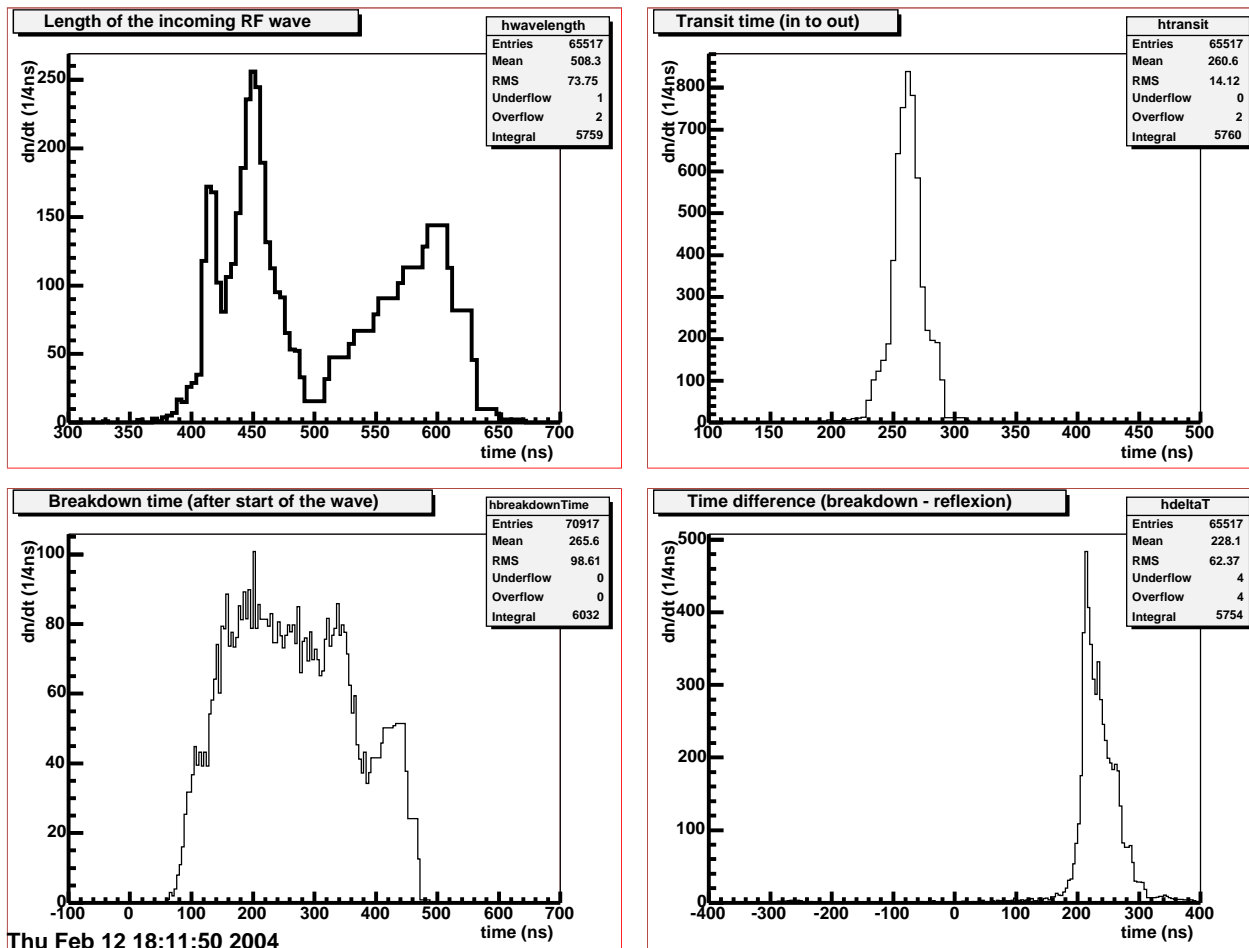
Figure 11: Analysis of the electromagnetic waves information recorded with each breakdown. The upper left figure shows the total length of the incoming RF wave. The upper right plot shows the transit time from the input to the output of the coupler. As this time is a constant the width of the peak gives the resolution of our measurement. The lower left plot shows the breakdown time after the start of the wave. The lower right plot gives the difference between the time at which the outgoing and reflected waves were recorded. Positive values correspond to breakdowns near the input kicker.

The analysis of the electromagnetic waves information is shown on figure 11. From this analysis one can see that there is no specific time at which the breakdown occurs but that almost all breakdowns occur near the input coupler.

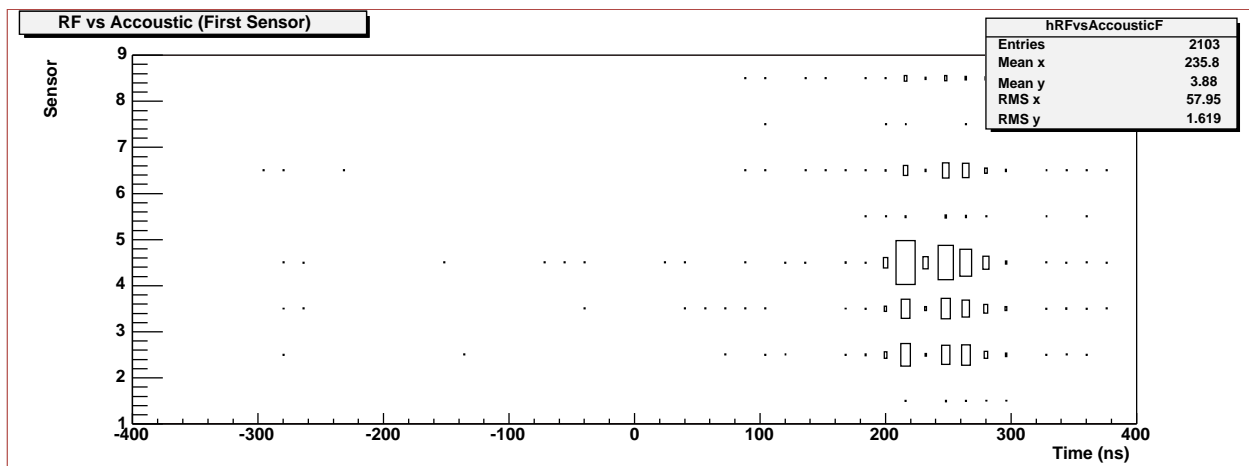
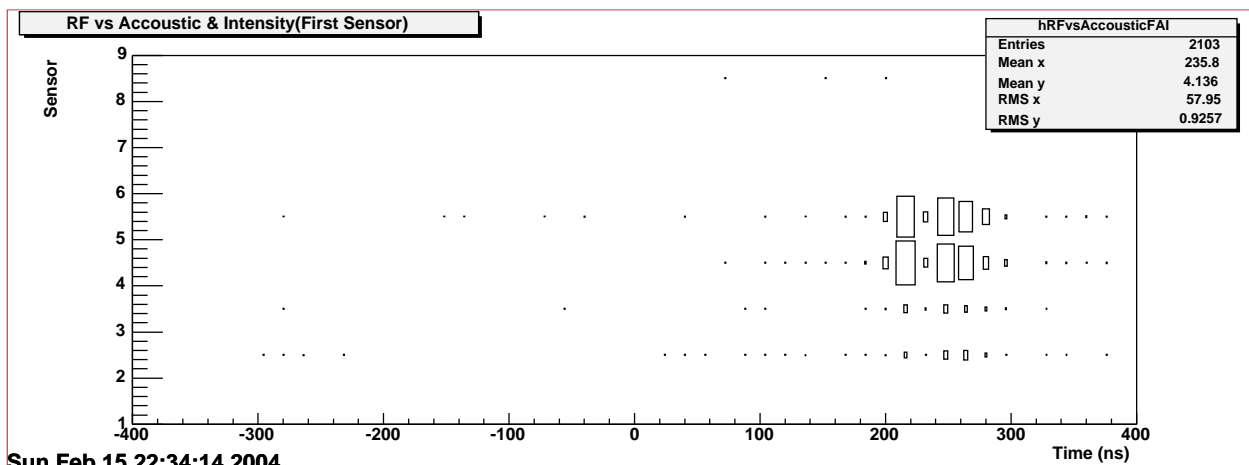
Figure 12: Correlations between the acoustic sensors analysis (vertical scale) and the electromagnetic waves analysis (horizontal scale).

The correlation between the information collected with the acoustic sensors and the electromagnetic waves analysis has been studied. This correlation can be seen on figure 12.

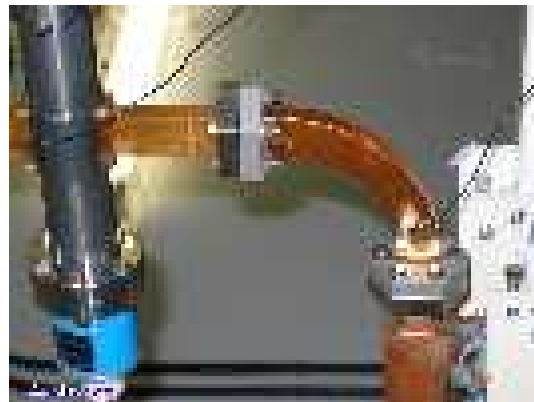
Figure 14: A piece of waveguide of the X-band test stand with an acoustic sensor.

A usual glue was used to stick the acoustic sensors on the waveguides at the location known to be the most likely to produce breakdowns. Acoustic sensors glued on the waveguides can be seen on figures 13 and 14.

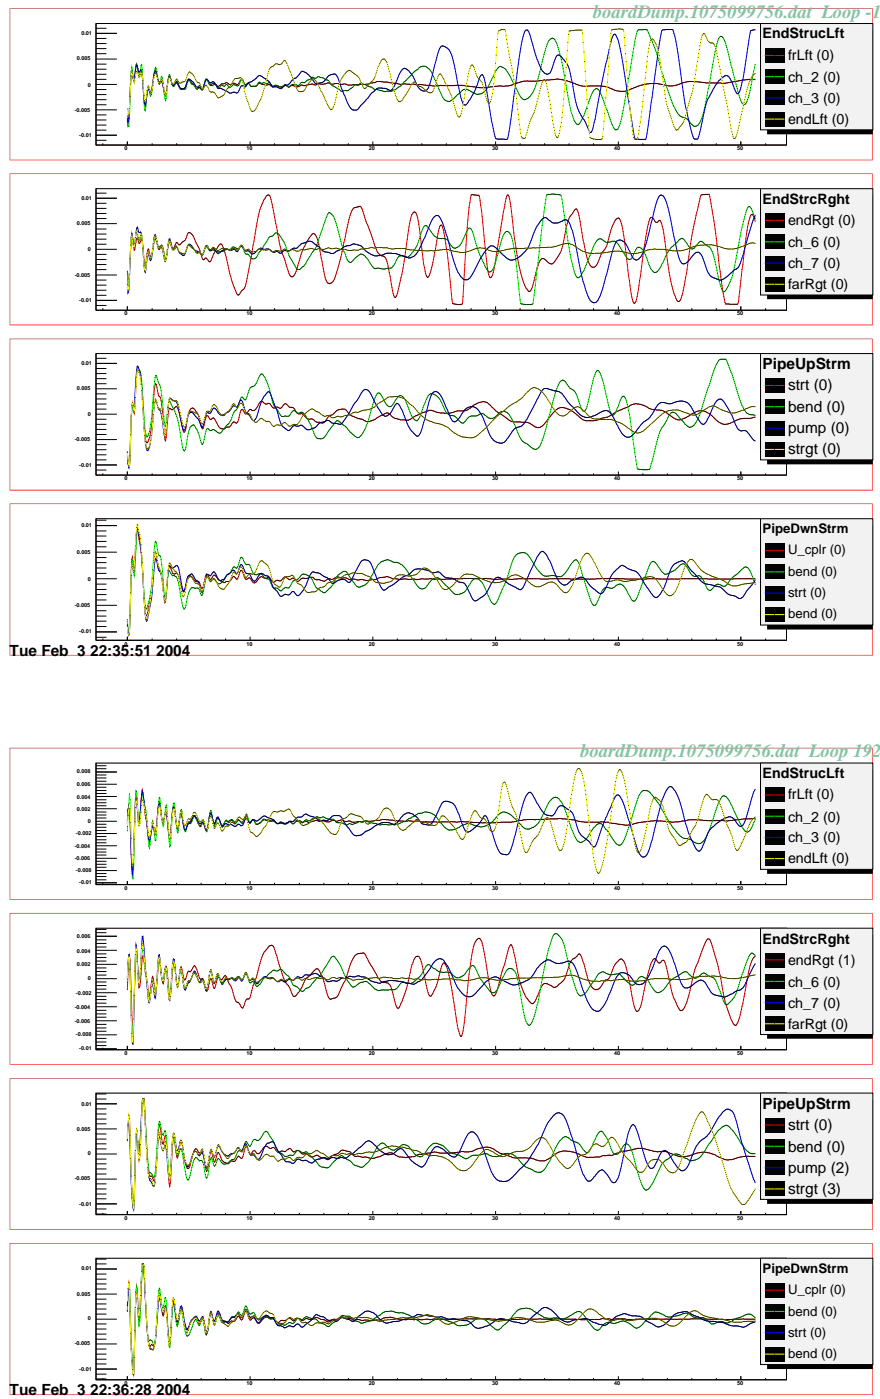
Figure 15: X-band events. On the top figure there is a breakdown on the 4 upper channels (upper plot) whereas on the bottom figure the noise recorded does not correspond to an actual breakdown.

The figure 15 page 11 (top) shows a typical event as recorded by the acoustic sensors at

On this event one can see that even before the breakdown there is a lot of noise recorded by the sensor, especially the klystron noise at the beginning of the record. The figure 15 (bottom) shows an example of non breakdown event with high intensity noise.

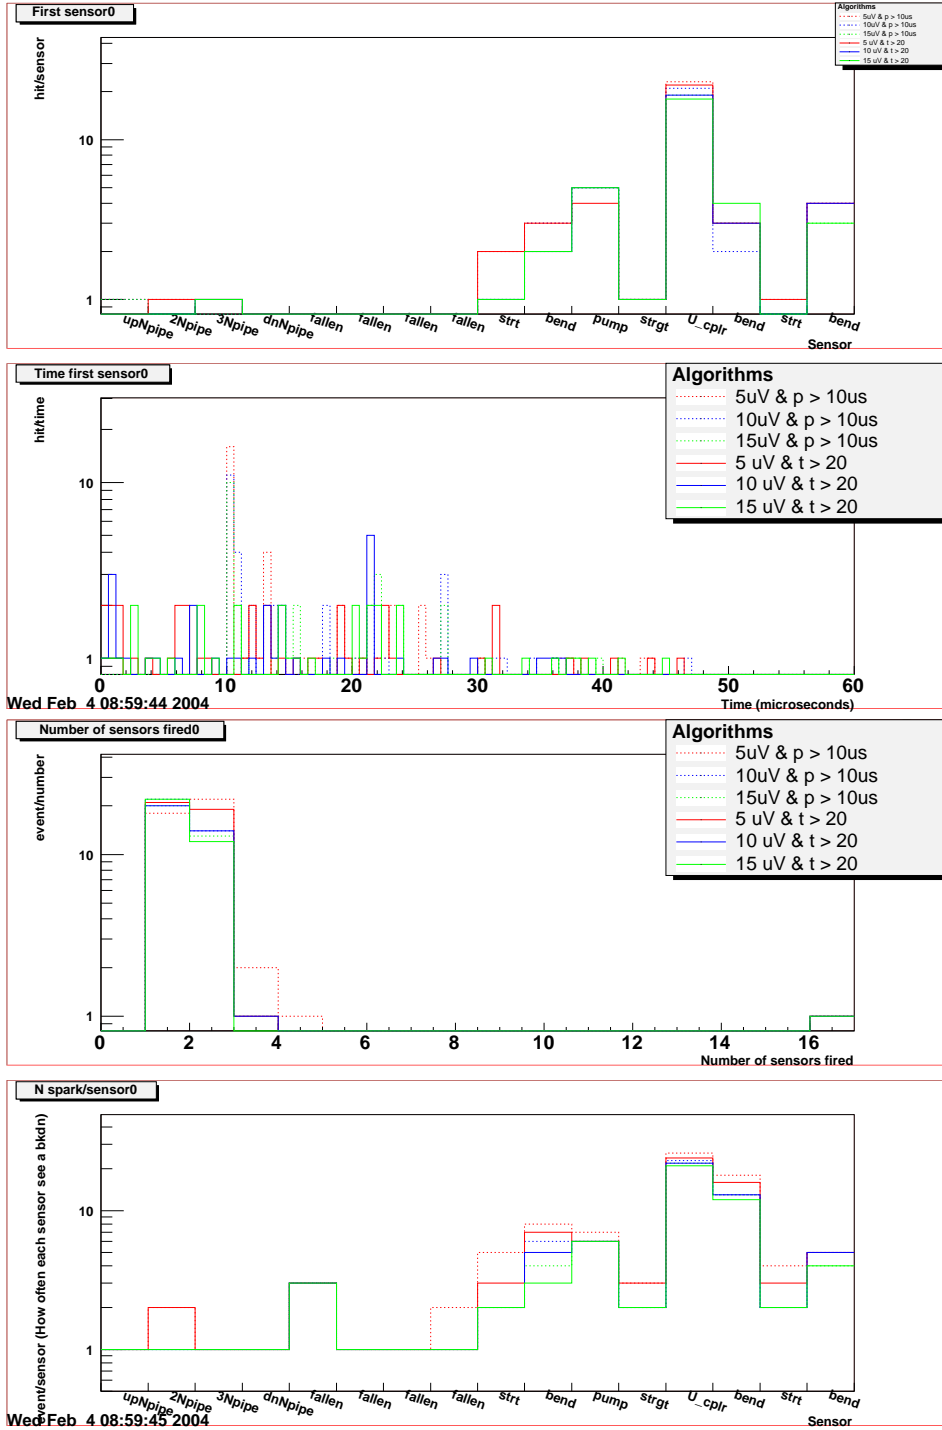
Figure 16: X-band analysis. All sensors used for this analysis were installed on waveguide components. The different colors correspond to different breakdown threshold. Dashed line correspond to simple breakdown and plain line to long breakdowns.

The statistical repartition of the breakdowns following this classification can be seen on figures 16 and 17.

These two figures correspond to different configuration of the acoustic sensors. Figure 16 uses data where all sensors were located on the waveguides. Some of them were located on straight section of the pipes whereas some other were located on bends or on a coupler. As one can expect most of the breakdowns were recorded near the bent waveguides and near the coupler. Half of these sensors were moved for the data used by figure 17. Those sensors have been relocated at the end of the accelerating structure, another location where many breakdowns (but also a lot of noise) were expected. The location of the beakdowns on that figure is conform to the expectations.

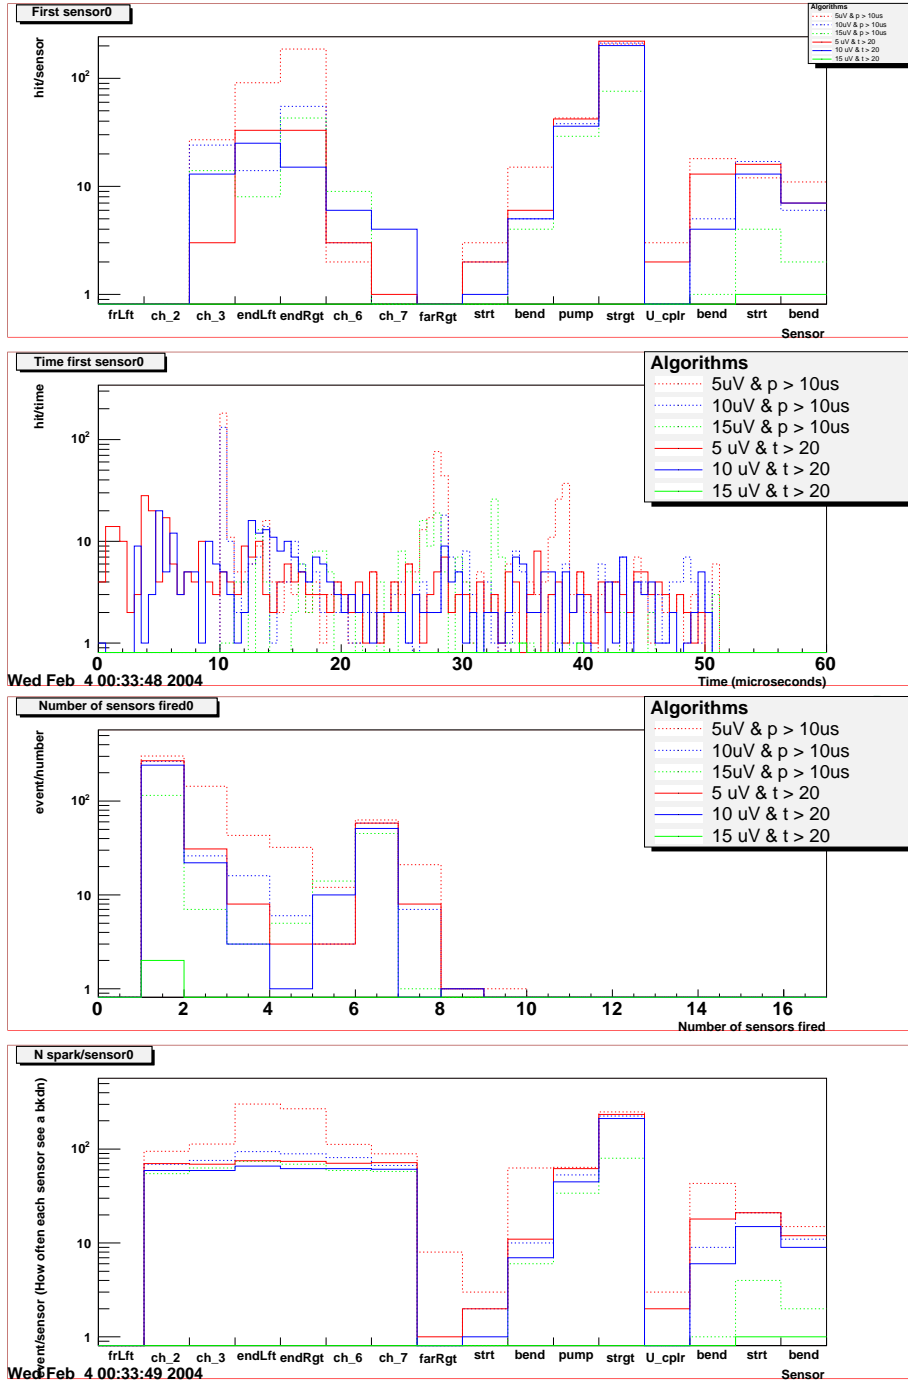
Figure 17: X-band analysis. Half of this sensors used for this analysis were installed on waveguide components and the other half were installed at the exit of the accelerating structure. The different colors correspond to different breakdown threshold. Dashed line correspond to simple breakdown and plain line to long breakdowns.
