Were the “Critical Evidence” presented in the South Korean Official Cheonan Report fabricated?

South Korean Joint Investigation Group (JIG) [1] presented two “critical scientific evidence” that link the sinking of the South Korean navy corvette Cheonan on March 26, 2010 to the alleged explosion of a North Korean torpedo: the now-infamous “No. 1” blue ink mark on the torpedo, and the electron-dispersive spectroscopy (EDS) and x-ray diffraction (XRD) data of the three “adsorbed materials” extracted from the ship, the torpedo and a small-scale test-explosion. In our previous paper [2], we described the inconsistency of JIG’s EDS and XRD data. Here we report our SEM, EDS, and XRD analyses on an Al powder that underwent melting followed by rapid quenching, and our simulation of the EDS spectra of Al_2O_3 and $\text{Al}(\text{OH})_3$. We obtained an experimental value of 0.25 for the EDS intensity ratio, $I(\text{O})/I(\text{Al})$, and a simulation result of $I(\text{O})/I(\text{Al}) \sim 0.23$ for Al_2O_3 formed on the surface of the adsorbed materials during an explosion. The JIG’s EDS data, however, showed very different values of ~ 0.9 for the same ratio. Interestingly, the high val

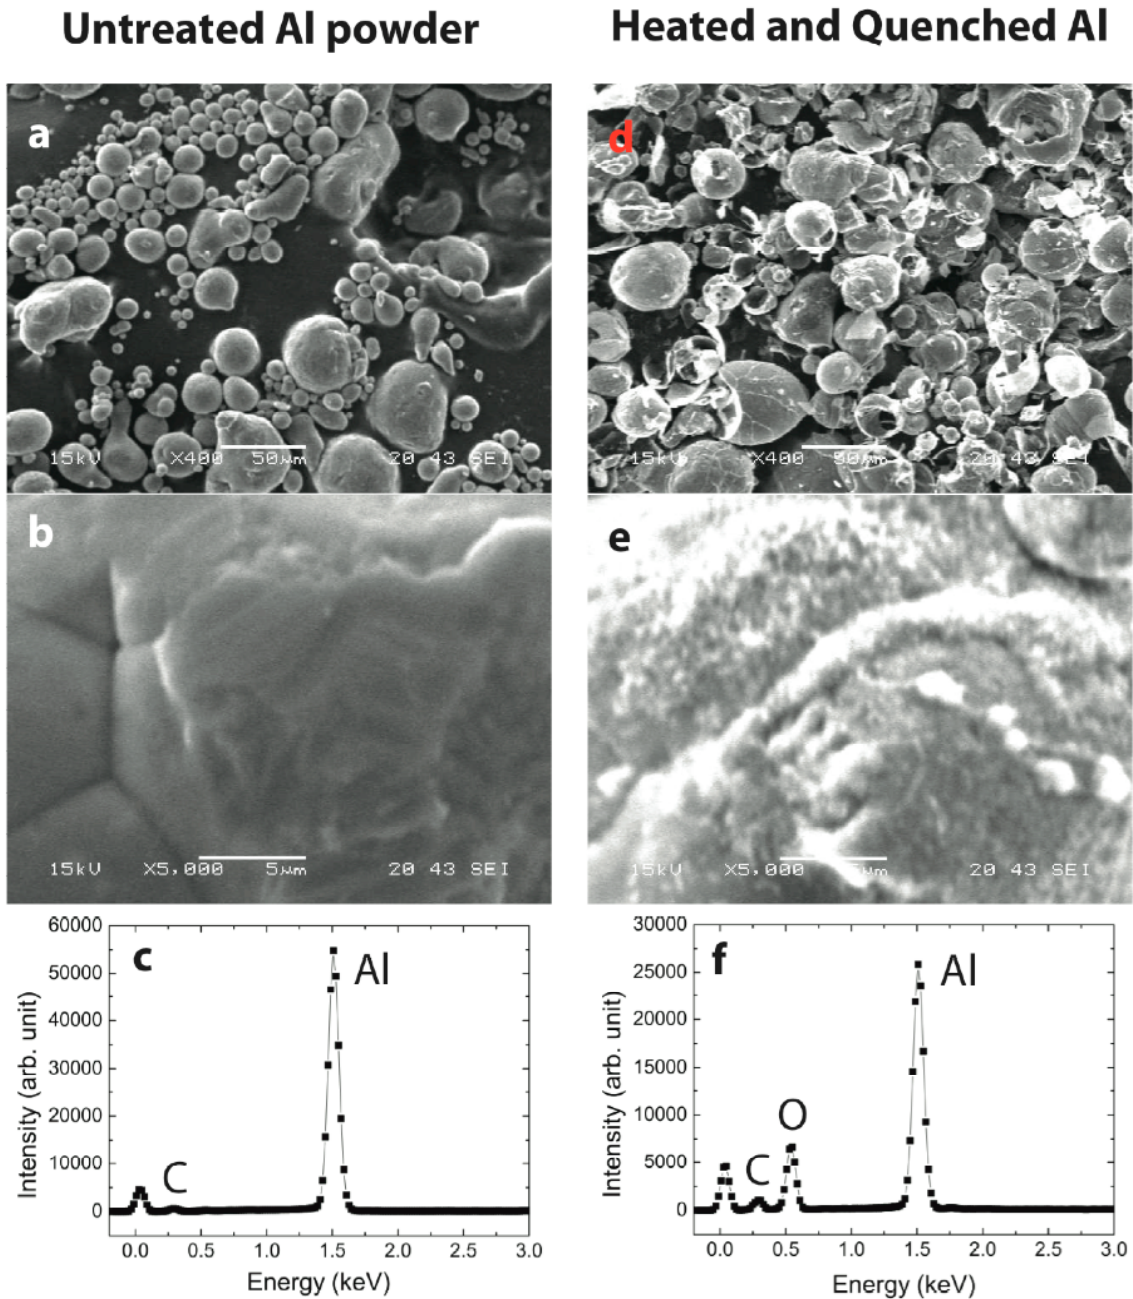
Fig. 1. SEM and EDS data of (a)-(c) the untreated Al sample and (d)-(f) the melted and rapidly quenched Al sample. (a), (b), (d) and (e) are the SEM images. (c) and (f) are the EDS data.

Fig. 1 (a)-(c) show the SEM images and the EDS data obtained from the first sample, Al-a. Fig. 1 (a) shows the SEM image, exhibiting the Al-a grains with typical sizes of $\sim 10 \mu\text{m}$ to $\sim 100 \mu\text{m}$. Fig. 1 (b) is a close-up of one large grain whose EDS data is shown in Fig. 1 (c). The EDS data of Al-a clearly exhibits the Al peak at around 1.5 keV. And there are no other peaks, except the signal of the carbon coated to give electrical conductivity for the measurements. Other grains also gave similar EDS data. On the other hand, its x-ray data (Fig. 2 (a)) exhibit only the pure Al Bragg peaks, which indicates that as expected the amount of Al_2O_3 is negligible in this untreated crystalline Al powder sample.

Fig. 1 (d)-(f) show the SEM images and the EDS data of the melted and then quenched second sample, Al-b. The SEM images (Fig. 1 (d) and (e)) are much shinier than those of the Al-a sample (Fig. 1 (a) and (b)). This tells that the

surfaces of the metallic Al grains are oxidized into the insulating Al₂O₃ from which the incident electrons are reflected rather than penetrating into the sample. Thus, the shiny SEM images indicate that oxidization occurred during the heating and quenching.

What are the implications of our results to the EDS and XRD data of the three “adsorbed materials” that were presented as one of the two “critical scientific evidence” in the South Korean official Cheonan report? **(1)** Our XRD data of the heat-treated sample, Al-b, are similar to those of the “adsorbed material”, AM-III, taken from their test-explosion [1,2]: strong Bragg peaks from crystalline Al and much weaker Bragg peaks from crystalline Al₂O₃ were present. This suggests that the JIG’s XRD data of the AM-III is correct, on the contrary to the JIG’s claim that the Al Bragg peaks observed in their AM-III XRD data are not associated with explosives because the XRD measurements were done with the Al-cover plate to which the AM-III samples were attached. **(2)** In the EDS data, our AM-b sample and the JIG’s AM-III sample both exhibit Al and O signals. However, the relative strength of the Al and O EDS signals, I(O)/I(Al), is very different in the two samples: I(O)/I(Al) = 0.25 for our AM-b (Fig. 1 (f)) while I(O)/I(Al) = 0.81 for JIG’s AM-III sample (Fig. 3 (c)).

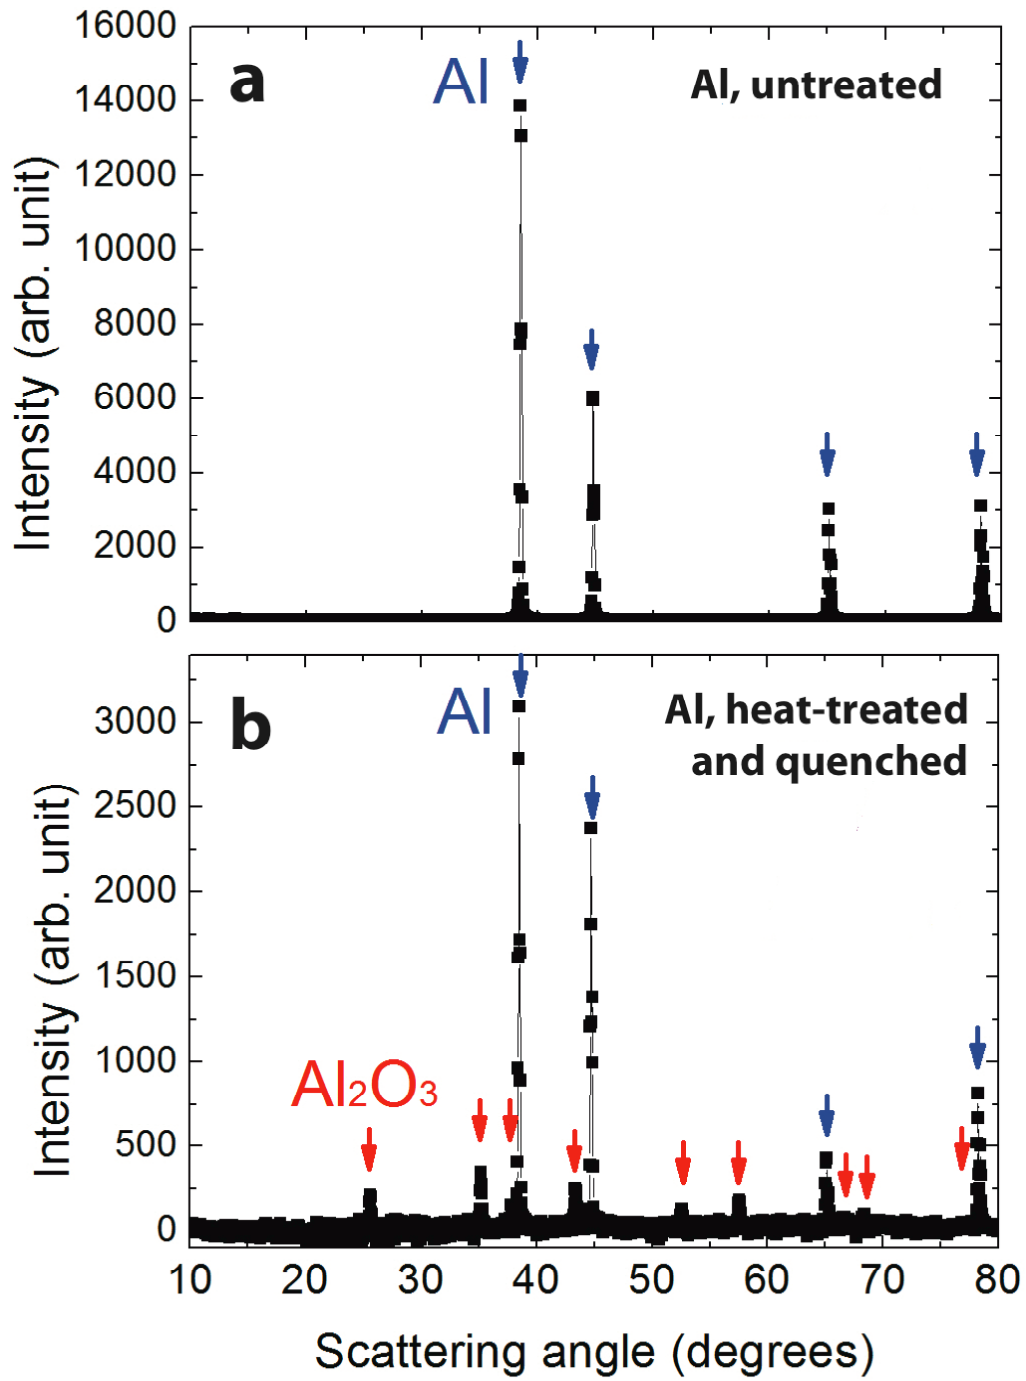
Fig. 2. X-ray data of (a) the untreated Al sample and (b) the melted and rapidly quenched Al sample.

As shown in Fig. 2 (b), the x-ray data of the heat-treated sample, Al-b, exhibit two sets of well-defined sharp Bragg peaks from crystalline Al and crystalline Al₂O₃. This clearly indicates that **(1) Al oxidizes partially** not entirely during the heating and rapid quenching, and that **(2) after the quenching the Al and the oxidized Al₂O₃ become crystalline** rather than amorphous! Our refinement of the data tells us that ~ 40 % of the Al has oxidized during the heat treatment. When compared with the x-ray data of the test-explosion sample, AM-III, presented in the official Cheonan report, in the test-explosion the amount of oxidized Al is much smaller than the 40 % oxidization observed here. We believe that it is because in our experiment the Al sample was above its melting temperature for ~ 40 minutes that is much longer than it would have during an explosion. Of course, the amount of the oxidized Al would depend on other factors as well such as the amount of oxygen in the surroundings and temperature, but from our heat-treatment results and their test-explosion results, one can safely say that the duration of the sample above its melting point is the most crucial, and the 40 % is probably close to the maximum oxidization fraction for an explosion. This was proved by their test-explosion.[1]

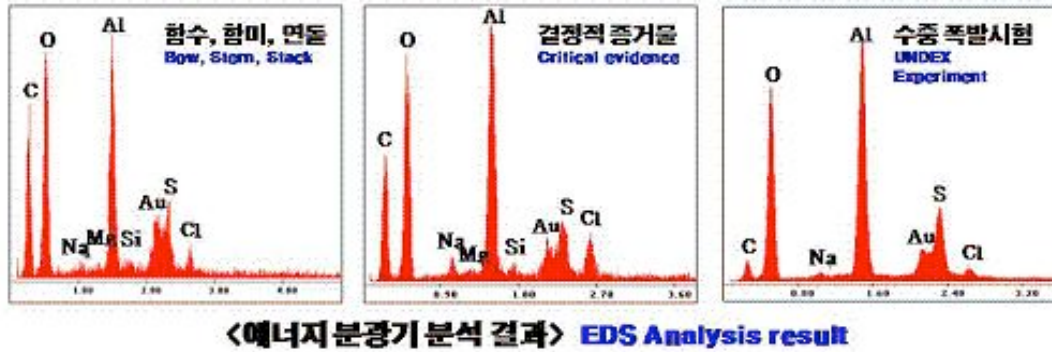
Fig. 3. The reported EDS data obtained from (a) AM-I (left panel), the absorbed material extracted from the “bow, stern, and stack” of the Cheon-An ship, (b) from AM-II (center), “critical evidence”, extracted from the propeller of the torpedo, and (c) from AM-III (right panel), “UNDEX Experiment”, extracted from the mock-up torpedo after explosion. The horizontal and vertical axes represent the energy and strength of the signal, respectively. This figure was taken from Ref. [1].

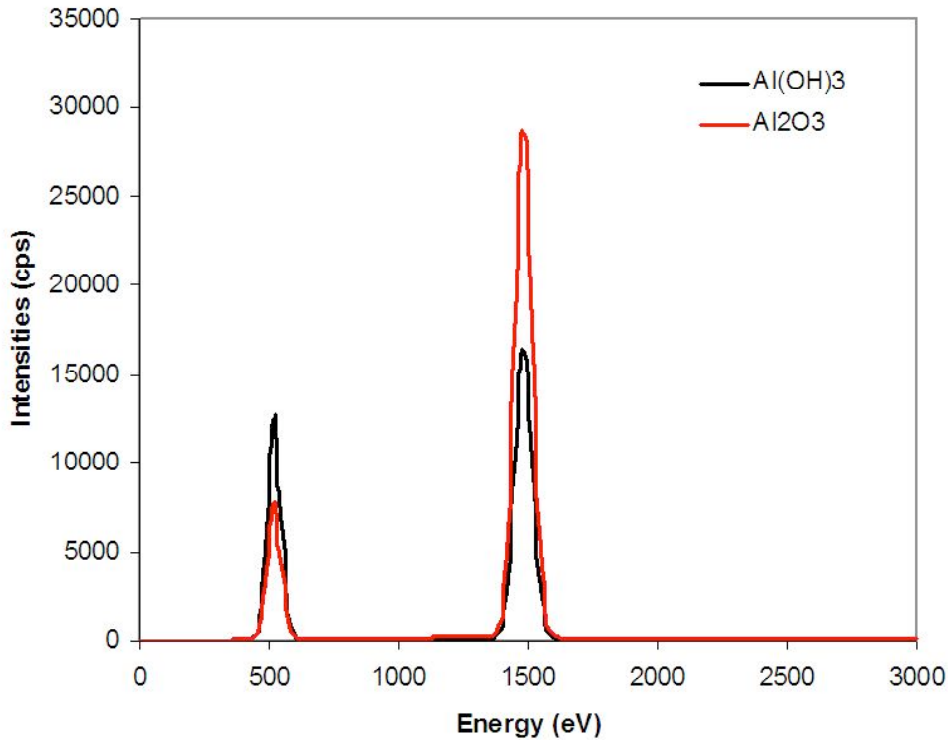
Fig. 4. EDS simulation results for Al_2O_3 (red line) and $\text{Al}(\text{OH})_3$ (black line).

EDS spectra for Al_2O_3 using the EDS simulation software, NIST DTSA II. As shown in Fig. 4, the $I(\text{O})/I(\text{Al})$ ratio should be ~ 0.23 for surface of samples that are predominantly Al_2O_3 (red line), as is the case in an explosion. This simulation result is consistent with our EDS data, $I(\text{O})/I(\text{Al}) \sim 0.25$ (Fig. 1 (f)). Other previous experimental studies have also shown similar value for the $I(\text{O})/I(\text{Al})$ ratio.[3] On the other hand, as seen in Fig. 3, all three samples, AM-I, AM-II, AM-III, presented by the JIG as evidence showed very high $I(\text{O})/I(\text{Al})$ ratios, 0.92 (AM-I), 0.90 (AM-II), and 0.81 (AM-III).[1] This is strikingly different from our experimental and simulated result and previously measured $I(\text{O})/I(\text{Al})$ ratio. What kind of Al-related materials would yield such a high $I(\text{O})/I(\text{Al})$ ratio? Fig. 4 shows the simulated EDS spectra for gibbsite ($\text{Al}(\text{OH})_3$) (black line) that is a clay mineral commonly formed by weathering processes, and it clearly shows that $I(\text{O})/I(\text{Al}) \sim 0.85$ for the gibbsite. Thus, if the JIG's EDS data for their AM-I and AM-II samples are correct, then their adsorbed materials are not associated with an explosive. Instead, the EDS spectra of AM-I and AM-II are mainly hydrated alumina, such as gibbsite $\text{Al}(\text{OH})_3$.

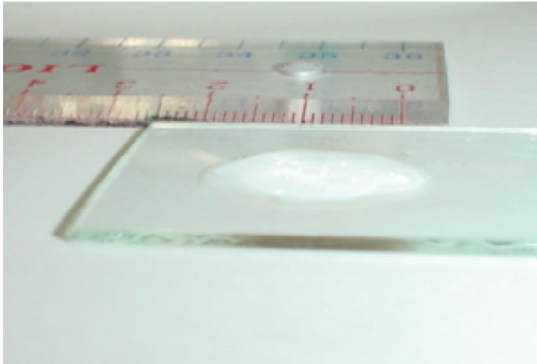
(a) x-ray sample

Fig. 5. Typical samples for (a) XRD and (b) EDS measurements. The plastic ruler shows length in red marks in the unit of cm. In (a), a thin layer of the white sample of 4.3 milligrams is placed on a glass plate. In (b), a white spot of 0.3 milligram sample is placed on a round carbon plate.

The x-ray portion was placed on a glass plate, while the EDS portion was placed on a carbon tape that was attached to a round carbon plate. The pictures of the x-ray and the EDS machine, and the loading of the samples were shown in the Supplementary Information. One thing to remember is that x-ray penetrates into the sample about a few hundreds μm while EDS penetrates only about several μm . Thus, EDS probes the atomic composition of the surface of the sample while x-ray probes the chemical material composition of the sample in bulk.

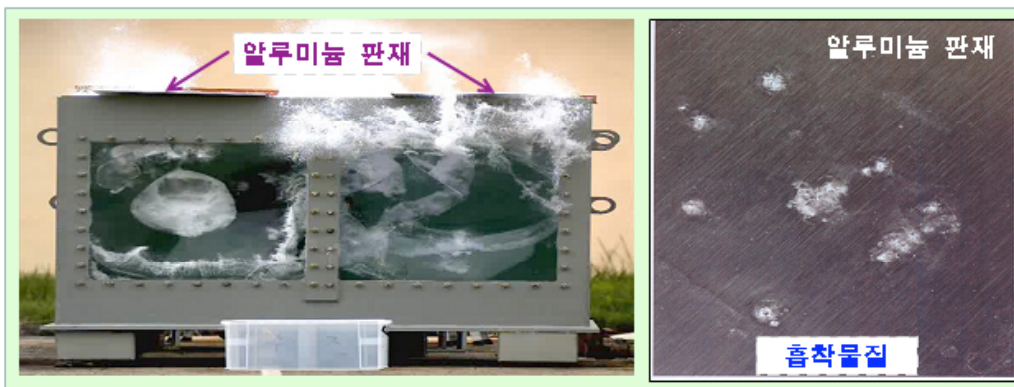
Fig. 6. The setup of the test-explosion experiment done by the JIG. This figure was taken from Ref. [1].

○ 수중폭발시험

- 조건 : 수조 규격 2m x 1.5m x 1.5m / 해수 4.5톤
- 폭약량 : 15g (RDX, TNT, AL분말 등)
