# The Effects of Radiation Damage on CLYC Performance

Katherine E. Mesick, Daniel D.S. Coupland, Suzanne F. Nowicki, and Laura C. Stonehill,

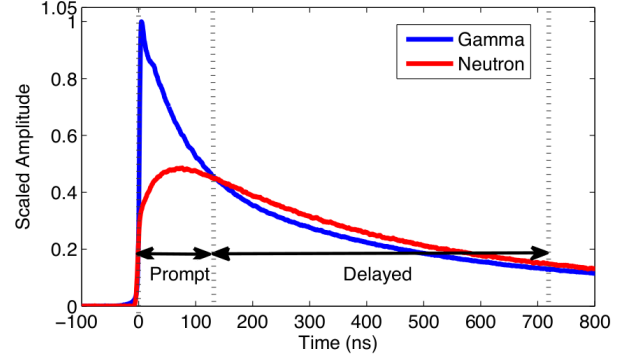
Fig. 1. CLYC pulse shapes in response to gamma and thermal neutron radiation.

$\text{Cs}_2\text{LiYCl}_6:\text{Ce}^{3+}$  (CLYC) has gained much attention recently for its ability to detect both gamma rays and neutrons within a single volume. It has excellent linearity and light yield, provides superior resolution to NaI and BGO, and provides thermal neutron sensitivity through neutron capture on  $^6\text{Li}$  with a Q-value of 4.8 MeV. Different characteristic time structures for gamma- and neutron-induced pulses in CLYC, shown in Fig. 1, allow for pulse-shape discrimination (PSD) to be achieved, as shown in Fig. 2, through integrating different regions of the pulse shapes.

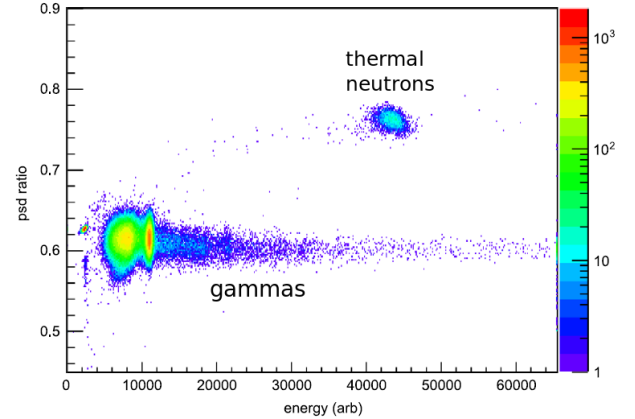
Fig. 2. Pulse-shape discrimination for CLYC, exhibiting distinct regions for gamma and thermal neutron events.

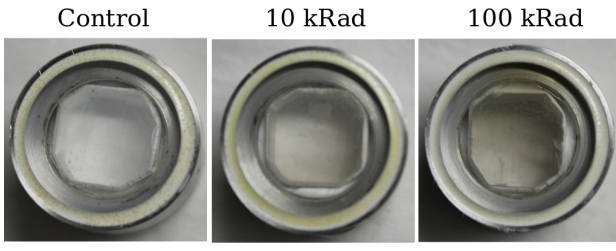
Fig. 3. CLYC samples showing discoloration in the irradiated crystals.

We irradiated two CLYC samples (1 cm cuboids) at the Los Alamos Neutron Science Center (LANSCE) facility with 800 MeV protons, one to approximately 10 kRad dose ( $4.8 \times 10^{11}$  protons) and one to approximately 100 kRad dose ( $4.8 \times 10^{12}$  protons). A third identical CLYC sample was not irradiated as a control. Discoloration of the irradiated CLYC samples can be seen in Fig. 3.

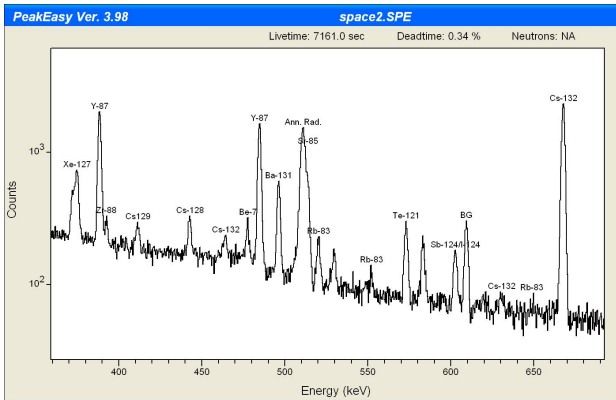
Fig. 4. Example of CLYC activation spectrum measured with HPGe after irradiation.

The activation spectrum of CLYC after irradiation is shown in Fig. 4. Most of the activation lines are attributable to the activation of the Cesium and Yttrium within CLYC or the housing material and have short half-lives from days to weeks. This activation and a reduction in light output leads to noise and poor resolution of CLYC immediately after irradiation, as indicated in Fig. 5. Here the MCA spectrum as measured in the presence of a  $^{137}\text{Cs}$  source shows the control with a 5.5% full-width half-maximum photopeak resolution at 662 keV, while the irradiated samples show degraded performance due to the abundance of short-lived activation products. After these activation products have decayed, a repeat measurement of  $^{137}\text{Cs}$ , shown in Fig. 6, shows the 662 keV photopeak visible for the irradiated CLYC samples, however with reduced light output and therefore worse resolution.

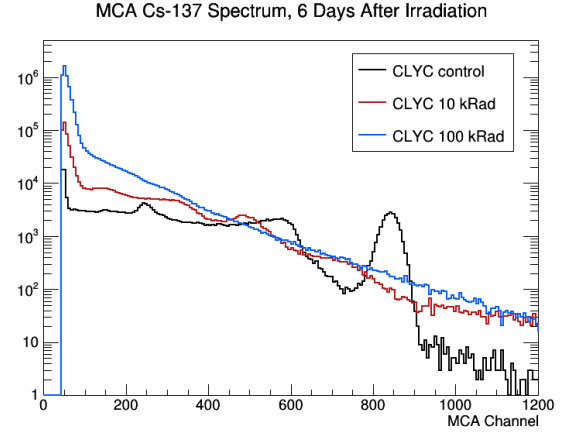
Fig. 5.  $^{137}\text{Cs}$  spectrum measured 6 days after irradiation showing large background from activation products.

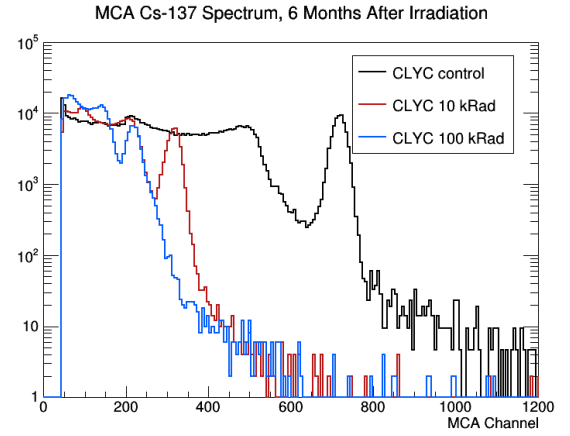
Fig. 6.  $^{137}\text{Cs}$  spectrum measured 6 months after irradiation showing reduced light output.
