Role of intermetallic phases in initiation and propagation of intergranular corrosion of an Al-Li-Cu-Mg alloy

Key words: aluminium-lithium alloy, intergranular corrosion, intermetallic phases, corrosion initiation and propagation

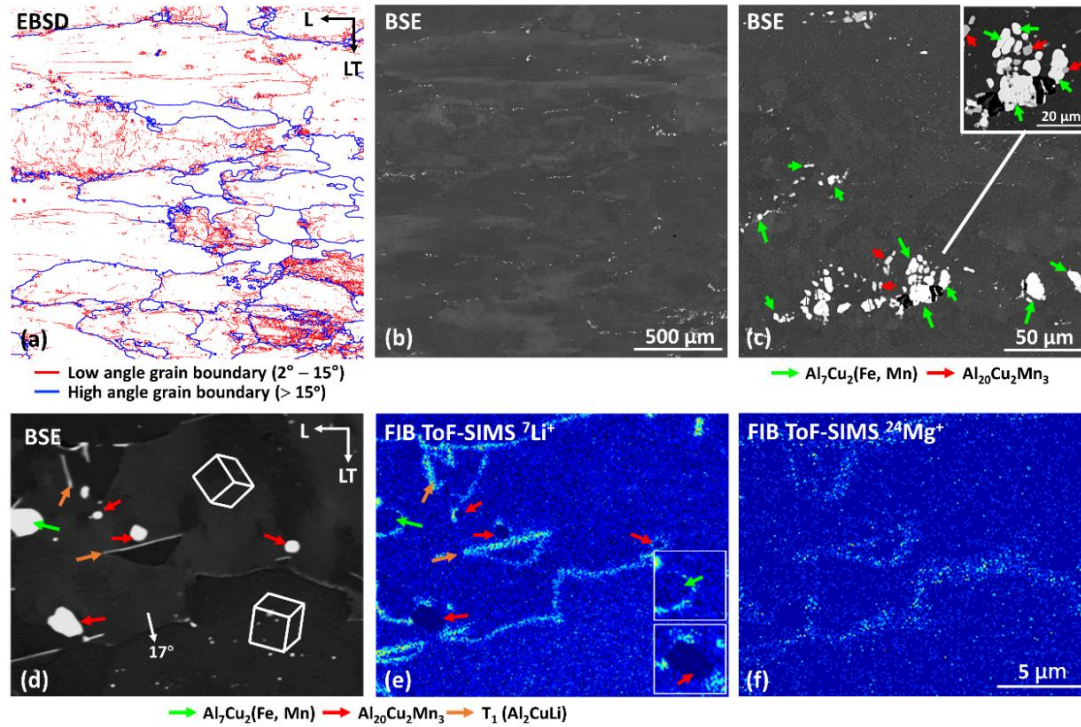
Figure 1 displays the EBSD grain boundary map and BSE micrographs providing an overview of microstructure together with a BSE micrograph and the correlative FIB

Figure 1a shows that the initial microstructure prior to corrosion immersion testing is predominantly composed of pancake-shaped unrecrystallised grains in combination with a small fraction of recrystallised grains (i.e. area fraction $\sim 10\%$) without internal substructure. Figure 1b further reveals the coarse constituent intermetallic phases that are preferentially distributed on high angle grain boundaries. BSE imaging at a higher magnification reveals the particles showing different contrast differentials, Figure 1c. The comparison as illustrated in Table 2 further shows a good agreement for the contents of Al, Cu and Mn between the experimentally measured composition and the compositions of equilibrium phases predicted using thermodynamic calculation. This confirms that the intermetallic particles with a shiny bright appearance in Figure 1c are the $\text{Al}_7\text{Cu}_2(\text{Fe}, \text{Mn})$ phases, whilst the ones appear in grey are the $\text{Al}_{20}\text{Cu}_2\text{Mn}_3$ phases. Zn and Mg were also detected in the constituent intermetallic particles at a trace level with no significant difference between the $\text{Al}_7\text{Cu}_2(\text{Fe}, \text{Mn})$ and $\text{Al}_{20}\text{Cu}_2\text{Mn}_3$ phases.

BSE imaging and the correlative high-spatial-resolution FIB ToF-SIMS analysis further reveal the Li-rich needle-shaped T_1 phase particles, Figures 1d and 1e. These quench-induced T_1 precipitates that are $\sim 5 \mu\text{m}$ in length were formed during solid solution treatment as revealed in a previous study conducted on the same material [36]. The $\text{Al}_7\text{Cu}_2(\text{Fe}, \text{Mn})$ particle also have a similar signal intensity of $^7\text{Li}^+$ as compared to the surrounding matrix, whilst the $^7\text{Li}^+$ signal from the $\text{Al}_{20}\text{Cu}_2\text{Mn}_3$ particles is considerably lower. In addition, the $^{24}\text{Mg}^+$ signal was detected from the $\text{Al}_7\text{Cu}_2(\text{Fe}, \text{Mn})$ particle, whilst no $^{24}\text{Mg}^+$ signal was obtained from the $\text{Al}_{20}\text{Cu}_2\text{Mn}_3$ particles. The FIB ToF-SIMS maps further reveal the segregation of Li and Mg on grain boundaries and the surface of intermetallic particles, Figures 1e and 1f. As previously reported, this is due to the presence of continuous trace of T_1 precipitates that were formed during artificial ageing [30]. Detailed TEM examinations further reveal the PFZs close to the quench-induced T_1 precipitates are $\sim 100 \text{ nm}$ in width, whilst the PFZs adjacent to the ageing-induced intergranular T_1 precipitates are $\sim 30 \text{ nm}$ in width, Figure S2. The δ'/θ' precipitates measuring $5 - 30 \text{ nm}$, the needle-shaped

Figure 1. (a) EBSD grain boundary map and (b) the correlative BSE micrograph providing an overview of the initial microstructure prior to corrosion immersion testing. Low angle and high angle grain boundaries are indicated in red and blue, respectively. (c) A BSE micrograph at a higher magnification showing details of constituent intermetallic phases. The $Al_7Cu_2(Fe, Mn)$ and $Al_{20}Cu_2Mn_3$ phases were identified using EDX as indicated by green and red arrows, respectively. (d) A BSE micrograph and (e, f) the correlative FIB ToF-SIMS chemical maps showing the distribution of $^7Li^+$ and $^{24}Mg^+$. The $Al_7Cu_2(Fe, Mn)$, $Al_{20}Cu_2Mn_3$ and quench-induced $T_1 (Al_2CuLi)$ phases were identified based on particle morphology and EDX as indicated by green, red and orange arrows, respectively. The insets and arrow in (d) indicate grain orientation and grain boundary misorientation as measured by EBSD.

The strong intensity of $^7\text{Li}^+$ signal from the particle-matrix interface (i.e. as shown in Figure 1) was provided by the Li-rich T_1 precipitates as previously indicated in [30] and Figure S9. These precipitates abundant in Li are electrochemically active and susceptible to anodic dissolution due to galvanic interaction with the surrounding matrix [13,53,54]. The dissolution of T_1 phases usually leads to the remnant of Cu-rich nanoparticles as previously reported in [54]. In the present case, remnants from the dissolved T_1 precipitates were not observed at the particle-matrix interface of $\text{Al}_7\text{Cu}_2(\text{Fe}, \text{Mn})$ phases in the initiation site of intergranular corrosion. This may be

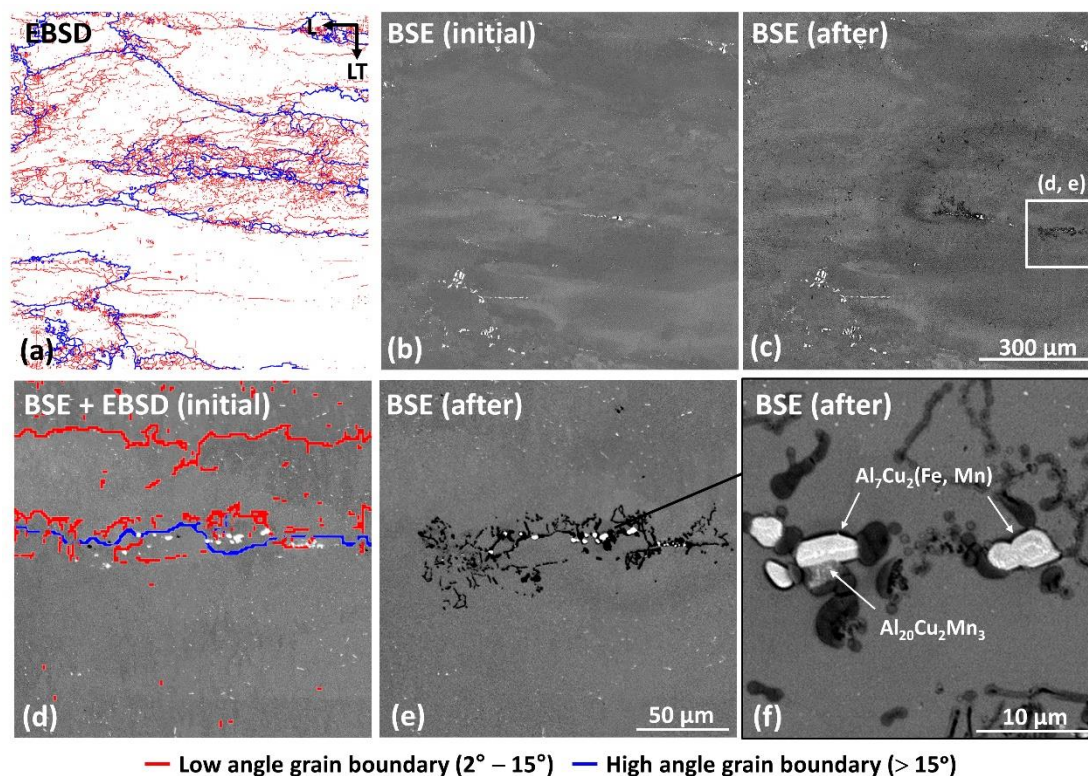
Figure 2 shows the correlative BSE micrographs and EBSD maps comparing the surface of specimen prior to and after 7 minutes of immersion with the BSE micrographs showing details of intermetallic particles.

Figure 2. (a) EBSD grain boundary map and (b, c) the correlative BSE micrographs comparing the surface of specimen prior to and after 7 minutes of immersion. (d) A BSE micrograph overlaid with EBSD grain boundary map detailing the surface prior to immersion and (e) the correlative BSE micrograph showing intergranular corrosion morphology. (f) A BSE micrograph showing details of the associated intermetallic particles as identified using EDX.

The comparison of sample surface as illustrated in Figures 2a – 2c shows the presence of intergranular corrosion associated with two clusters of intermetallic phases associated with a dense network of grain boundary in the early stage of corrosion immersion testing after 7 minutes of immersion. A ring of corrosion product with a diameter of $> 500 \mu\text{m}$ was also observed in the surrounding area. Figures 2d and 2e reveal a strong correlation of intergranular corrosion with the low angle and high angle grain boundaries associated with intermetallic phases. Figure 2f further reveals trenches measuring $100 - 200 \text{ nm}$ in width in the matrix adjacent to the $\text{Al}_7\text{Cu}_2(\text{Fe}, \text{Mn})$ particles. In addition, corrosion morphology was observed on the surfaces of

both $\text{Al}_7\text{Cu}_2(\text{Fe}, \text{Mn})$ and $\text{Al}_{20}\text{Cu}_2\text{Mn}_3$ phases.

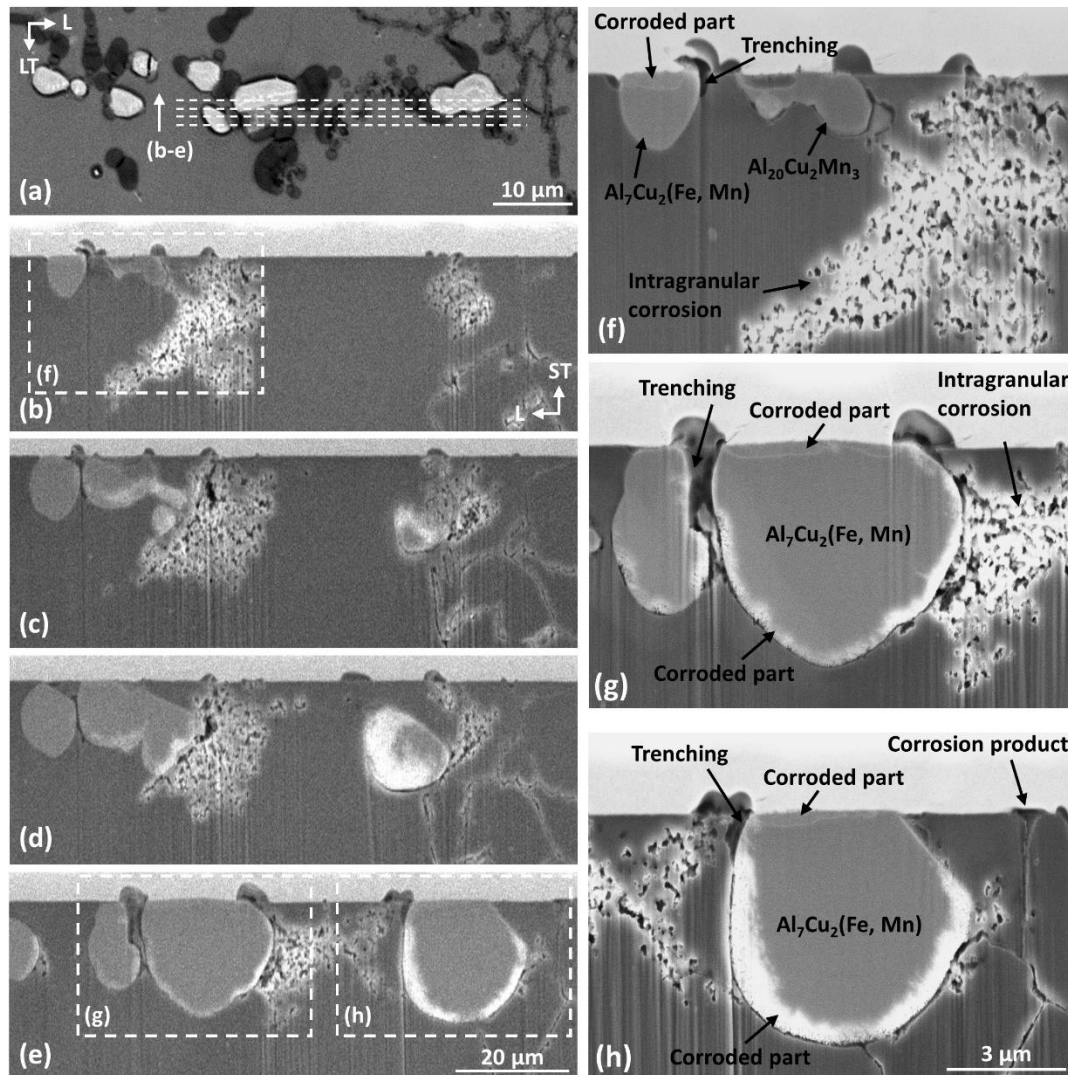
Figure 3 shows the SE micrographs collected from cross-section at the site of intergranular corrosion showing an overview of corrosion morphology and details of the associated intermetallic particles.

Figure 3. SE micrographs showing (a) surface and (b-e) cross-sections at the site of intergranular corrosion after 7 minutes of immersion. The cross-sections were fabricated using a FIB-SEM at the locations indicated by dash lines in (a). (f-h) SE micrographs showing details of the associated intermetallic particles from the locations as indicated in (c, e).

Figures 3a – 3e clearly reveal intergranular corrosion morphology and the associated intermetallic particles that were identified to be the $\text{Al}_7\text{Cu}_2(\text{Fe}, \text{Mn})$ and $\text{Al}_{20}\text{Cu}_2\text{Mn}_3$ phases using EDX. The subsurface attack of intergranular corrosion preferentially propagates in the L direction with a maximum depth of corrosion attack in the ST

direction at $\sim 20 \mu\text{m}$, Figure S3. Detailed SE micrographs from the intermetallic particles further confirm the presence of trenches in the matrix adjacent to the $\text{Al}_7\text{Cu}_2(\text{Fe}, \text{Mn})$ phases, whilst trenches were not observed adjacent to the $\text{Al}_{20}\text{Cu}_2\text{Mn}_3$ phases, Figures 3f – 3h. In addition, different characteristics of corrosion morphology were observed in the intermetallic phases at top surface and from $\sim 1 \mu\text{m}$ beneath the top surface along the interface with the surrounding matrix. The corroded areas are $< 200 \text{ nm}$ and $200 - 500 \text{ nm}$ in width at top surface and close to the subsurface particle-matrix interface, respectively. Corrosion products are also accumulated at top surface adjacent to the intermetallic particles or connected with grain boundaries. Intergranular corrosion attack leads to subsurface crevices at the particle-matrix interface and grain boundaries with a width of $\sim 50 \text{ nm}$. Crystallographic corrosion attack within the grain/sub-grain interiors was also observed adjacent to the intermetallic particles.

corrosion in the early stage of corrosion immersion testing. In addition, the clusters containing large particles of $\text{Al}_7\text{Cu}_2(\text{Fe}, \text{Mn})$ phase with a close interspacing distance facilitate a large cathode/anode area ratio that effectively supports the formation of trenches via anodic dissolution in the adjacent Al matrix [42], as observed in Figure 3.

The $\text{Al}_7\text{Cu}_2(\text{Fe}, \text{Mn})$ phases containing Mg, Si and Zn at a trace level were corroded at top surface and close to the subsurface particle-matrix interface, Figures 3 and 4. This indicates that the $\text{Al}_7\text{Cu}_2(\text{Fe}, \text{Mn})$ phases were electrochemically active and susceptible to corrosion attack in an alkaline environment established in the cathodic region. The corrosion of $\text{Al}_7\text{Cu}_2(\text{Fe}, \text{Mn})$ at top surface involves the dissolution of Al, Mg, Si and Mn with the formation of a top layer where Cu_2O and Cu coexist, Figures 4 and 5. The morphological characteristics and elemental distribution in the corroded region at top surface are similar to the de-alloyed intermetallic phases after immersion in an aerated NaCl electrolyte as previously reported in [27]. In this case, the de-alloying of $\text{Al}_7\text{Cu}_2(\text{Fe}, \text{Mn})$ phase takes place via selective dissolution of less noble elements as driven by galvanic interaction between the relatively noble Cu-rich remnant and the intact part of intermetallic [44]. The selective dissolution of Al, Mg, Si, Mn and Fe was previously reported for synthesized compounds or intermetallic phases in acidic and neutral electrolytes [29,43,45], whilst Cu and Zn are relatively stable during de-alloying [27,46]. The formation of Cu_2O in the top layer is mainly due to the oxidation of detached Cu debris released from the de-alloyed porous structure, while the oxidation of Cu to Cu_2O may also occur at top surface after intermetallic particle was completely isolated from the surrounding matrix [27]. The de-alloying of $\text{Al}_7\text{Cu}_2(\text{Fe}, \text{Mn})$ phase close to the subsurface particle-matrix interface leads to the Cu-rich remnant with a nanoporous structure similar to the existing observations from the de-alloyed intermetallic phases [29,47]. The de-alloyed structure formed in the subsurface region is relatively coarser than top surface. This is possibly due to an acidified electrolyte within the crevices along particle-matrix interface that impedes the repassivation of de-alloying process and, in turn, promotes porosity evolution [48].

to the front of trenches [49,50]. The acidified electrolyte effectively impedes repassivation and supports continuous corrosion attack along the particle-matrix interface and the associated grain boundary as observed in Figure 3. Crystallographic corrosion was also initiated from the interface of $\text{Al}_7\text{Cu}_2(\text{Fe}, \text{Mn})$ phases and propagated in the adjacent grains containing the highly active Li-rich phases including δ' and T_1 precipitates as previously reported in [51,52]. In addition, the cathodic reaction in the acidified electrolyte typically involves the formation of H_2 gas that creates a dynamic convection current within crevices [19,20]. This leads to the expulsion of corrosion products through the network of corroded grain boundaries and particle-matrix interface to the top surface of specimen [20], as observed in Figure 3. The formation of ring-like feature as observed in the periphery of initiation site (Figure 2c) is also related with a gel-like film of aluminium hydroxide filled with H_2 gas as previously proposed in [17,19].

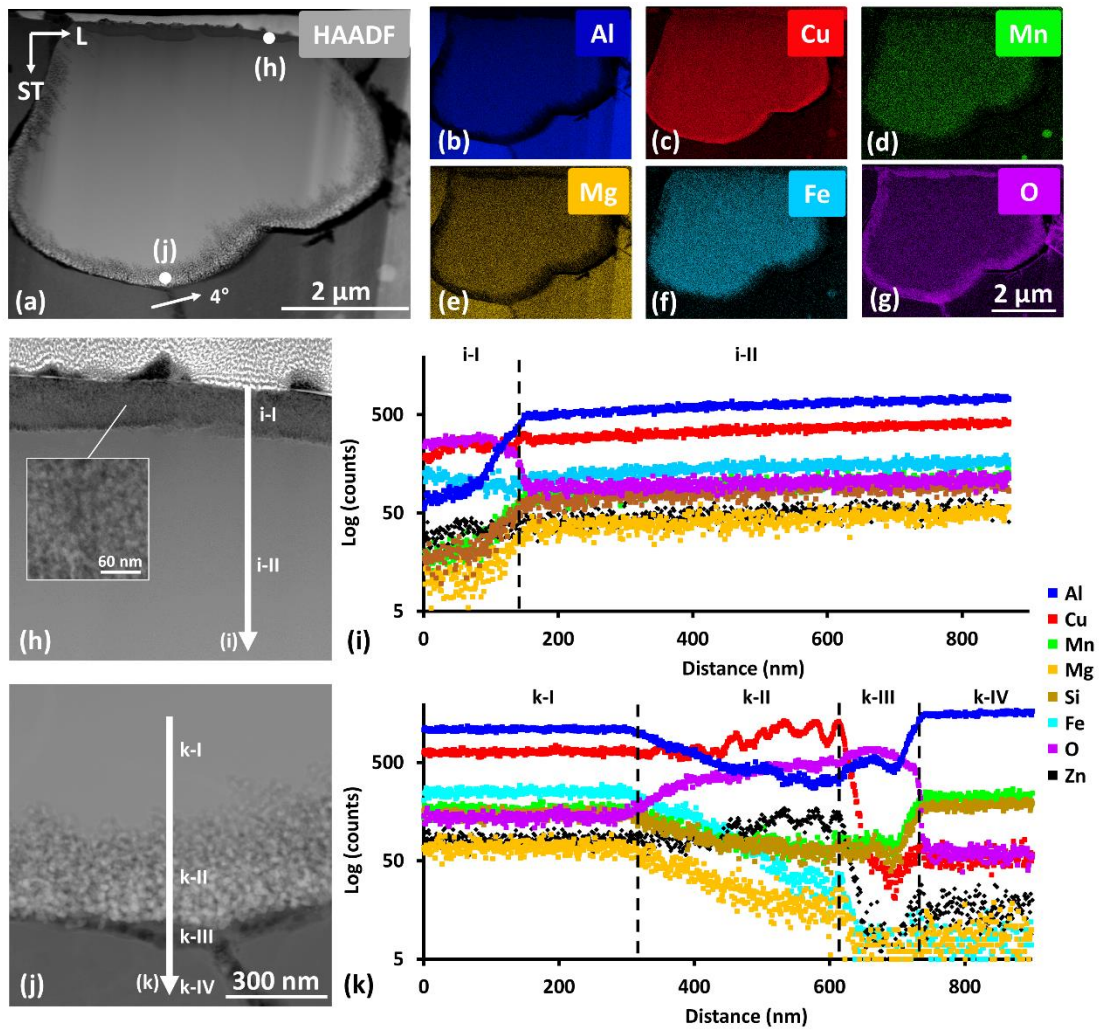
Detailed examinations were further conducted using TEM with a particular focus on the initiation site of intergranular corrosion. Figure 4 shows a HAADF-STEM and the correlative STEM-EDX maps from the intermetallic particle as presented in Figure 3h, with the STEM-EDX line-profiles detailing the chemical variations across top surface and the interface with the surrounding matrix.

Figures 4a – 4g clearly shows the selective depletion of Al, Mg and Mn in the corroded part of $\text{Al}_7\text{Cu}_2(\text{Fe}, \text{Mn})$ phase with relative abundance of O in the same regions. Figures 4h and 4j further reveal nano-porous structure close to top surface and the subsurface particle-matrix interface of intermetallic particle. The porous structure is relatively coarser close to the subsurface particle-matrix interface. The STEM-EDX line profile across top surface shows that the contents of Al, Mg, Si and Mn are considerably lower in the de-alloyed region (i.e. Region i-I) than the intact part of intermetallic particle (i.e. Region i-II), while the contents of Cu, Fe and Zn are slightly decreased in the de-alloyed part, Figure 4i. Figure 4k reveals that the contents of Al, Mg, Si, Fe and Mn are evidently lower towards the particle-matrix interface, whilst the relative enrichment of Cu and Zn was observed in the region $< 200 \text{ nm}$ away from the interface (i.e. Region k-II). In addition, a thin layer abundant in Al and O was observed with a thickness measuring $\sim 50 \text{ nm}$ in the matrix adjacent to the de-alloyed particle (i.e. Region k-III).

Figure 4. (a) A HAADF-STEM micrograph and (b-g) STEM-EDX maps providing an overview of an $\text{Al}_7\text{Cu}_2(\text{Fe}, \text{Mn})$ intermetallic particle at the initiation site of intergranular corrosion after 7 minutes of immersion. The number in (a) indicates the misorientation of grain boundary. (h, j) The HAADF-STEM micrographs at a higher magnification showing details of corrosion morphology at the locations as indicated in (a), with (i, k) STEM-EDX line profiles with a thickness of 50 pixels showing chemical variations across top surface and the particle-matrix interface. The inset in (h) shows the detail of corrosion morphology close to top surface.

The corrosion propagation along particle-matrix interface leads to the formation of a thin layer containing Al and O arising from the hydrolysis of dissolved Al ions, Figure 4. Due to a fast propagation rate along the particle-matrix interface, the $\text{Al}_7\text{Cu}_2(\text{Fe}, \text{Mn})$ phase was completely isolated from the surrounding matrix after 7 minutes of immersion. Once isolated, the $\text{Al}_7\text{Cu}_2(\text{Fe}, \text{Mn})$ phases at the initiation site stopped acting as the external cathodes that support propagation of intergranular corrosion down the surface. These particles then underwent self-dissolution including Cu at an increased corrosion potential towards a porous cluster containing Cu_2O [27]. Due to a lack of galvanic interaction between the isolated intermetallic phases and the surrounding matrix, corrosion products were not formed at top surface adjacent to the isolated particles, Figures 6.

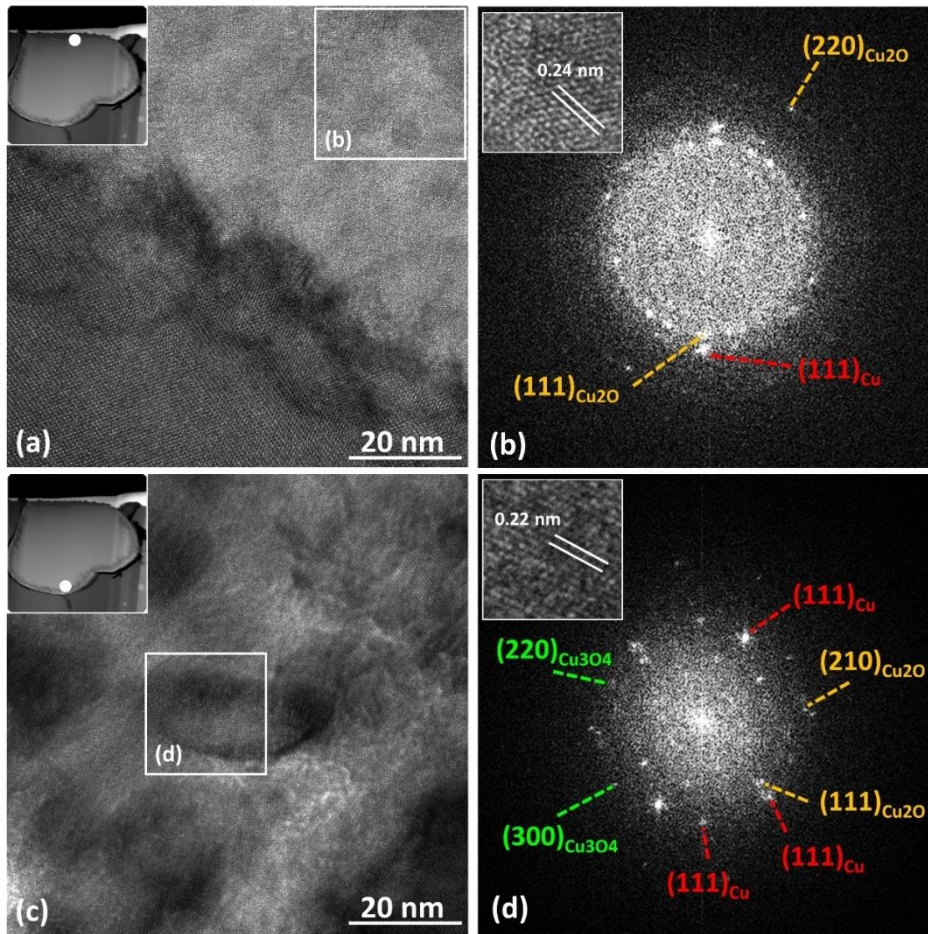
Figure 5 shows the HR-TEM micrographs collected from top surface and the subsurface particle-matrix interface from the $\text{Al}_7\text{Cu}_2(\text{Fe}, \text{Mn})$ particle. Figures 5a and 5b reveal a nanocrystalline structure containing Cu_2O and Cu in the corroded region close to top surface. The reflections corresponding to Cu, Cu_2O and Cu_3O_4 were identified from the corroded structure close to the subsurface interface, Figures 5c and 5d.

Figure 5. HR-TEM micrographs collected from (a) top surface and (c) the subsurface particle-matrix interface with (b, d) fast Fourier transformation (FFT) patterns from the boxed regions. The insets in (a) and (c) indicate the locations where the HR-TEM micrographs were collected. The insets in (b) and (d) show details in the targeted regions.

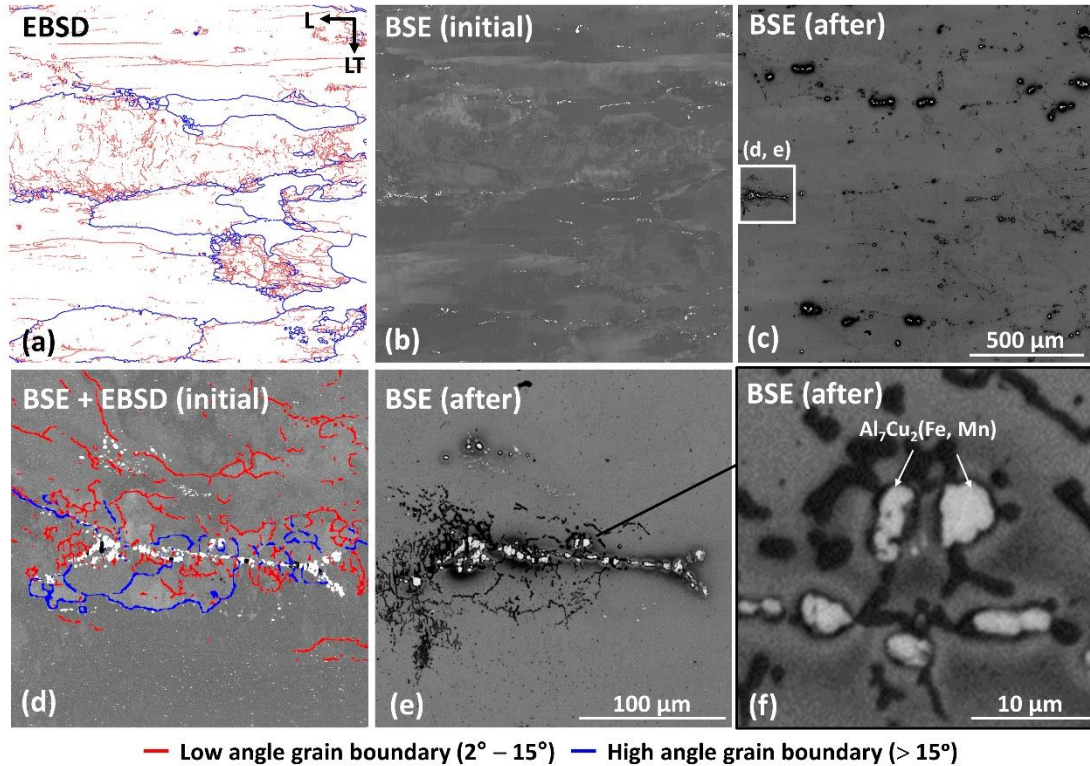
The correlative comparison as illustrated in Figures 6a – 6c reveals intergranular corrosion associated with a cluster of intermetallic phases after 30 minutes of immersion. The presence of corrosion products was also observed adjacent to the clusters of intermetallic phases that are not related with intergranular corrosion. Figures 6d and 6e further reveal intergranular corrosion attack through the network of low angle and high angle grain boundaries. The intermetallic particles associated with intergranular corrosion are predominantly the $Al_7Cu_2(Fe, Mn)$ phases as identified

using EDX, Figure 6f. The accumulation of corrosion products adjacent to these intermetallic phases is not as evident as compared to the intermetallic particles that are not related with intergranular corrosion, Figure S4.

Figure 6. (a) EBSD grain boundary map and (b, c) the correlative BSE micrographs comparing the surface of specimen prior to and after 30 minutes of immersion. (d) A BSE micrograph overlaid with EBSD grain boundary map detailing the surface prior to immersion and (e) the correlative BSE micrograph showing intergranular corrosion morphology. (f) A BSE micrograph showing details of the associated intermetallic particles as identified using EDX.

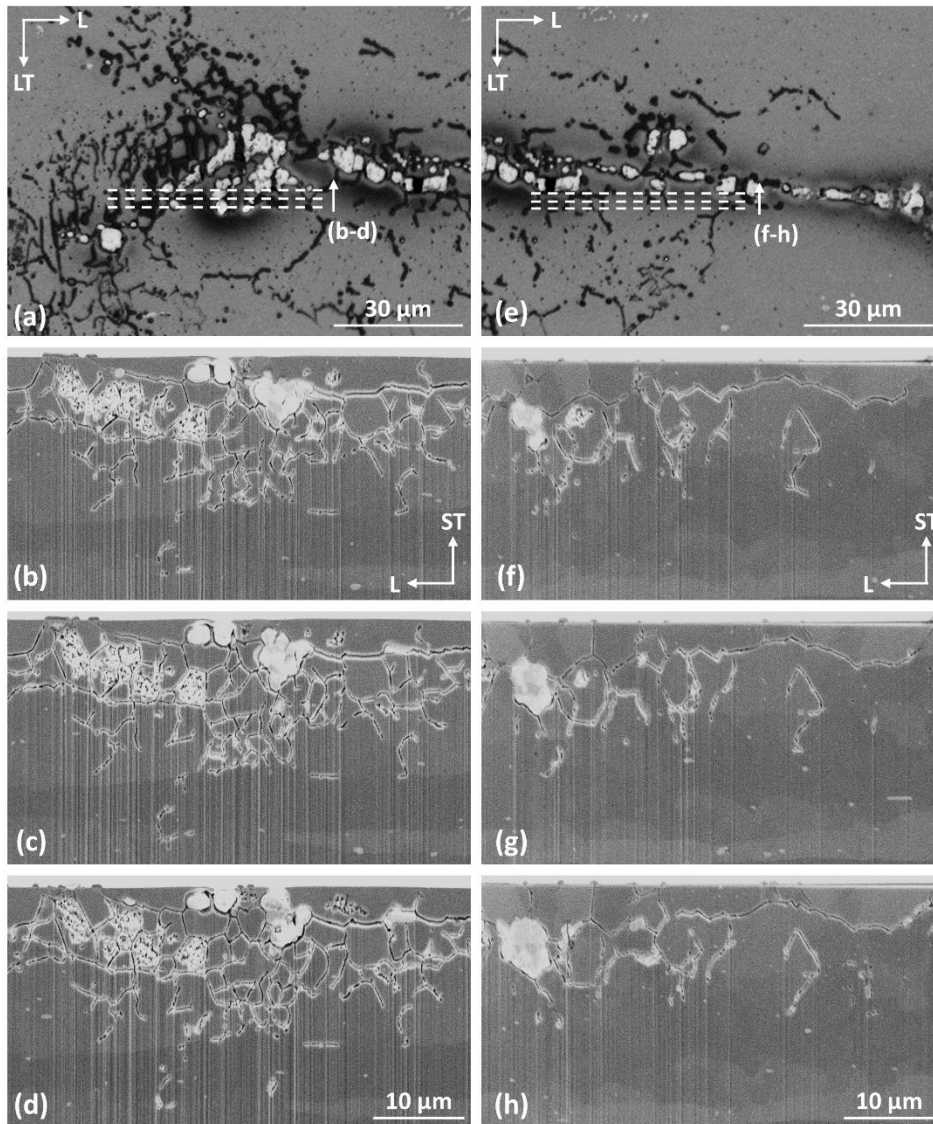
Figure 7 shows the SE micrographs collected from the cross-section of intergranular corrosion after 30 minutes of immersion. Figures 7a – 7d reveal corrosion morphology predominantly with intergranular corrosion and crystallographic corrosion within the grain interiors. The maximum depth of corrosion attack after 30 minutes of immersion is $\sim 20 \mu\text{m}$ in the ST direction, Figure S5. The intermetallic particles associated with intergranular corrosion are isolated from the adjacent matrix due to corrosion attack along the particle-matrix interface. These phases are clusters of the $\text{Al}_7\text{Cu}_2(\text{Fe}, \text{Mn})$ and $\text{Al}_{20}\text{Cu}_2\text{Mn}_3$ phases as identified using EDX. Figure 7e – 7h further reveal the intermetallic phases associated with intergranular corrosion in the subsurface region. The corrosion attack preferentially propagates through the

particle-matrix interface, then follow along the network of the associated grain boundaries.

Figure 7. SE micrographs showing (a, e) surface and (b-d, f-h) cross-sections at the site of intergranular corrosion after 30 minutes of immersion. The cross-sections were fabricated using a FIB-SEM at the locations indicated by dash lines in (a) and (e).

The propagation of intergranular corrosion away from the initiation site follows the network of grain boundary and the interface of intermetallic phases in the subsurface region, Figure 7. De-alloying of the Al₇Cu₂(Fe, Mn) phases associated with corrosion attack leads to the dissolution of Li, Mg, Al, Fe and Mn, resulting in a porous remnant containing Cu and Cu-oxides, Figures 8 – 10. De-alloying of intermetallic phases contributes to the propagation of intergranular corrosion by enhancing the acidity within the local crevice environment via the hydrolysis of dissolved metal ions. Corrosion morphology corresponding to de-alloying was not observed for the Al₂₀Cu₂Mn₃ phases associated with intergranular corrosion. However, the self-dissolution of a Al₂₀Cu₂Mn₃ particle being isolated from the surrounding matrix was observed after 30 minutes of immersion, Figure 9. Importantly, the examination of a Al₇Cu₂(Fe, Mn) phase at corrosion front has highlighted the particle-matrix interface as the preferred path for corrosion propagation ahead of the de-alloyed region, Figure 12. This indicates that corrosion propagation was facilitated by the anodic dissolution of Al matrix adjacent to the cathodic intermetallic phases with an effect of galvanic coupling. The noble particles of intermetallic phase also act as the internal cathodes that support corrosion propagation along the associated grain boundaries.

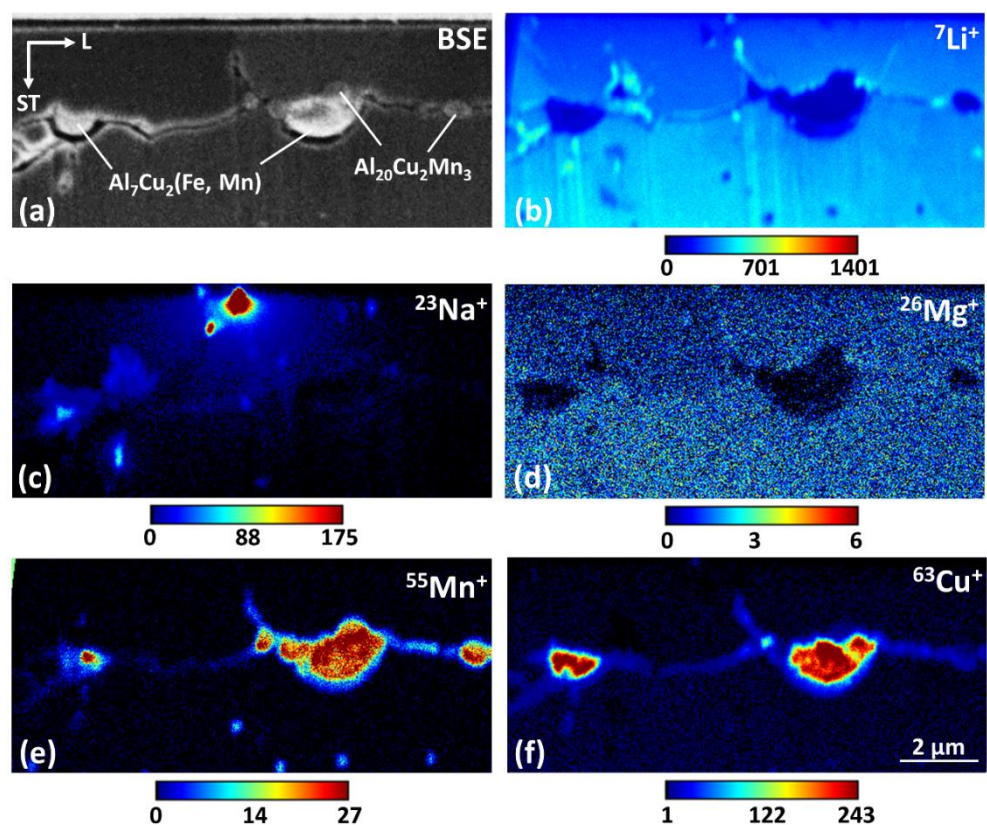
Detailed examinations were further performed in the subsurface propagation area of intergranular corrosion using NanoSIMS and TEM on a lamella extracted using a FIB-SEM, Figure S6. Figure 8 first shows the NanoSIMS chemical maps and the correlative BSE micrographs obtained from the cross-section of intergranular corrosion after 30 minutes of immersion. The chemical maps clearly reveal the depletion of Li and Mg in the intermetallic phases associated with intergranular

corrosion, whilst these particles are relative abundant in Mn and Cu. The ‘spots’ showing strong intensity of ${}^7\text{Li}^+$ signal was also observed within or adjacent to the crevice of intergranular corrosion along the corroded grain boundary, Figure 8b. These ‘spots’ are related with the locations showing a strong intensity of ${}^{23}\text{Na}^+$ signal, Figure 8c. In addition, strong intensities of ${}^{55}\text{Mn}^+$ and ${}^{63}\text{Cu}^+$ were collected along the grain boundary, Figures 8e and 8f.

Figure 8. (a) A BSE micrograph and the correlative NanoSIMS chemical maps showing the distribution of (b) ${}^7\text{Li}^+$, (c) ${}^{23}\text{Na}^+$, (d) ${}^{26}\text{Mg}^+$, (e) ${}^{55}\text{Mn}^+$ and (f) ${}^{63}\text{Cu}^+$. The intermetallic phases as indicated in (a) were identified using EDX. The location where the NanoSIMS analysis was performed is indicated in Figure S6.

The redistribution of dissolved Li has been observed within the crevices where Na was detected after corrosion immersion testing, Figure 8. The co-existence of Li and Na in corrosion products suggests that Li was effectively dissolved in the acidified electrolyte containing Na⁺, as previously reported in [43,53]. It is considered that the dynamic convection currents created by H₂ gas flow leads to the redeposition of dissolved Li ion at the locations with favourable geometric characteristics. This further leads to the remnants where Na and Li coexist as the specimen was dried after corrosion immersion testing. In addition, the redeposition of Mn within crevices as shown in Figure 8 has been related with the dissolution of Al₂₀Cu₂Mn₃ and Al₇Cu₂(Fe, Mn) phases. This is supported by the observation of Mn enrichment on the internal surface of crevice close to the dissolved particles of intermetallic phases,

Figure 9. The Cu-rich nanolayer along crevices as shown in Figures 8 and 10 is consistent with observations from an existing study conducted on AA6005 alloy [55]. The Cu-rich nanolayer was formed by the selective dissolution of Al along the corroded grain boundary via a de-alloying mechanism, which, in turn, acted as the internal cathode that supports continuous propagation of intergranular corrosion through the network of grain boundary [55].

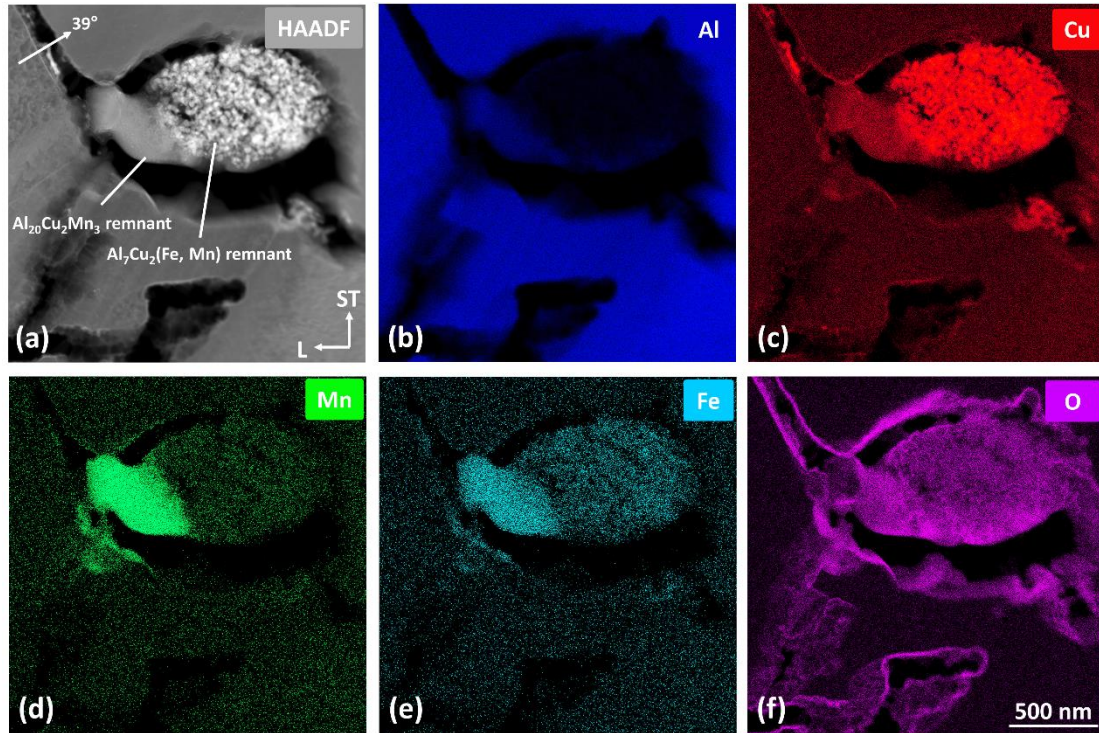
Figure 9 displays a HAADF-STEM micrograph and the correlative STEM-EDX chemical maps showing details of intergranular corrosion and the associated intermetallic phases in the region as indicated in Figure S6. Table 3 further shows the chemical composition for the remnants of intermetallic phases based on quantitative EDX analysis.

Figure 9. (a) A HAADF-STEM micrograph and (b-f) the correlative STEM-EDX chemical maps showing details of the remnants of $\text{Al}_7\text{Cu}_2(\text{Fe, Mn})$ and $\text{Al}_{20}\text{Cu}_2\text{Mn}_3$ phases in the subsurface propagation area of intergranular corrosion after 30 minutes of immersion. The number in (a) indicates the misorientation of grain boundary. The location where the analysis was performed is indicated in Figure S6.

In the same region, intergranular corrosion propagates along a high angle grain boundary (i.e. $\sim 39^\circ$ in misorientation) associated with the cluster of intermetallic phases, causing a crevice measuring ~ 120 nm in width, Figure 9a. Corrosion attack at the particle-matrix interface also leads to crevices measuring ~ 100 nm and ~ 270 nm in width as observed above and beneath the intermetallic particles, respectively. The

internal surface of crevice is enriched in Cu and O, while the enrichment of Fe and Mn was also observed within the crevice close to the $\text{Al}_{20}\text{Cu}_2\text{Mn}_3$ particle, Figures 9b – 9f. STEM-EDX line profile further reveals a thin layer abundant in Si and O at the internal surface of corroded grain boundary, whilst the Cu-rich layer is in the matrix adjacent to the crevice, Figure 10d. In addition, nanoscale particles of corroded remnants measuring < 200 nm in length were observed within the crevice of corroded grain boundary adjacent to the intermetallic phases, Figures 9a and 10a. STEM-EDX analysis reveals the enrichment of Cu and O for these remnants, Figures 9c and 9f.

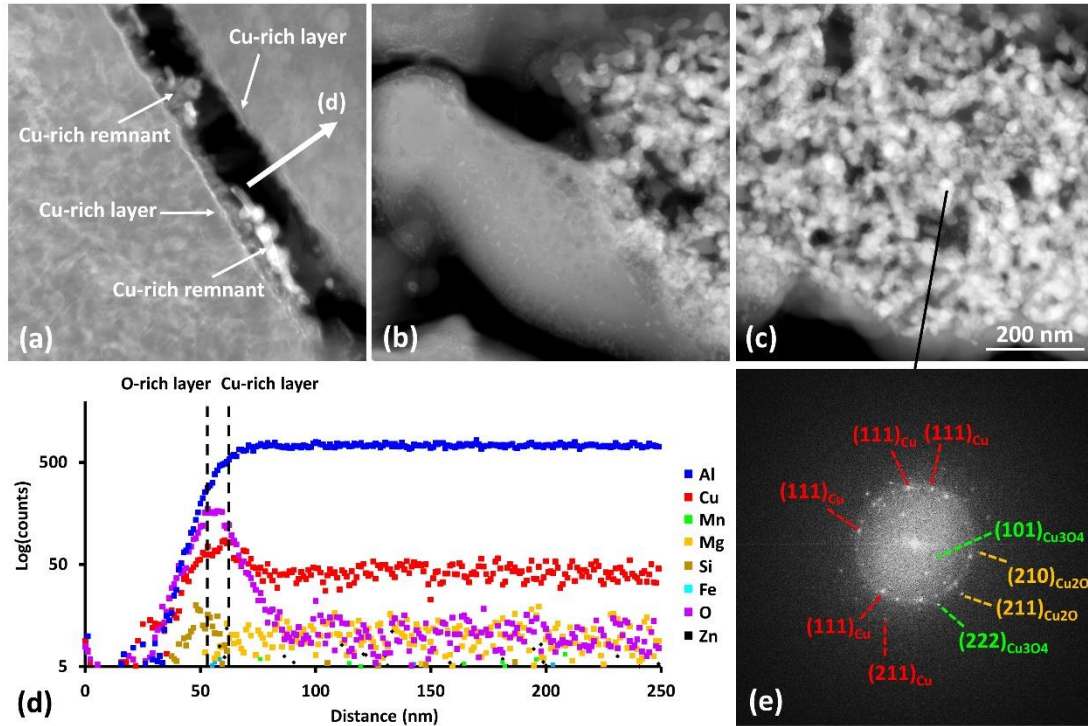
Figure 10 further shows the HAADF-STEM micrographs collected at a higher magnification showing details of corrosion morphology along corroded grain boundary and the associated intermetallic phases. A STEM-EDX line profile is provided to detail the chemical variation across the internal surface of corroded grain boundary. An FFT pattern is also provided to exhibit crystallography for the remnant of a $\text{Al}_7\text{Cu}_2(\text{Fe, Mn})$ particle.

Figure 10. HAADF-STEM micrographs showing details of (a) corroded grain boundary and the corroded remnants of (b) $Al_{20}Cu_2Mn_3$ and (c) $Al_7Cu_2(Fe, Mn)$ phases. (d) A STEM-EDX line profile with a line thickness of 50 pixels showing chemical variation across the internal surface of corroded grain boundary in (a). (e) An FFT pattern of a HR-TEM micrograph collected from the remnant of $Al_7Cu_2(Fe, Mn)$ phase as shown in (c).

HAADF-STEM imaging reveals the nanoporous structure for the remnant of a corroded $Al_7Cu_2(Fe, Mn)$ intermetallic phase with the adjacent $Al_{20}Cu_2Mn_3$ phase showing no porous structure, Figures 9a, 10b and 10c. The corrosion of $Al_7Cu_2(Fe, Mn)$ phase leads to a Cu, O-rich remnant with relative depletion of Al, Fe and Mn as revealed by STEM-EDX analysis, Figures 9b – 9f and Table 3. HR-TEM imaging further identifies the reflections corresponding to Cu, Cu_2O and Cu_3O_4 from the Cu, O-rich remnant, Figure 10e. Table 3 also shows that the remnant of $Al_{20}Cu_2Mn_3$ phase contains a higher content of O and lower contents of Al, Mn, Fe and Cu than the original composition as indicated in Table 2.

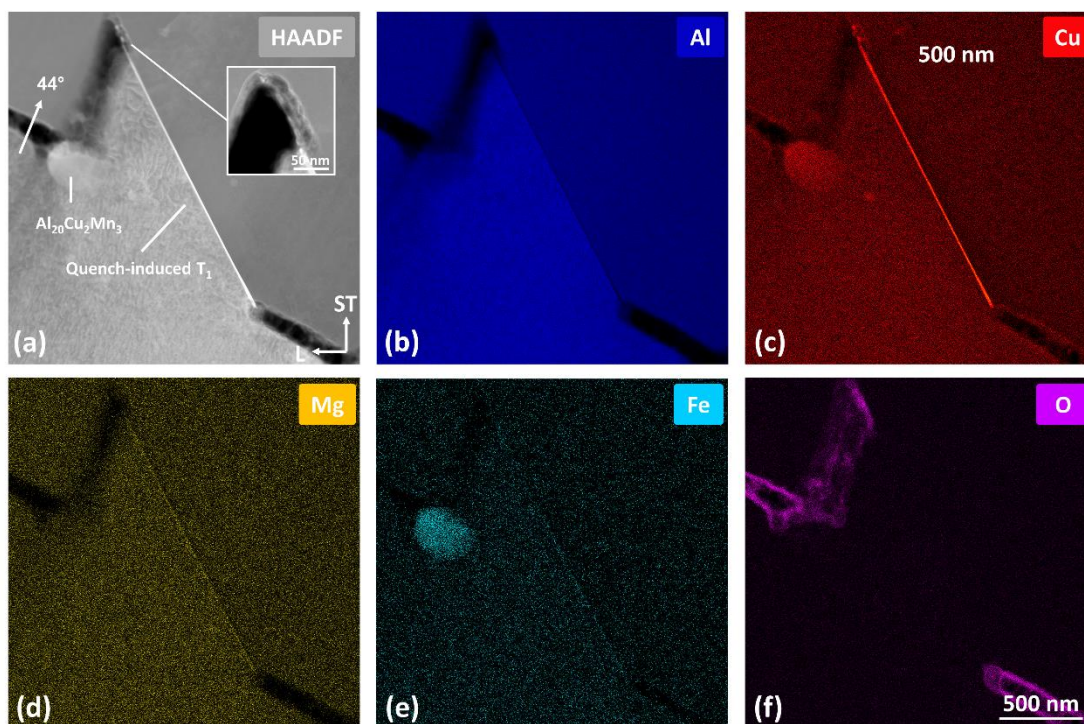
Figure 11 shows a HAADF-STEM micrograph and the correlative STEM-EDX chemical maps showing details of intergranular corrosion and the associated quench-induced T_1 precipitate in the region as indicated in Figure S6.

Figure 11. (a) A HAADF-STEM micrograph and (b-f) the correlative STEM-EDX chemical maps showing details of intergranular corrosion and the associated $\text{Al}_{20}\text{Cu}_2\text{Mn}_3$ and quench-induced T_1 phases after 30 minutes of immersion. The number in (a) indicates the misorientation of grain boundary. The inset in (a) reveals details from the corroded region of T_1 precipitate. The location where the analysis was performed is indicated in Figure S6.

In this region, intergranular corrosion propagates along a high angle grain boundary (i.e. $\sim 44^\circ$ in misorientation) and the particle-matrix interface of a $\text{Al}_{20}\text{Cu}_2\text{Mn}_3$ phase, Figure 11a. It also leads to the corrosion of a large quench-induced T_1 precipitate,

with the associated grain boundaries corroded at the both ends. STEM-EDX analysis further reveals the Cu, O-rich remnants in the corroded regions with the relative depletion of Al, Mg and Fe, Figures 11b – 11e. Corrosion morphology was also observed in the matrix adjacent to the Cu, O-rich remnants. In addition, the relatively smaller particles of intergranular T_1 precipitates (~ 200 nm in length) on the same grain boundary were completely corroded to Cu, O-rich remnants within the crevice of intergranular corrosion, Figure S7.

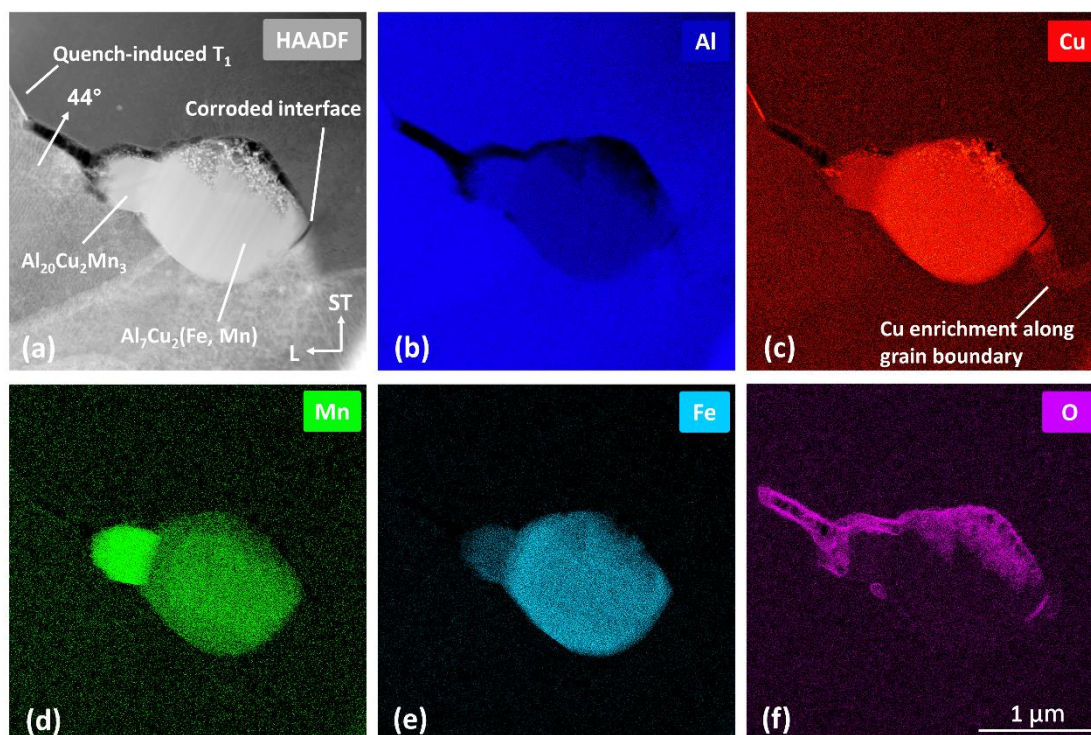
Figure 12 further displays a HAADF-STEM micrograph and the correlative STEM-EDX chemical maps showing details of intergranular corrosion and the associated intermetallic phases in the region as indicated in Figure S6.

Figure 12. (a) A HAADF-STEM micrograph and (b-f) the correlative STEM-EDX chemical maps showing details of the remnants of $Al_7Cu_2(Fe, Mn)$ and $Al_{20}Cu_2Mn_3$ phases in the subsurface propagation area of intergranular corrosion after 30 minutes of immersion. The number in (a) indicates the misorientation of grain boundary. The location where the analysis was performed is indicated in Figure S6.

In this region, the $Al_7Cu_2(Fe, Mn)$ phase has the nanoporous morphology close to the corroded particle-matrix interface, whilst the $Al_{20}Cu_2Mn_3$ phase is not significantly changed. The corrosion of $Al_7Cu_2(Fe, Mn)$ phase leads to the selective depletion of Al, Fe and Mn with the enrichment of Cu, Figures 12b – 12e. In particular, the

decohesion of interface arising from corrosion attack was observed at the front end of corrosion crevice where the corrosion morphology of $\text{Al}_7\text{Cu}_2(\text{Fe}, \text{Mn})$ phase is not present. The enrichment of Cu within the regions ~ 170 nm in width was also observed along the associated grain boundary ahead of the corroded particle-matrix interface, Figure 12c. HR-TEM imaging further reveals the structural change to the lattice of $\text{Al}_7\text{Cu}_2(\text{Fe}, \text{Mn})$ phase along the $\langle 011 \rangle$ crystal direction and the corresponding reflections to Cu in the adjacent Al matrix close to the corroded particle-matrix interface, Figure S8.

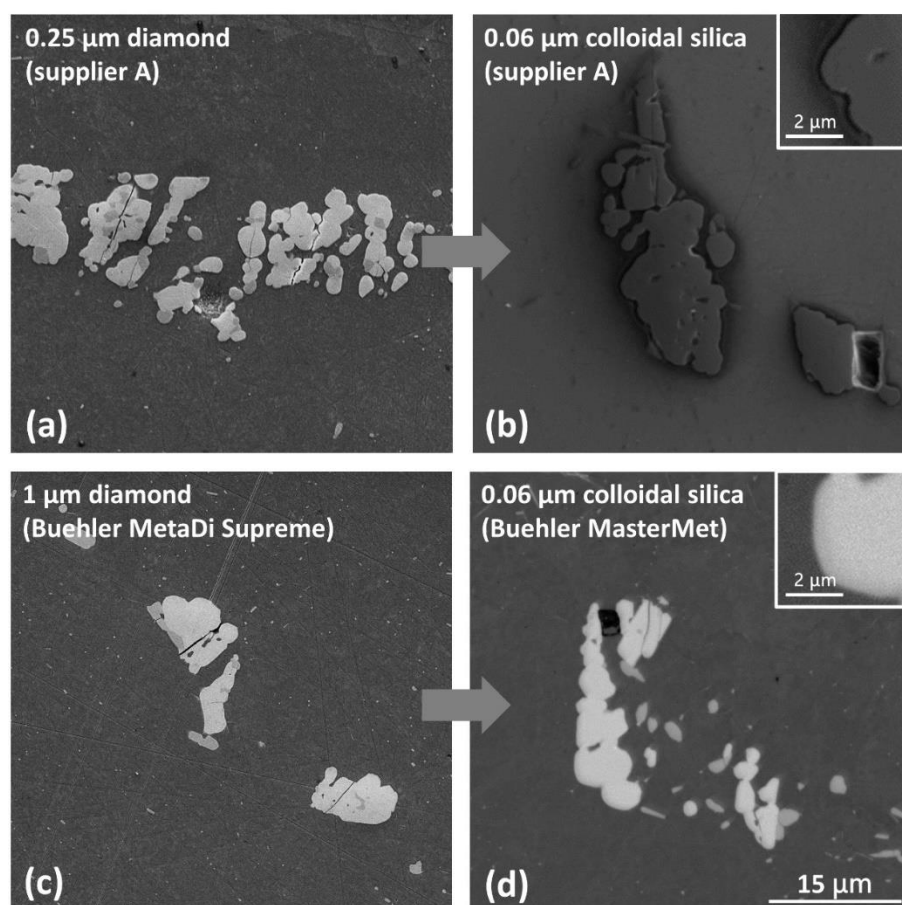
Figure S1. BSE micrographs collected at 5 kV showing the surface of specimen after polishing with (a) 0.25 μm diamond suspension then (b) 0.06 μm colloidal silica suspension provided by Supplier A. Corrosion attack on intermetallic particles with trenching in the surrounding matrix were clearly observed. The same specimen was then grinded and prepared using (c) Buehler MetaDi Supreme 1 μm polycrystalline diamond suspension followed by (d) a solution of 1:1.5 Buehler Mastermet 0.06 μm colloidal silica suspension to deionised water. The corrosion attack to intermetallic particles was prevented. The insets in (b) and (d) further detail the surface topography at the interface of intermetallic particles with the surrounding matrix.

Figure S1. After polishing, the specimens were first analysed using correlative electron and ion microscopy to investigate the initial microstructure prior to corrosion immersion testing. The specimens were then gently polished in the solution of colloidal silica suspension for ~ 10 s to remove the hydrocarbon contamination deposited in the regions that were analysed using electron and ion microscopy. Further, the specimens were cleaned ultrasonically in an ethanol bath for 20 minutes and dried in a cool air stream prior to immersion testing. Corrosion immersion testing was conducted at room temperature in an aerated solution of 3.5 wt. % NaCl in deionised water. Specimens were immersed for 7 and 30 minutes, followed by thoroughly rinsed in deionised water and dried in a cool air stream for post-mortem examinations of corrosion morphology.

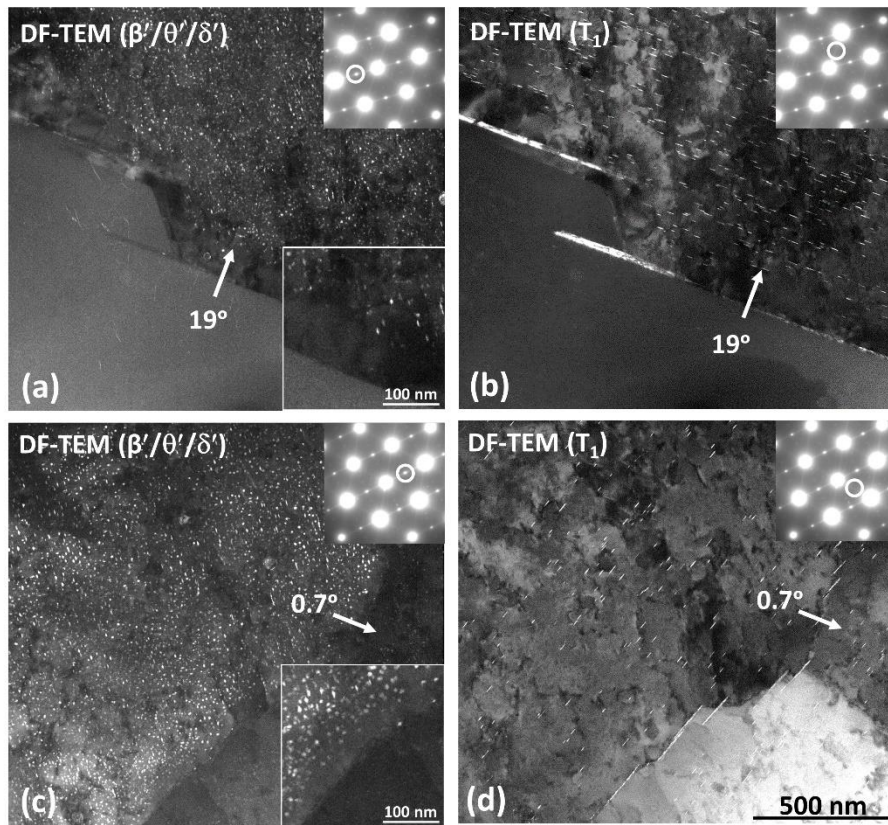
Figure S2. DF-TEM micrographs collected with the superlattice reflections of (a, c) the $\delta'/\theta'/\beta'$ precipitates and (b, d) the edge-on T_1 precipitates. The insets show the reflections selected for DF-TEM imaging and details of precipitates in a magnified view. The arrows indicate the misorientation of grain boundary.

intragranular T_1 precipitates < 30 nm in length and the circular β' dispersoids < 50 nm in diameter were also observed using DF-TEM imaging with the corresponding reflections, Figure S2.

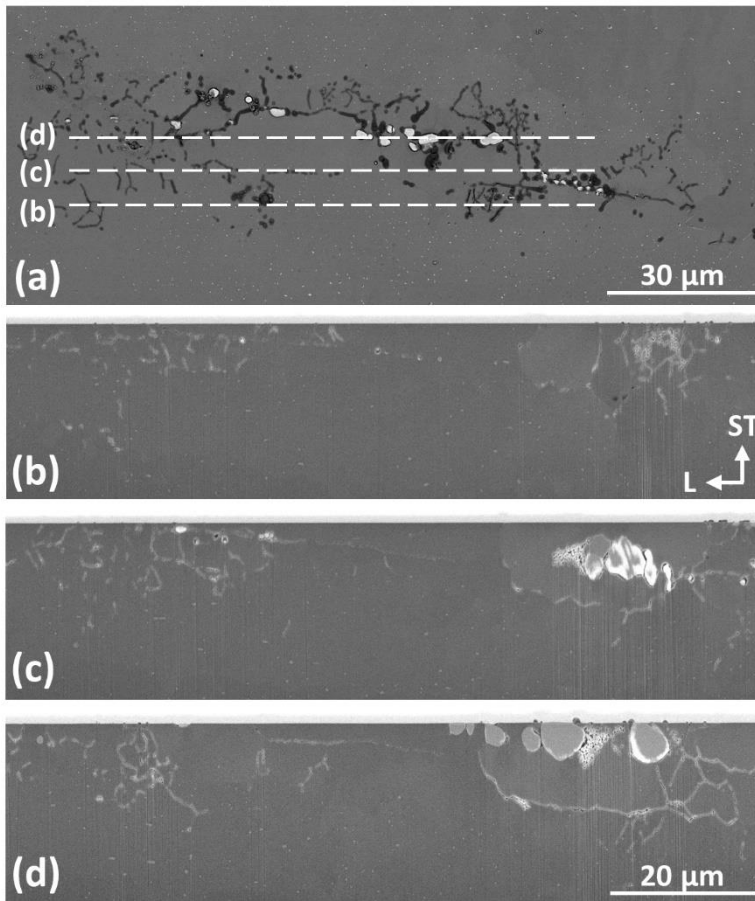
Figure S3. SE micrographs providing an overview of (a) surface and (b-d) cross-sections at the site of intergranular corrosion after 7 minutes of immersion. The cross-sections were fabricated using a FIB-SEM at the locations indicated by dash lines in (a).
