Role of intermetallic phases in initiation and propagation of intergranular corrosion of an Al-Li-Cu-Mg alloy

Key words: aluminium-lithium alloy, intergranular corrosion, intermetallic phases, corrosion initiation and propagation

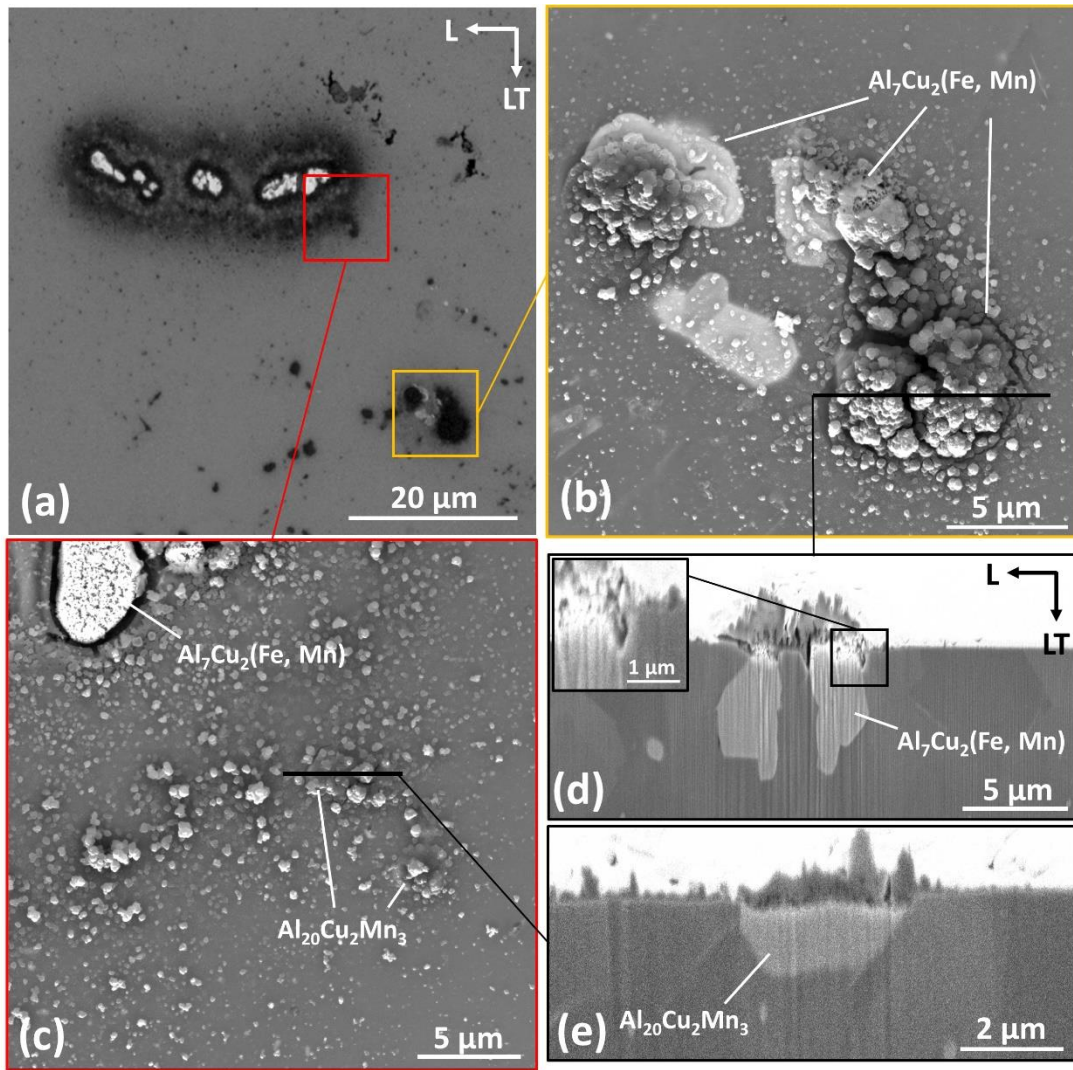
Figure S4. (a – c) BSE micrographs showing the intermetallic phases that are not related with intergranular corrosion after 30 minutes of immersion. (d, e) SE micrographs showing details of the targeted $\text{Al}_7\text{Cu}_2(\text{Fe, Mn})$ and $\text{Al}_{20}\text{Cu}_2\text{Mn}_3$ particles from cross-sections.

using EDX, Figure 6f. The accumulation of corrosion products adjacent to these intermetallic phases is not as evident as compared to the intermetallic particles that are not related with intergranular corrosion, Figure S4.

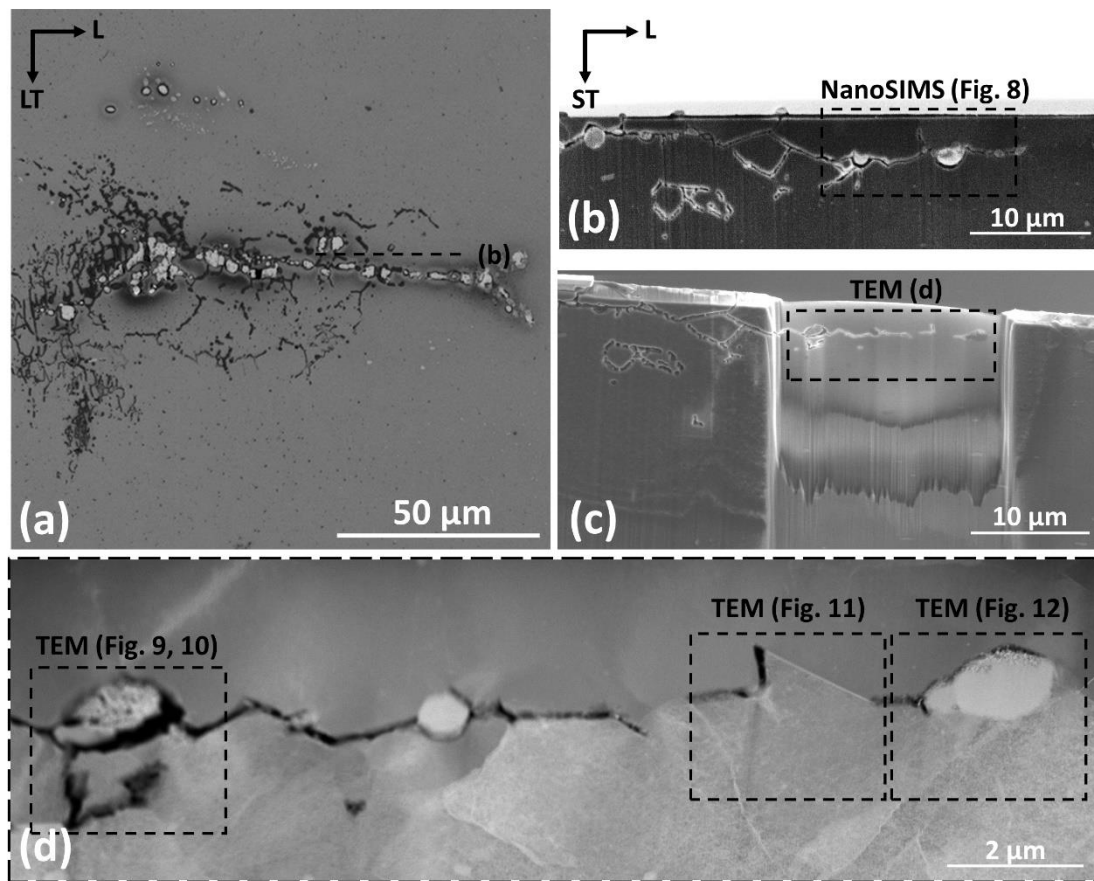
Figure S6. BSE micrograph showing (a) top-view and (b, c) cross-section of intergranular corrosion after 30 minutes of immersion. NanoSIMS and TEM analyses were conducted in the boxed areas in (b) and (c). (d) A HAADF-STEM micrograph showing an overview of TEM specimen. The detailed examinations as illustrated in Figures 9 – 12 were conducted in the boxed areas in (d).

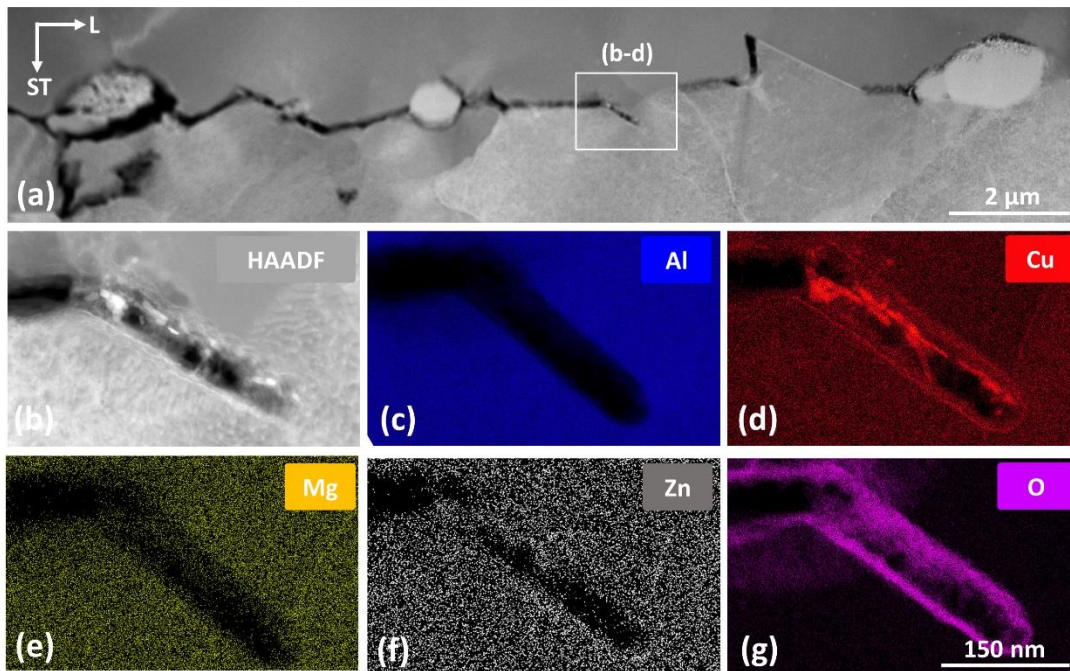
Figure S7. HAADF-STEM micrographs showing (a) an overview and (b) the details of a corroded intergranular T_1 precipitate after 30 minutes of immersion. (c, d) STEM-EDX maps showing the distribution of Cu and O in the same region.

with the associated grain boundaries corroded at the both ends. STEM-EDX analysis further reveals the Cu, O-rich remnants in the corroded regions with the relative depletion of Al, Mg and Fe, Figures 11b – 11e. Corrosion morphology was also observed in the matrix adjacent to the Cu, O-rich remnants. In addition, the relatively smaller particles of intergranular T_1 precipitates (~ 200 nm in length) on the same grain boundary were completely corroded to Cu, O-rich remnants within the crevice of intergranular corrosion, Figure S7.

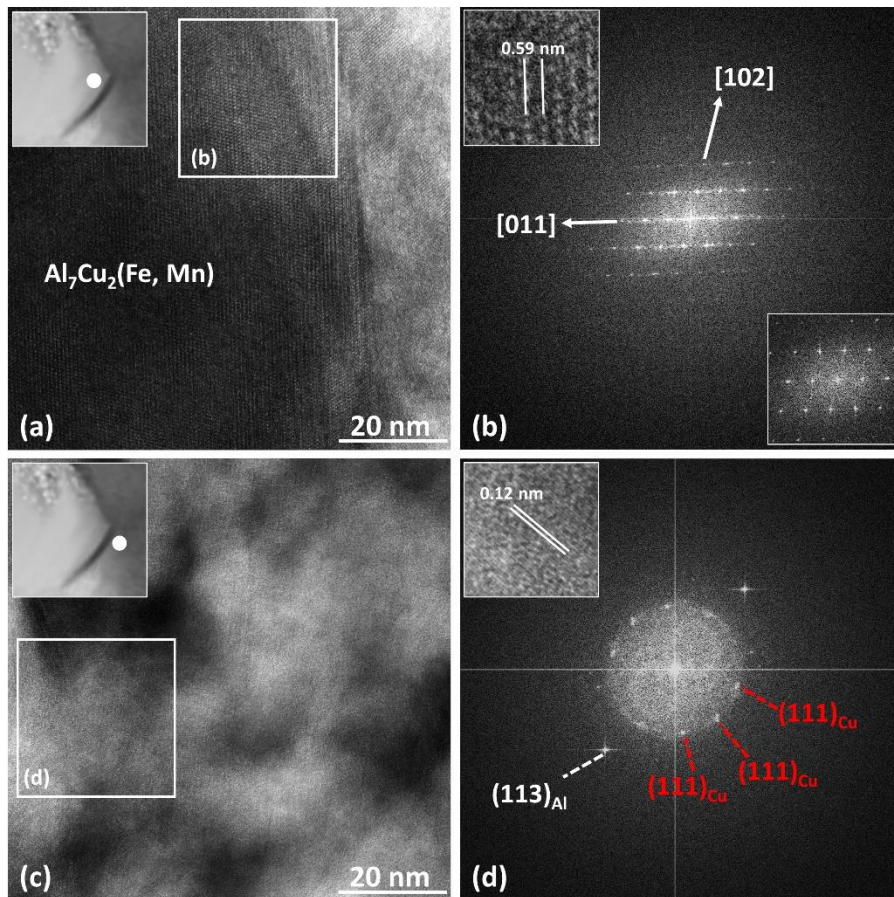
Figure S8. HR-TEM micrographs collected from (a) the $\text{Al}_7\text{Cu}_2(\text{Fe, Mn})$ phase and (c) the adjacent matrix close to the particle-matrix interface with (b, d) FFT patterns from the boxed regions. The insets in (a) and (c) indicate the locations where the HR-TEM micrographs were collected. The insets in (b) and (d) show details in the targeted regions and an FFT pattern from the intact part of $\text{Al}_7\text{Cu}_2(\text{Fe, Mn})$ phase.

decohesion of interface arising from corrosion attack was observed at the front end of corrosion crevice where the corrosion morphology of $\text{Al}_7\text{Cu}_2(\text{Fe}, \text{Mn})$ phase is not present. The enrichment of Cu within the regions ~ 170 nm in width was also observed along the associated grain boundary ahead of the corroded particle-matrix interface, Figure 12c. HR-TEM imaging further reveals the structural change to the lattice of $\text{Al}_7\text{Cu}_2(\text{Fe}, \text{Mn})$ phase along the $\langle 011 \rangle$ crystal direction and the corresponding reflections to Cu in the adjacent Al matrix close to the corroded particle-matrix interface, Figure S8.

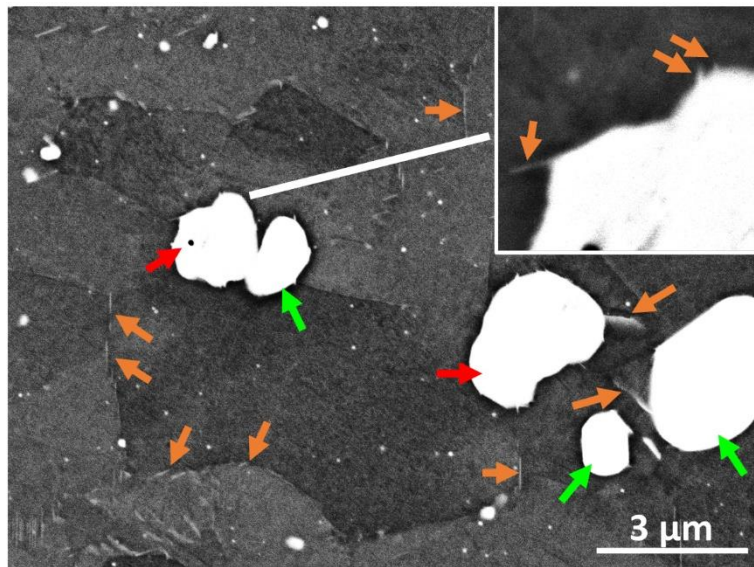
→ $\text{Al}_7\text{Cu}_2(\text{Fe}, \text{Mn})$ → $\text{Al}_{20}\text{Cu}_2\text{Mn}_3$ → $\text{T}_1 (\text{Al}_2\text{CuLi})$

Figure S9. A BSE micrograph showing T_1 precipitate formed close to the interface of $\text{Al}_7\text{Cu}_2(\text{Fe}, \text{Mn})$ and $\text{Al}_{20}\text{Cu}_2\text{Mn}_3$ phases with the surrounding matrix. The inset details the interfacial T_1 precipitates at a higher magnification.

The strong intensity of $^7\text{Li}^+$ signal from the particle-matrix interface (i.e. as shown in Figure 1) was provided by the Li-rich T_1 precipitates as previously indicated in [30] and Figure S9. These precipitates abundant in Li are electrochemically active and susceptible to anodic dissolution due to galvanic interaction with the surrounding matrix [13,53,54]. The dissolution of T_1 phases usually leads to the remnant of Cu-rich nanoparticles as previously reported in [54]. In the present case, remnants from the dissolved T_1 precipitates were not observed at the particle-matrix interface of $\text{Al}_7\text{Cu}_2(\text{Fe}, \text{Mn})$ phases in the initiation site of intergranular corrosion. This may be
