## Optical Tests of a 2.5-m diameter Liquid Mirror: Behavior under External Perturbations and Scattered Light Measurements

Luc Girard, and Ermanno F. Borra,  
 Centre d'Optique, Photonique et Laser,  
 Département de Physique, Université Laval, Québec, Qc, G1K 7P4  
 email : borra@phy.ulaval.ca, girard@phy.ulaval.ca

### Abstract

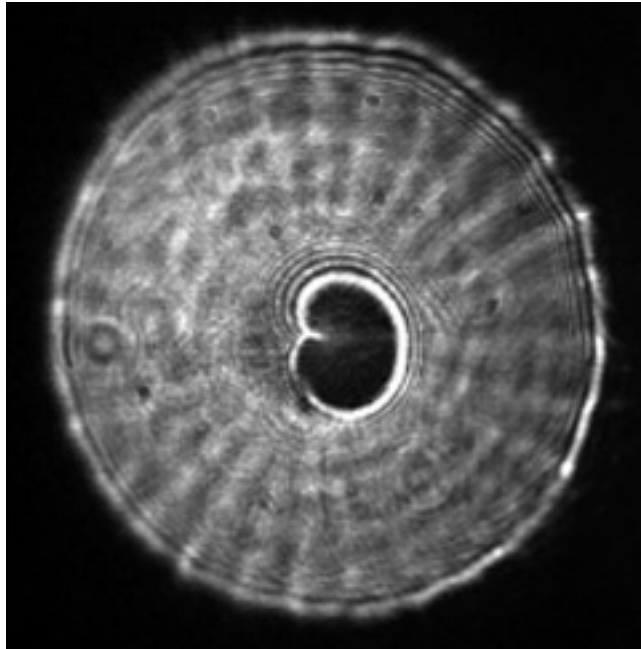
Figure 3

- FIGURE 3: Defocused PSF of the 2.5-m liquid mirror with a 1-arcsecond leveling error. The cardioid-like feature at the center can be used to adjust the axis of rotation of the mirror. One can also see radial defects caused by movement of the liquid over the container.

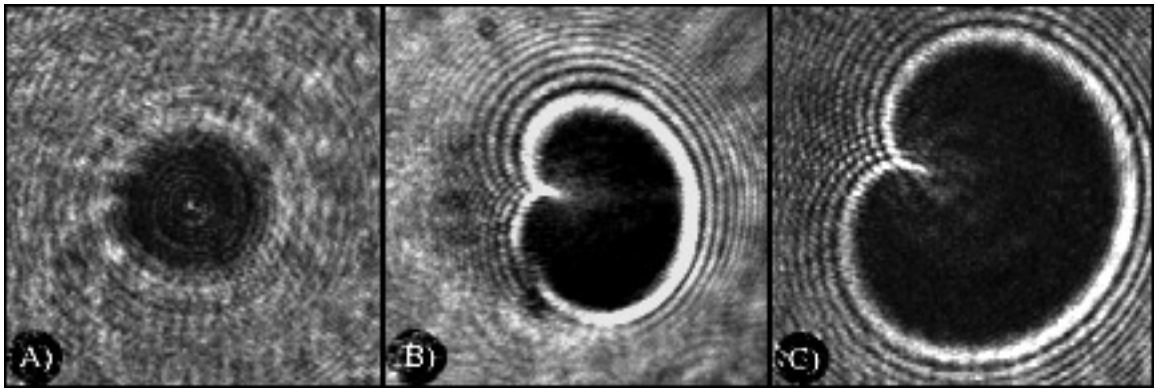
- FIGURE 13: Defocused PSFs of the central region of the mirror showing the cardioid-like defect for A) no leveling error, B) 1 arcsec leveling error, and C) 3 arcsecs leveling error.

Measuring leveling errors with a high quality level can certainly be done but, at least with a spirit level, it involves delicate measurements, easily disturbed by the environment. Furthermore, we find that a level made while the mirror is stopped changes by a few arcseconds after spinup and after the final mercury surface settles. This is presumably due to flexures induced by a nonuniform mercury distribution on the surface of the container. We also find that the level of the mirror changes after pump down<sup>2</sup>, probably due to flexure of the container and the mount induced by a nonuniform distribution of mercury. Obviously the level must be checked after the layer is closed. We have found a simple optical test that allows accurate leveling. The technique uses the grooves present on the surface of the container. The grooves, located at the center and at the edges of the mirror, are needed to allow a thin layer of mercury<sup>2</sup>. The center of the mirror has also a small metal hollow tube to pump down the mercury layer<sup>2</sup>. Because the mercury is deeper in the grooves, a leveling error introduces a local deformation that looks like coma. We found that this coma-like local defect is very sensitive to leveling errors and can be used to align the mirror. The defect is readily visible on out of focus images of the PSF. Figure 13 shows the defect at the center of the mirror that has contours looking like a cardioid curve. The figure shows the appearance of the cardioid for three leveling errors. The shape of the cardioid can be used to level the mirror with an accuracy of 0.1 arcseconds. The cardioid method uses the center of the mirror but the very edges of the mirror are also sensitive to leveling errors and can also be used to adjust the level. However, the edges are not as sensitive to leveling errors as the center of the mirror. Note that there may be an angular shift between the direction of the tilt and the maximum of the coma-like deformation. The shift depends on the thickness of mercury.

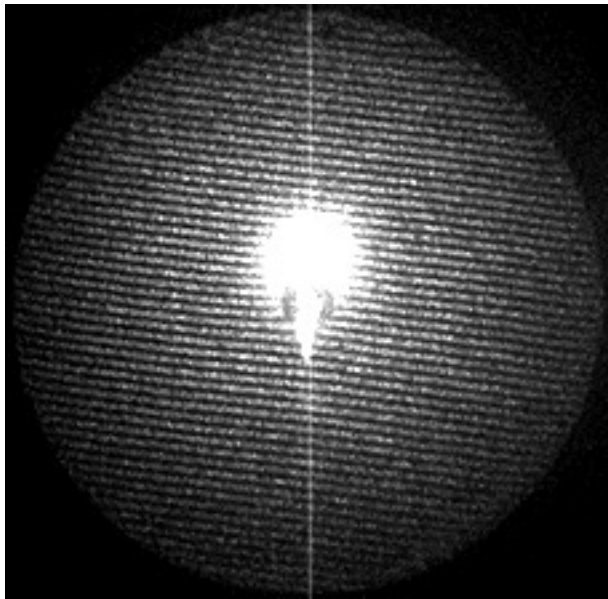
- FIGURE 1: Typical scatterplate interferogram of the 2.5-m liquid mirror having a mercury layer of 0.85 mm. The shadow of the hollow central cylinder, used for mercury manipulation, can be seen below the characteristic hot spot of the scatterplate interferogram.

Figure 1 shows a typical interferogram and Figure 2 shows the wavefront obtained from it. The spatial resolution on the mirror is typically 6X6 cm but we can get resolutions as high as 1.5X4 cm. As discussed in <sup>2</sup> and <sup>3</sup>, we remove from the raw wavefronts mean values of focus, coma and spherical aberrations. The mean values are small and are obtained from averages of several wavefronts. Experiments and computer simulations give us compelling reasons to believe that they are produced by the auxiliary optical components in the testing setup as discussed in previous articles <sup>2, 3</sup>. Independent measurements of a 1.4-m liquid mirror have been made <sup>8</sup>, finding negligible coma and spherical aberration within the uncertainties of the measurements.

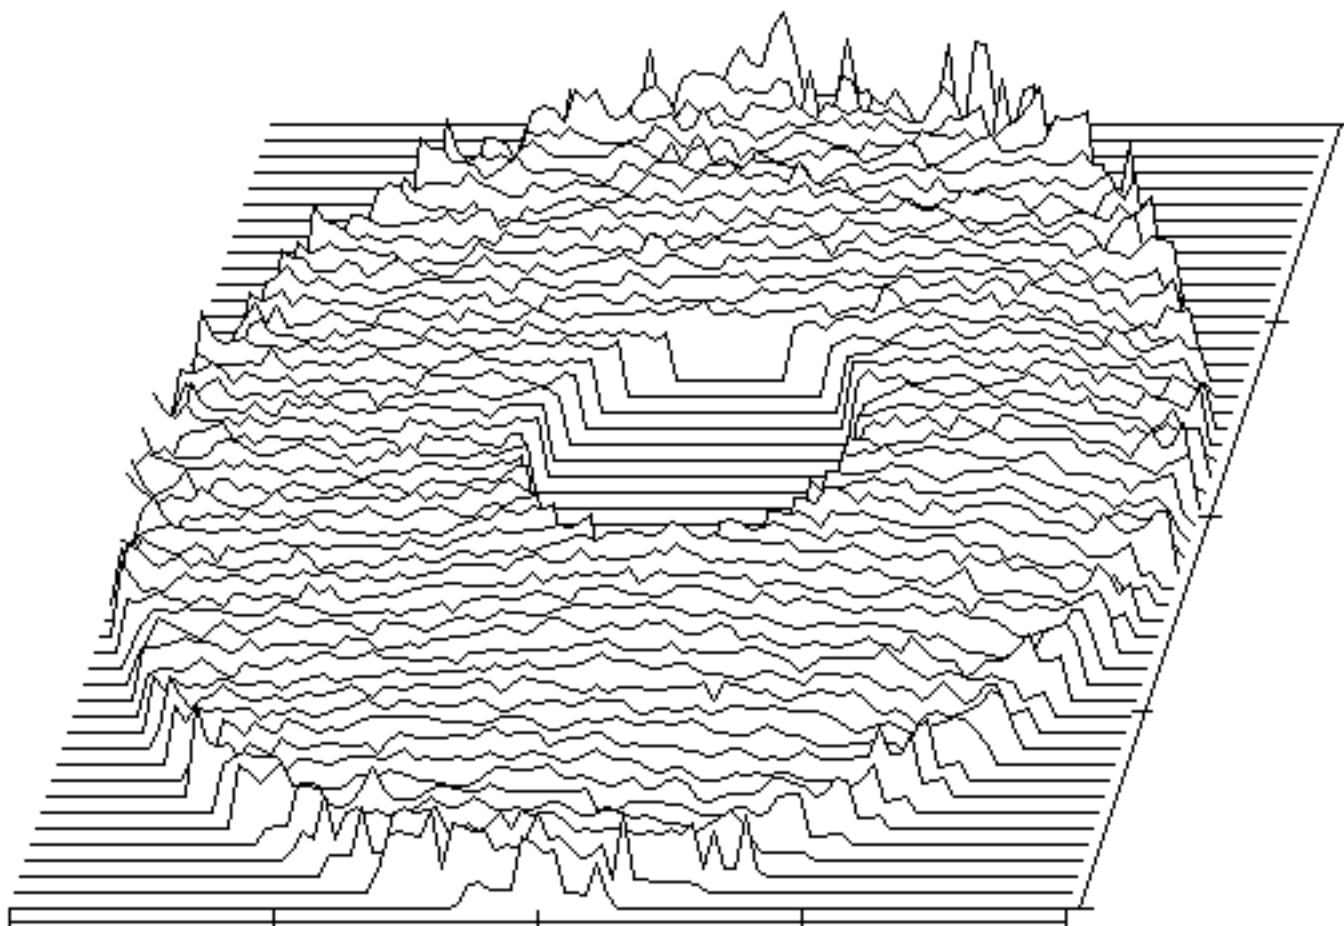
Figure 2

- FIGURE 2: Wavefront of the mirror with a mercury layer of 0.85 mm. This instantaneous three-dimensional rendering of the surface corresponds to the interferogram shown in figure 1.

Rms: 0.052

P-V: 0.448

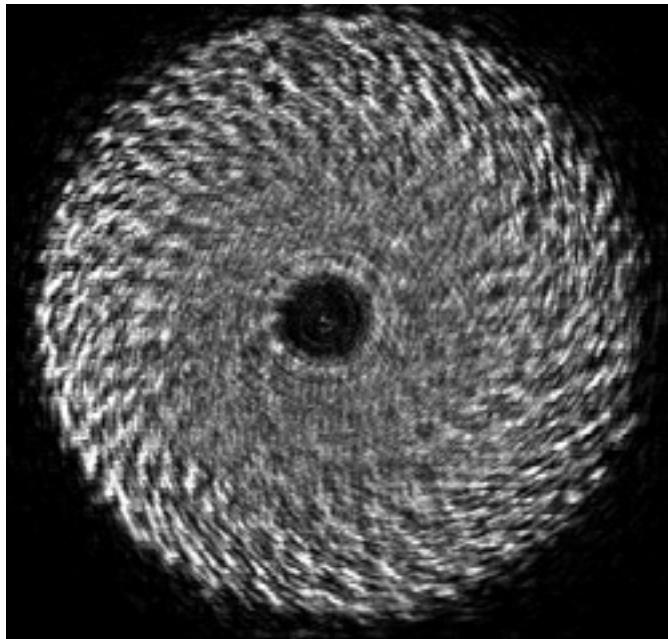
- FIGURE 4: Defocused PSF of the mirror with a mercury layer of 3.0 mm showing the spiral-shaped defects .
- FIGURE 5: Defocused PSF showing the outer region of the mirror with mercury thicknesses of 0.8 and 1.8 mm. The scales are matched so that the edge of the mirror on both images are overlapping. The region from 1.0 m to 1.25 m is missing from the image at 1.8 mm. One can see that the spirals extend much further towards the center of the mirror for the thicker layer.

The surface of the mirror shows spiral-shaped defects, hereafter referred to as “spirals”. The easiest way to see the spirals is to observe an out of focus PSF (Fig.4).

Figure 4 was taken with a layer of mercury 3 mm thick to increase the visibility of the surface spirals. The thicker the layer, the more prominent the spirals and the closer they approach the center of the mirror. For a thickness of 0.5 mm one can only see the spirals up to a distance of about 12 cm from the rim. Note however that stating that the mirror has a thickness of x mm is somewhat misleading. First, the thickness quoted is an average thickness computed from the area of the mirror and the mass of mercury used. Because the mirror sags under the weight of mercury, it is certain that the thickness of mercury is not uniform. Furthermore, the outer 5 cm of the mirror have a greater depth of mercury (6 to 8 mm) needed to stabilize thin mercury layers<sup>2</sup>. Figure 5 shows the outer regions of mirrors having two different thicknesses of mercury (1.8 and 0.8 mm). The scales are matched, but the region from 1.0 m to 1.25 m is missing for the image at 1.8 mm. It shows that the spirals extend much further to the center for the thicker layer. A substantial fraction of the contribution to the spirals obviously comes from the mercury surface because the amplitudes decrease with the thickness of mercury, as expected from liquid damping theory<sup>2</sup>. These observations clearly emphasize the importance of working with as thin a layer of mercury as practical.

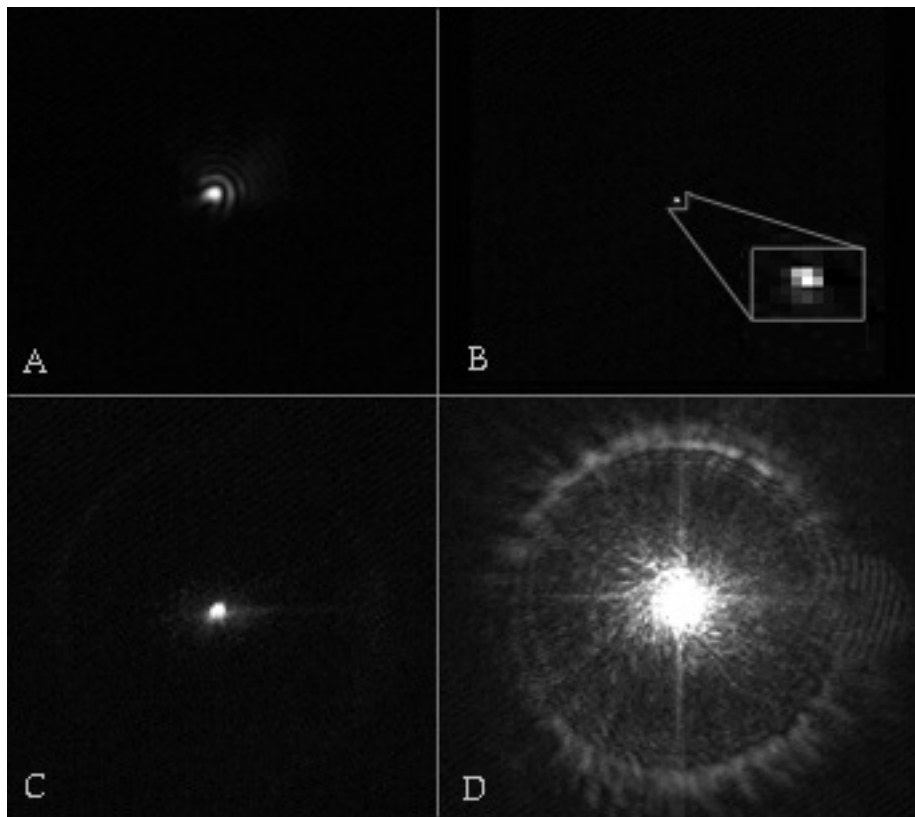
- FIGURE 7: Sequence of PSFs used for scattered light measurements. The individual frames are 30 arcseconds wide. One can see in A an unsaturated PSF observed with a 10X microscope objective. (2.5" FOV). In B, C and D, we show the PSF directly imaged on the CCD with various levels of saturation. In D, one see weak structures far from the center of the PSF (concentric ring, diffraction cross, ghost images, etc.).

We have carried out a detailed study of the scattered light generated by the mirror and its causes. The observations consist of direct observations of the artificial star created by a laser and a spatial filter. We use the same basic instrumental setup of the interferometry, including the null lenses. The measurements were carried out for three distinct mercury thicknesses: 0.54 mm, 0.8 mm and 1.8 mm. Our framegrabber has only 8 bits hence has an insufficient dynamic range to measure an adequate range of the intensity of the PSF, which extends over several orders of magnitude. It is therefore necessary to reconstruct the PSF from series of observations of PSFs having different levels of exposures, some of them with a heavily overexposed core. Figure 7 shows a typical sequence of PSFs. Note that the image in A was taken with a 10X microscope objective. Note also the structure surrounding the heavily saturated PSF at right (Fig. 7.D). This structure is discussed in the remainder of this section. A ghost image is

apparent at the right of the PSF in D. It is subtracted during data reduction. Getting the azimuthally averaged composite PSF involves some technically challenging operations described in <sup>2,3</sup>. Because the light beam encounters a total of 23 surfaces, refracting and reflecting, in its journey from the pinhole to the CCD, there is bound to be a significant contribution from the auxiliary optics in the form of scattered light or parasitic reflections.

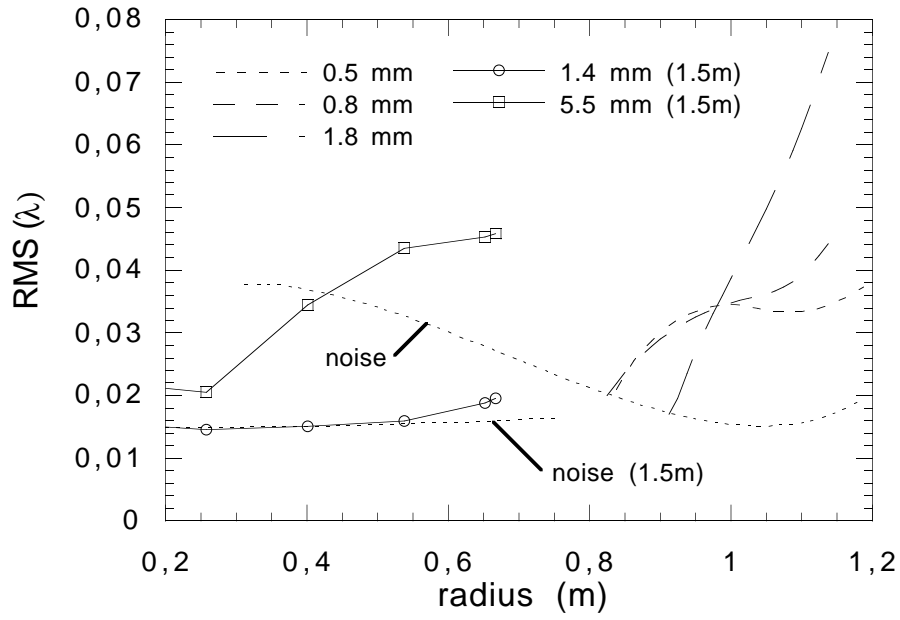
- FIGURE 6: RMS amplitude of the spiral-shaped defects of two mirrors having respectively 1.5-m and 2.5-m diameters. The graph shows that the amplitude is greater for the 2.5-m having a rim speed 1.67 times faster than the 1.5-m. It also indicates that the spirals are an edge effect.

We have studied quantitatively the spirals with the scatterplate and the Shack interferometers. Figure 6 summarizes the main information. The figure displays the RMS amplitudes of the spirals measured on the 2.5-m mirror for three thicknesses of mercury as identified on the figures. The data do not extend further inward than 0.8 meters because the amplitudes decreased below detection. Taken at face value Figure 6 indicates that, between 0.85 and 0.95 m, the spirals were stronger for 0.8-mm and 0.5-mm layers than for 1.8-mm layers. This conclusion is mistaken because the measurements were very difficult and, the amplitudes of the spirals being small, the signals tend to be comparable to the noise of the interferometer. Also, the interferometry has a resolution barely sufficient to spatially resolve the spirals. As a consequence, the information contained in Figure 6 must be considered with some caution. One can trust the general trends displayed in the figure, more than the absolute values or detailed features of the curves.

In the same figure, we have plotted the amplitudes of the spirals measured by Content<sup>11</sup> on a 1.5-m liquid mirror. Content made his measurements for thicknesses of mercury that differ from ours but there is enough thickness bracketing to allow us to make a meaningful comparison. Comparing the amplitudes at the rims of the 2 mirrors, we can see that, for a given thickness, the amplitudes of the spirals are greater at the rim of the 2.5-m than they are at the rim of the 1.5-m. This is to be expected since the rim of the 2.5-m travels 1.67 times faster than the rim of the 1.5-m. We can also see that extrapolating the amplitude of the spirals beyond 0.7-m radius and 1.4-mm thickness on the 1.5-m predicts amplitudes that are too large when compared to the data taken with the 2.5-m. This is consistent with the assumption that the spirals are an edge effect. This assumption

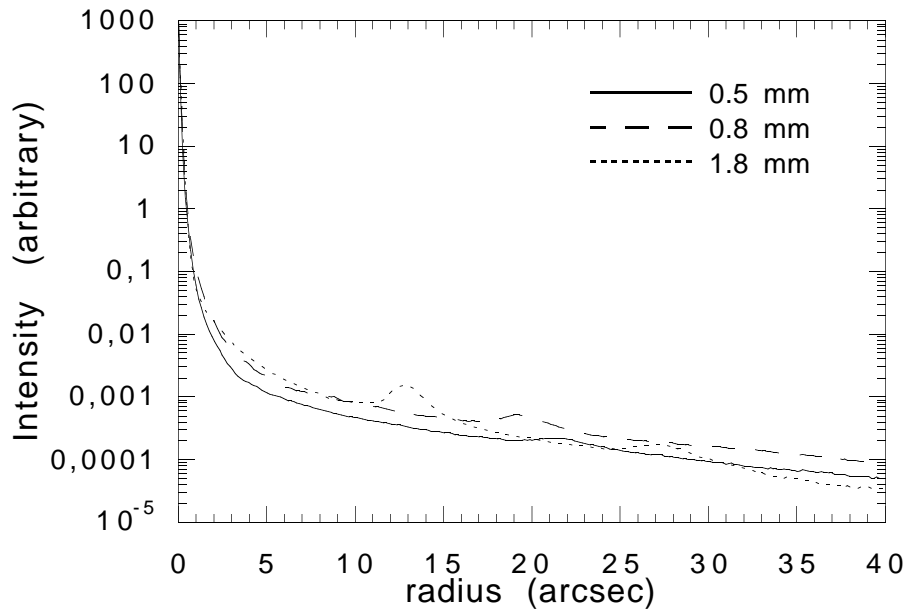
- FIGURE 8: Azimuthally averaged PSFs obtained for three mercury thicknesses on the 2.5-m liquid mirror. They show that scattered light decreases with mercury thickness. The bump at 12.8" for the curve at 1.8 mm is caused by concentric waves on the mirror.

Figure 8 shows the composite PSFs obtained for the three mercury thicknesses. We can see that scattered light decreases with the thickness of mercury. This decrease quantifies what one sees by looking at the pupil of the mirror revealed by the out-of-focus PSF: that spirals and concentric rings decrease with thickness. The decrease appears particularly important going from 0.8 mm to 0.5 mm. The prominent bump at 12.8 arcseconds, for the 1.8-mm layer is due to the concentric rings seen in Figure 7, while the spirals contribute mostly to the region from 2 to 10 arcseconds. There is some inconsistency for radii  $> 15$  arcseconds where the figure seems to indicate that the thicker layer actually has less scattered light than the thinner ones. However, one should not attach too much significance to that region. The far wings are less reliable since difficulties in joining the PSFs and estimating the background contribution particularly affect those regions

A straight comparison of the three curves in figure 8 underestimates the importance of working with thin mercury layers. To stabilize thin mercury layers, a groove is present around the rim of the container <sup>2</sup>: As a consequence, there always is a thicker layer of mercury at the rim. Although the 5 mm deep groove is present for all thicknesses, it is relatively more important for the thinner layers. As a consequence, damping is not improved that much at the rim by decreasing layer thickness, particularly for the thinner layers. We can see this by looking at an out-of-focus image of the PSF. Figures 9 and 10 quantify this observation. We show three PSFs (Fig. 9) as well as three encircled energy curves (Fig. 10) obtained with a 0.5-mm layer: for the complete mirror, the mirror with a diaphragm that excludes the outer 12% of the radius, as well as the whole mirror with a 0.41 arcsecond leveling error. One can see that the mirror with a diaphragm has substantially less scattered light than the whole mirror. We can also see that a small leveling error does increase the amount of scattered light. This last issue is further discussed in section 3.3. A similar figure for 0.8 mm <sup>9</sup> shows a similar, but smaller, difference between the mirrors with and without a diaphragm, a result which was expected. The difference is substantially smaller for the 1.8-mm layer <sup>9</sup>.

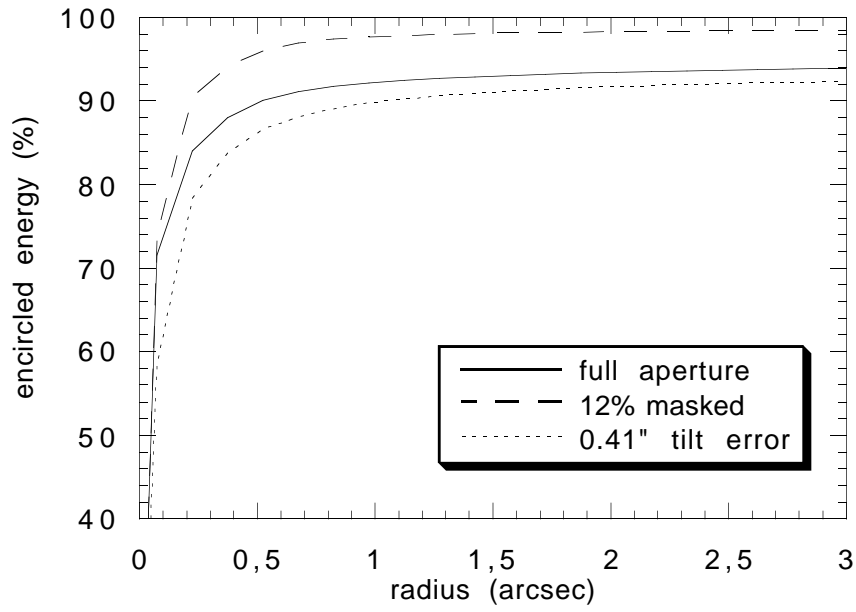
Figure 9

- FIGURE 9: Azimuthally averaged PSF obtained with a 0.5 mm mercury layer for the complete mirror, the mirror with a diaphragm that excludes the outer 12% of the radius, as well as the complete mirror with a 0.41" leveling error.

Figures 9, 10, 11 indicate that leveling errors introduce scattered light. However, tilt-induced misalignments of the null lenses complicate scattered light measurements with leveling errors by affecting the normalization of the PSF. We correct for this effect but there is a significant uncertainty associated with this correction, especially with the 0.41 arcseconds data. To further investigate the effect of a leveling error on scattered light, we have introduced a 1.25 arcsecond leveling error on a mirror having 0.8 mm of mercury. The larger leveling error allows us to discriminate more easily between real leveling-induced scattered light and an erroneous correction for coma. Figure 11 shows four PSFs taken with a 0.8-mm thick layer. Three PSFs were taken consecutively with the same mirror adjustment. Because we were concerned with scattered light measurements that illustrate the effects of the wind and level misalignments, and that, consequently, we are looking for relative changes in scattered light, we did not optimize the painstaking adjustment of the null lenses necessary to obtain a high value of the Strehl ratio. As a consequence the core of the PSF suffers from some null-lens-induced coma and, mostly, spherical aberrations. These aberrations are not on the mirror. The PSF labeled “reference” shows, for comparison, a PSF obtained with good alignments of the null lenses. This is

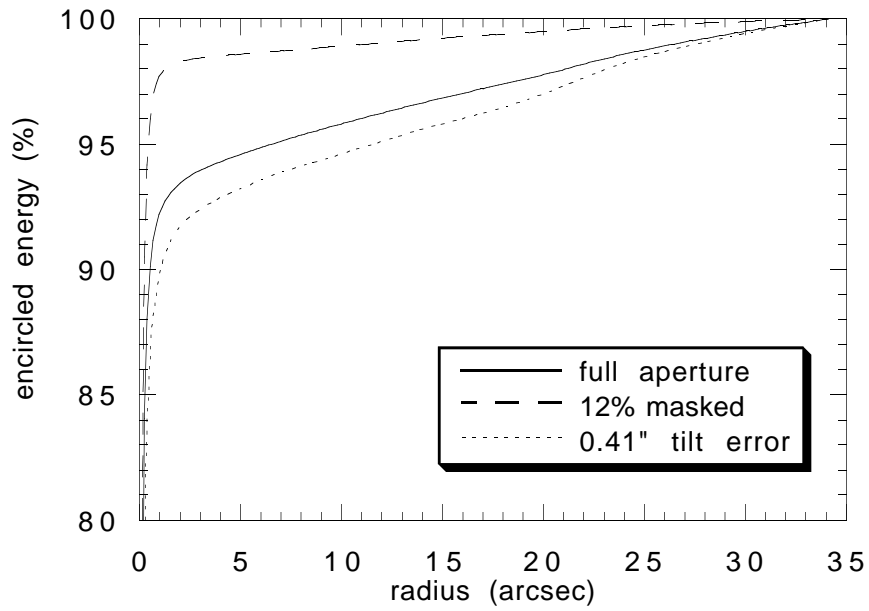
Figure 10

- FIGURE 10: Encircled energy curves obtained with a 0.5-mm mercury layer for the entire mirror, the mirror with a diaphragm that excludes the outer 12% of the radius, and the entire mirror with a 0.41" leveling error.

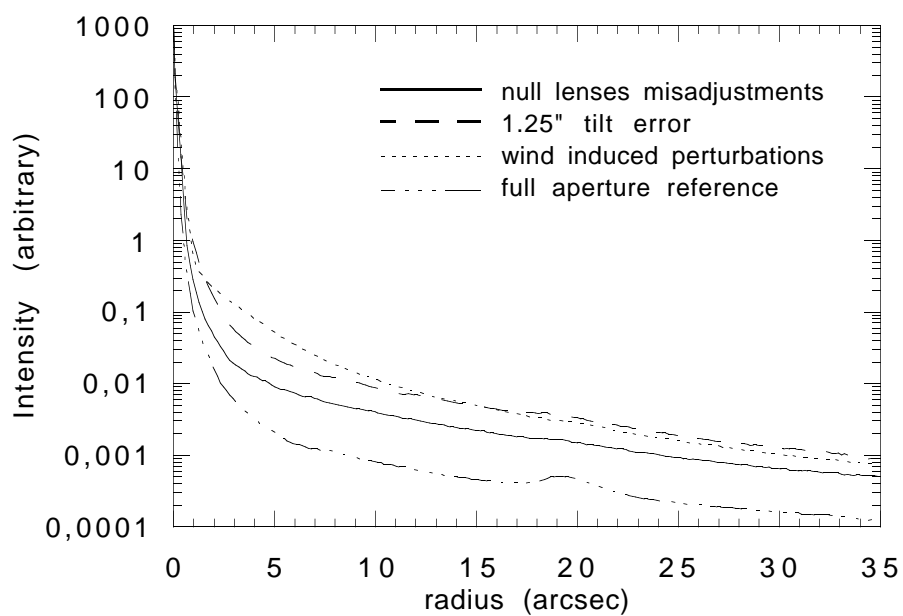
- FIGURE 11: Azimuthally averaged PSF obtained with a 0.8-mm mercury layer for the mirror under perturbation. Three curves are obtained with the same null lenses alignments: the complete mirror without external perturbation, the mirror with 1.25" leveling error, and the mirror perturbed with a few km/h wind. The reference for a 0.8 mm mercury thickness, with good null lenses alignments, is also shown.

the PSF displayed in Figure 8. The difference between the 2 PSFs at 0.8 mm thickness illustrates the fact that misalignments of the null lenses influence scattered light measurements by affecting the normalization of the PSF. Figure 11 shows that a tilted mirror has excess scattered light. This scattered light comes from a coma-like surface deformation that is caused by a leveling error <sup>2</sup> and from an increased print-through. This coma-like deformation is on the mirror, unlike the coma and spherical aberrations that come from misaligned null lenses. Eye inspection of out of focus PSFs shows that a leveling error introduces more print-through. This is presumably due to the fact that a leveling error causes the mercury layer to slosh over the surface of the container.

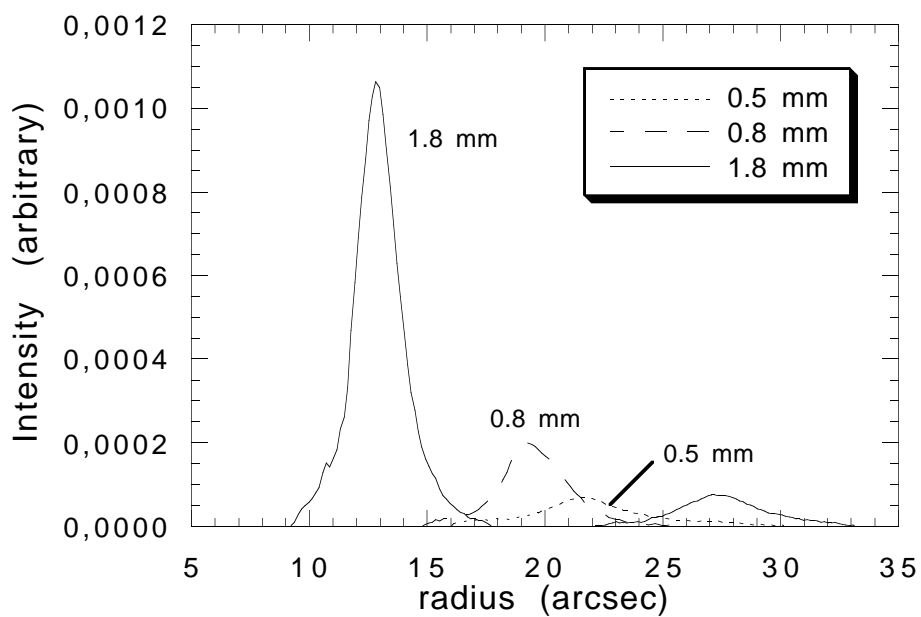
- FIGURE 12: Azimuthally averaged rings extracted from PSFs at various thicknesses of figure 8. These rings are caused by concentric waves on the surface of the mirror acting as a phase grating.

We have extracted the contribution from the vibration induced bumps by subtracting the continuum of the PSF. The bumps so extracted are shown in Figure 12 for three mercury thicknesses. Note the decrease in amplitude with decreasing thickness, illustrating once more the importance of working with thin layers. Also note that the location of the bumps changes with mercury thickness, indicating that the resonant frequency of the mirror has changed. This is not surprising since mercury contributes significantly to the mass budget of the mirror. However, the location of the bumps cannot be modeled with a naive harmonic oscillator formula where the mass dependence is given by  $\sqrt{\text{mass}}$ . Presumably this is due to the complexity of the system that contains an air bearing and a

composite material container. It must also be noted that Figure 12 is for a complete mirror. Visual inspection of an out-of focus PSF shows that for the 0.8-mm layer and, especially, the 0.5-mm layer, the concentric waves are much more prominent at the very center of the mirror (masked for the data in Fig. 12) as well as the rim, a behavior expected from the fact that the layer of mercury is thicker at the edges.
